Collision between freight trains 1901S and 5132S

Dry Creek, South Australia | 11 October 2011

ATSB Transport Safety Report

RO-2011-016

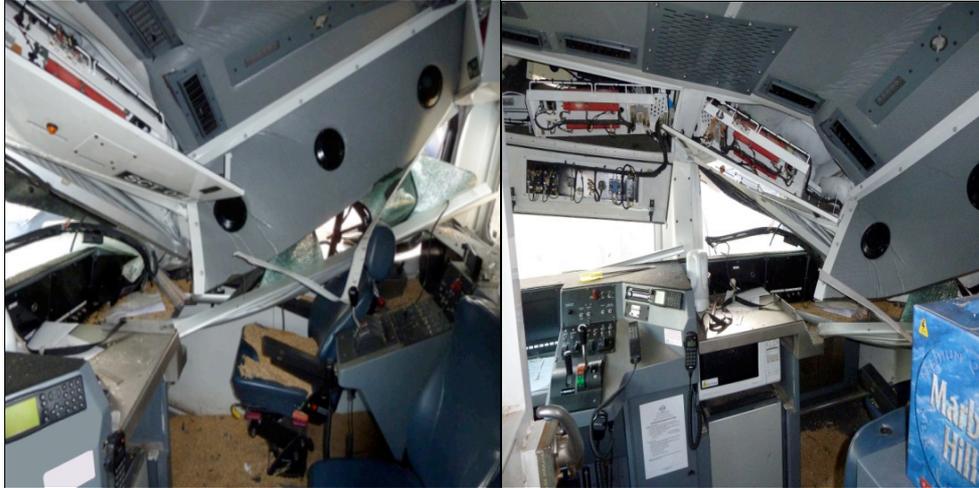
Figure 3: Internal collision damage to locomotive SCT 014 driver compartment

The collision resulted in significant damage to the right-hand side of the driver compartment (Figure 3) and lead bogie of the lead locomotive, SCT 014, of train 1901S. The extent of damage meant that the locomotive was not movable until the completion of an inspection and temporary repairs on site.

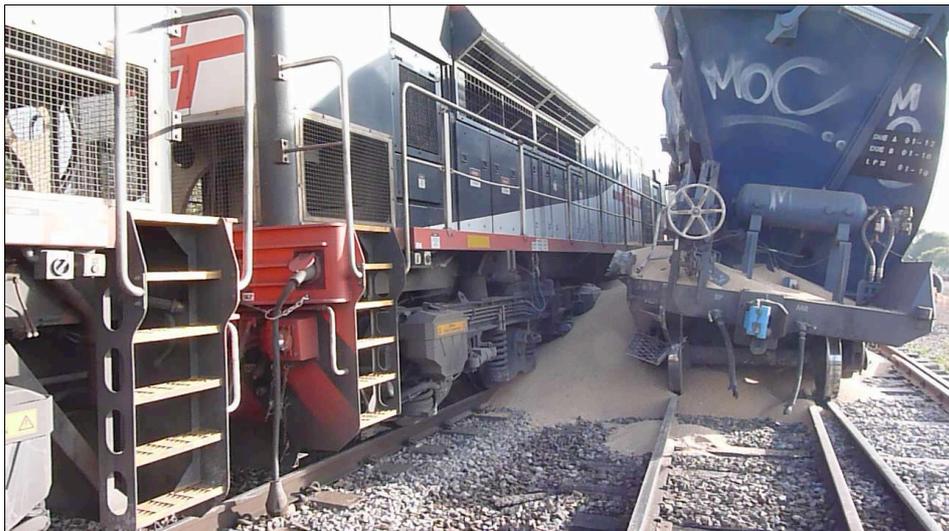
Figure 4: Collision damage to the side of CGAY 896D

The impact with train 5132S was approximately mid consist, resulting in significant damage to three wagons (CGAY 899H, CGAY 896D, CGAY 903D), splitting the side of each and causing grain to spill onto the track (Figure 4). The impact force from the collision also caused wagons CGAY 896D and CGAY 903D to derail.

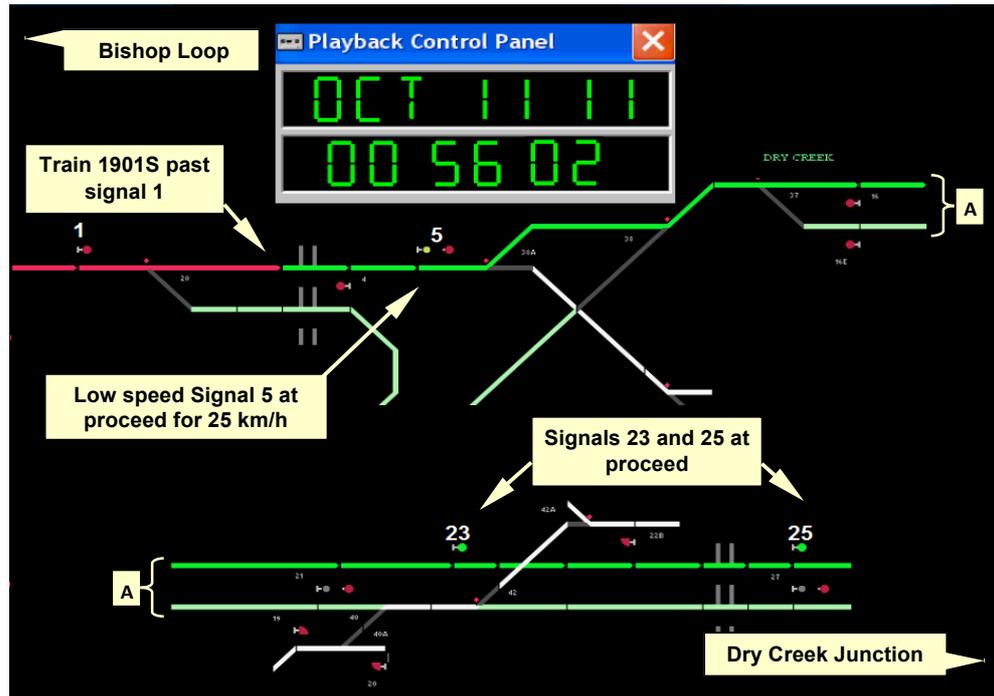
Figure 5: Reconstruction of Phoenix playback showing signal indications as train 1901S passed signal 1 and entered triangle

Train 1901S departed Bishop Loop arriving at signal 1, Dry Creek South at about 0033. When train 7DA2 and the light engines had vacated Dry Creek South, signal 1 cleared to proceed. Train 1901S entered the triangle connecting the railway from Pelican Point to the main line (Figure 5) passing signal 1 at 0056:02. The driver then proceeded to advance train 1901S through Dry Creek in accordance with the signal indications.

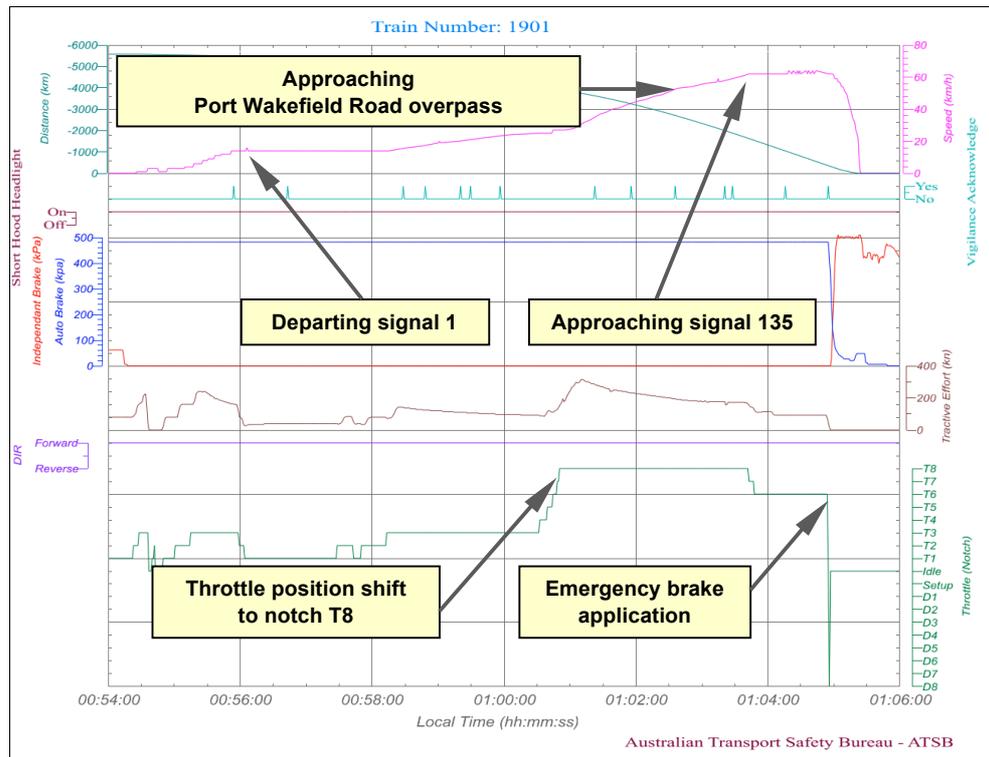
Figure 6: Data log extract from train 1901S showing speed and throttle settings as it approached signal 135

As train 1901S progressed through Dry Creek, the driver and co-driver cross checked the signal indications and discussed an appropriate driving strategy for the track ahead. They determined that there was a slight rising grade¹⁰ and decided to accelerate the train to a target speed of 60 km/h due to a Temporary Speed Restriction (TSR) of 60 km/h just prior to the Mawson Overpass at Dry Creek North. To achieve the target speed, the driver began to apply power increasing the train speed as they approached signal 25 at Dry Creek. An examination of the locomotive data log confirms the application of power to throttle notch T8 (full power position). The data log also shows the throttle remained in notch T8, increasing the train speed towards 60 km/h (Figure 6) as the train passed signal 135.

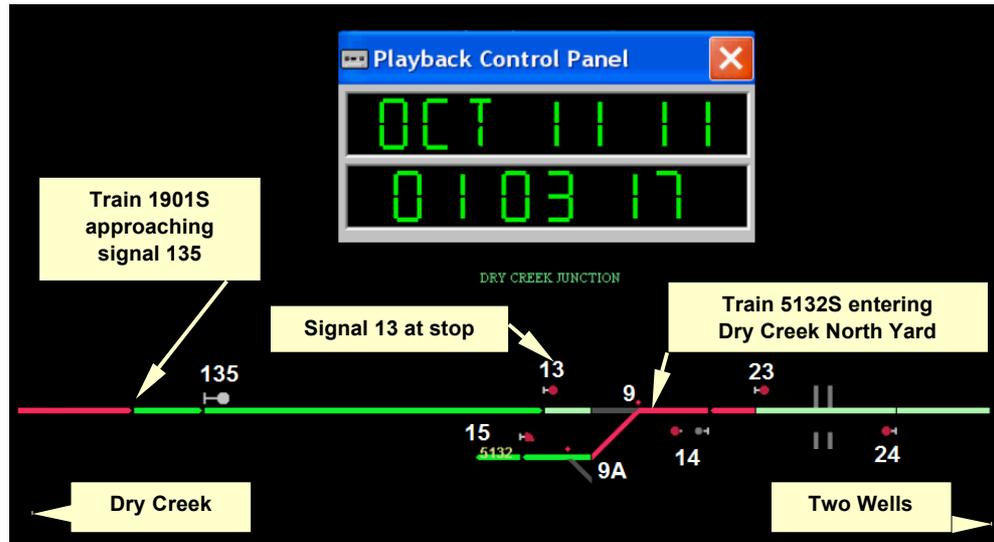
Figure 7: Extract from Phoenix playback, Train 1901S as it approached signal 135 and Train 5132S entered Dry Creek North Yard

There was, however, no locomotive shunting within the Dry Creek North Yard at that time. An examination of the Phoenix playback later established that the headlight was that of the lead locomotive (705) on train 5132S, which was moving southwards and entering the Dry Creek North Yard (Figure 7).

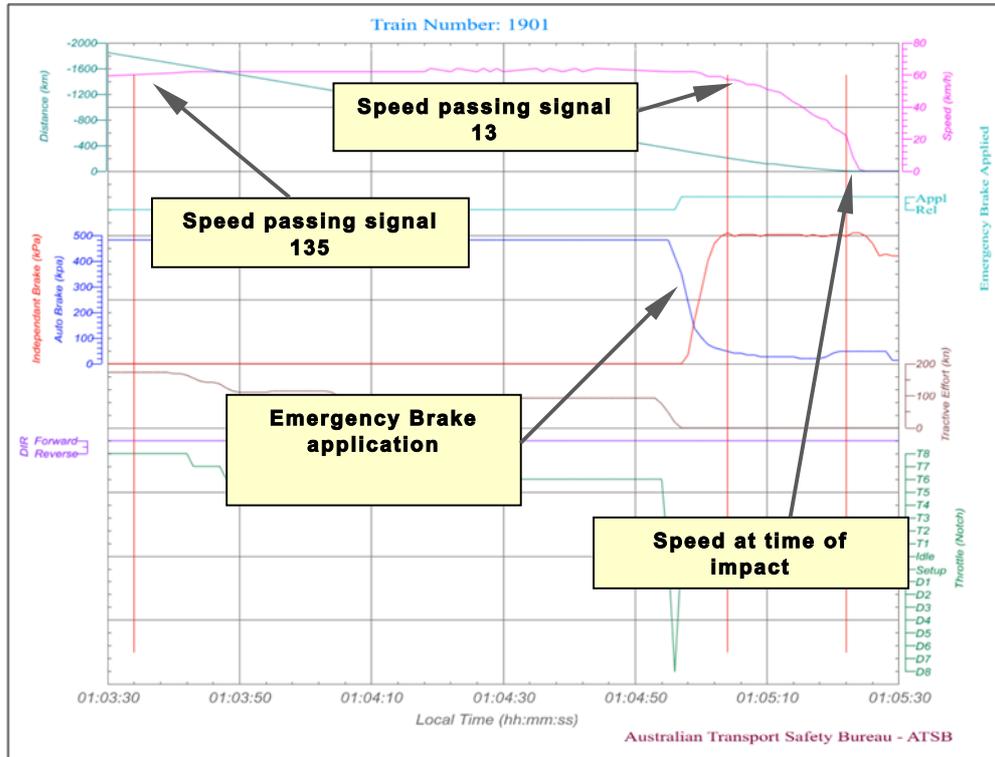
Figure 8: Data log extract from train 1901S showing the relative position of signals 135 and 13, and the speed at time of impact with train 5132S

As 1901S progressed towards Dry Creek Junction, the driver continued to maintain a relatively constant speed of about 60 km/h. The driver remained distracted by the bright headlights ahead and, believing that the opposing train was engaged in shunting operations in the yard, he flashed his headlight to prompt the driver of the locomotive ahead to dip his lights.

The data log of locomotive SCT 014 recorded that at 0104:57 (approximately 100 m from signal 13) the driver made an emergency brake application. Train 1901S passed signal 13 displaying a stop aspect at 0105:03, and travelled a further 218 m before colliding at a speed of approximately 22 km/h with the wagons mid consist of train 5132S.

An examination of the data log from SCT 014 found that 1901S was travelling at a speed of 62 km/h immediately prior to the emergency brake application, at a distance of 321 m from the point of collision. The application of emergency braking decelerated train 1901S to a speed of 22 km/h at the point of collision with train 5132S.

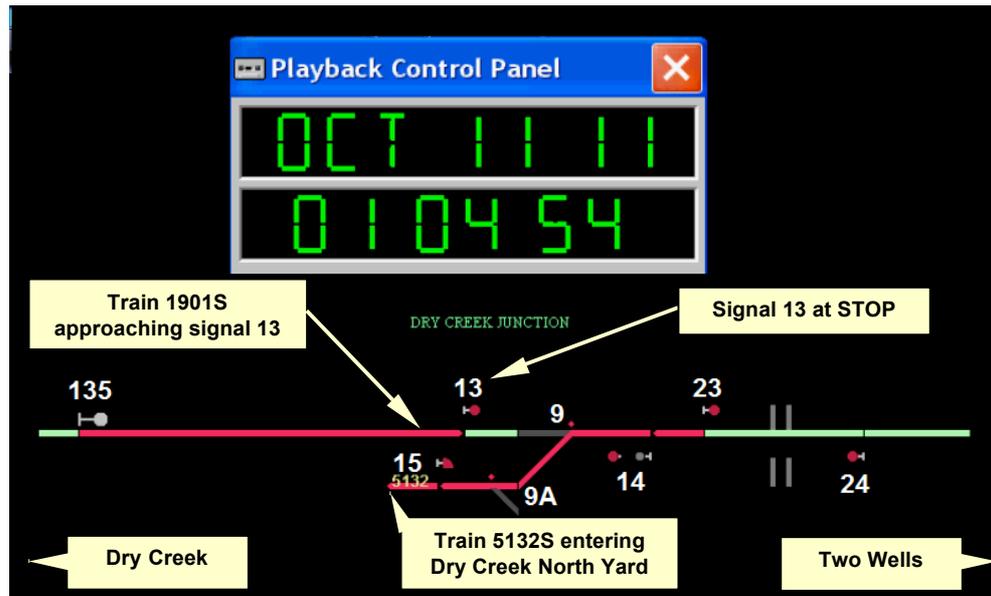
Figure 9: Extract from Phoenix playback, train 1901S approaching signal 13

It was established that when train 1901S had passed the lead locomotive of 5132S, the driver and co-driver (1901S) sighted signal 13 at stop (Figure 9) and saw the back end of train 5132S occupying the main line ahead.
