Multiple SPAD by freight train 9837

Hurlstone Park, New South Wales | 30 January 2013

ATSB Transport Safety Report

RO-2013-003

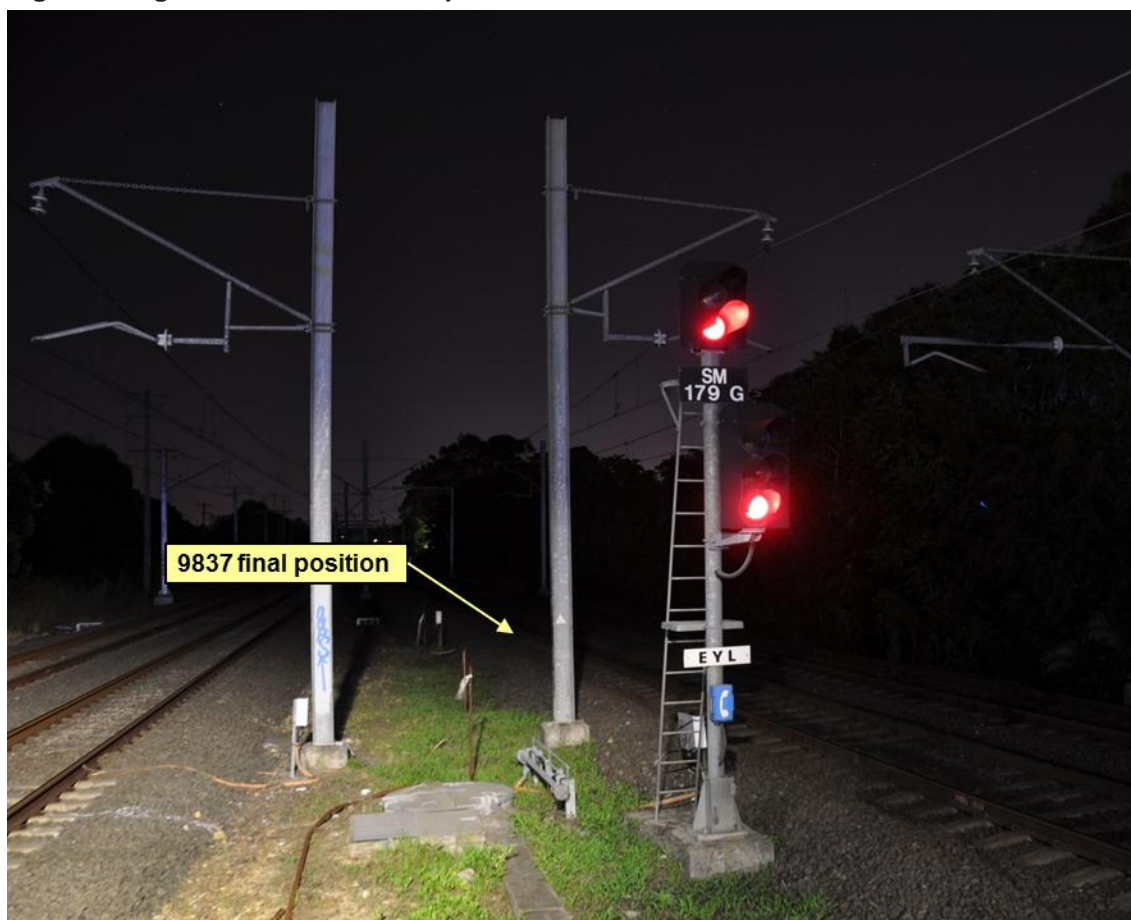
Figure 2: Signal SM179G and final position of front of 9837 after the SPAD

The second SPAD occurred at 0230:17 when train 9837 passed signal SM115G while it was displaying a stop indication. Shortly after passing this signal the driver reduced the throttle from power to idle. The driver made a brake application around signal SM179G which was displaying a clear indication (green light over green light) which brought the train to a stand approximately 33 m past signal SM179G (Figure 2).

The train came to a stand approximately 33 m past signal SM179G, which was 701 m past the first signal at stop and 310 m past the second signal at stop. Signal SM179G was not passed at stop as it was showing a clear aspect. It is an automatic signal which means it is one that cannot be controlled by the area controller but instead operates according to track circuits. The configuration of the tracks and signals at Hurlstone Park is shown below (Figure 4).

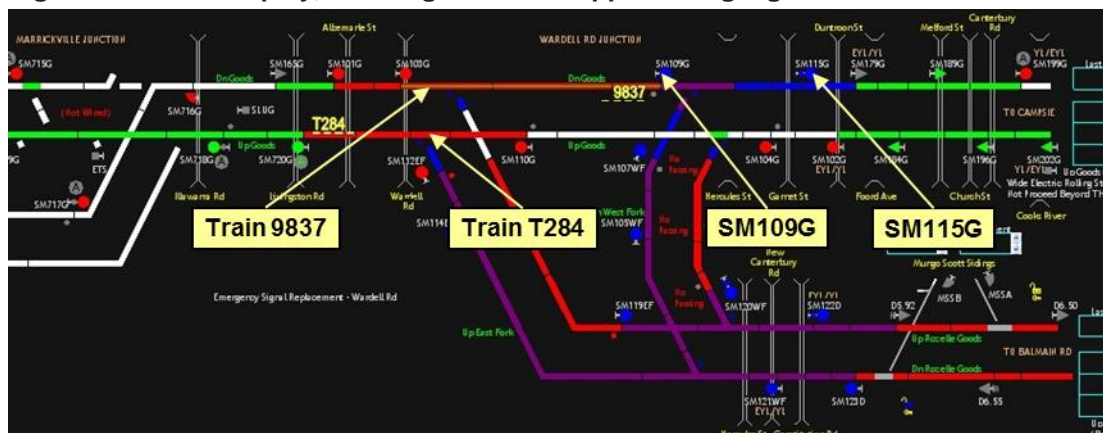
Figure 6: ATRICS replay, showing train 9837 approaching signal SM109G

The ATRICS system has a replay capability which investigators used to review the operation of the system and trains on the night of the incident. Figure 6 shows train 9837 approaching the first of the two stopped and blocked protecting signals, SM109G.

Examination of the ATRICS replay revealed that, when the area controller utilised a command in ATRICS to block signals SM109G and SM115G, the track beyond those signals, in the usual direction of travel, changed from white to blue, indicating a block on the section. The colour changes demonstrate there is recognition of physical changes to the track conditions at the software level.

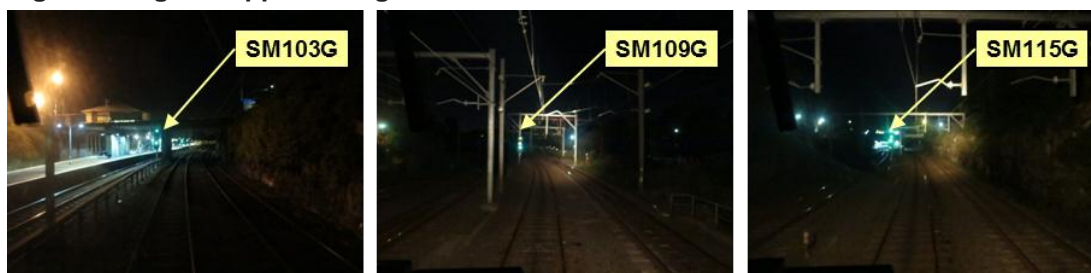
Figure 7: Signals approaching Hurlstone Park

The signal engineer also conducted signal sighting tests on 31 January 2013 at 0400 to replicate the conditions on the morning of the incident. He found signal SM103G to be operational with: 'no obstructions or impediment to sighting.' There was clear sighting differentiation between this signal and another nearby signal SM171B on the Down Bankstown line. There was no report of any signal malfunction or problem with signal visibility with any other signal in the vicinity of the incident.

NSW Office of Transport Safety Investigations (OTSI) investigators travelled in the front cab of a locomotive on 7 March 2013 at 2200 and conducted an inspection of the signals during similar lighting conditions experienced during the incident. Photographs were taken of the key signals (Figure 7). They observed that the signal indications were clearly visible, there were no physical impediments to visibility, and that ambient or background lighting was unlikely to have caused any confusion between signals.
