Safeworking breach involving a Local Possession Authority

Revesby, New South Wales | 10 July 2013

ATSB Transport Safety Report
Rail Occurrence Investigation
RO-2013-017
Final – 19 September 2014

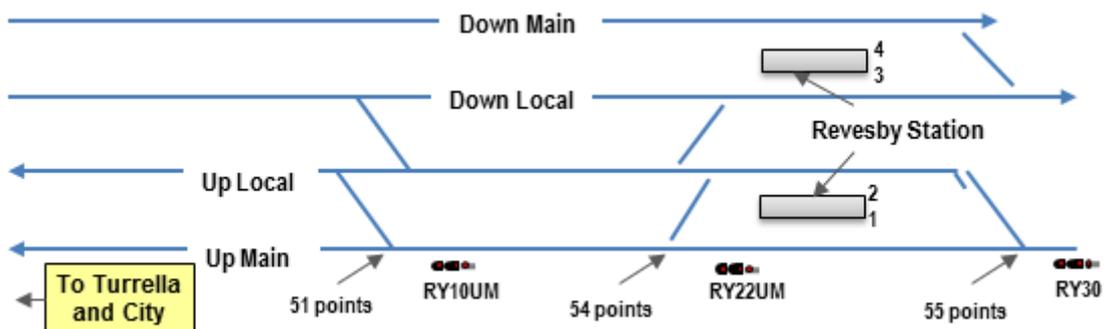
Figure 1: Diagram of configuration of track and signals at Revesby

At 0913 the train controller (TC) contacted two area controllers (ACs), both located at Sydenham signal complex, to discuss a possession³ which was due to commence at 0930. These ACs were on the Wollie Creek Panel (controlling the Turrella end of the possession) and Revesby Panel (controlling the Revesby end). The possession protection method to be used was Local Possession Authority (LPA), which is used to close a defined portion of track for a specified period. LPAs must be advertised in a Special Train Notice (STN)⁴ at least seven days in advance and two STNs were issued advertising the work – STN 1003-2013 (the ‘proforma’ STN which showed the possession ‘limits’ or boundaries) and STN 1004-2013 (which showed the train running/pathing). In anticipation of the possession going ahead at the appointed time, the train controller initially sought four assurances from the ACs – that they had a copy of the STN, they understood the limits of the LPA, that the section was clear of rail traffic and relevant blocking facilities⁵ were applied. The train controller received affirmation from both ACs and he then stated the limits of the possession as: ‘Up Main line Revesby clear of 55 crossover back to Turrella clear of 502 crossover’ (the track layout at Revesby is shown in Figure 1). For his part, the AC rostered on the Revesby Panel assumed the possession was clear of 51 points at Revesby, an assumption reinforced by his recollection of the pathing for up services in a previous possession configuration, and the pathing on STN 1004, which incorrectly pathed city-bound services via 51 points.

At 1045, the relief AC on the Revesby panel made preparations for the next city-bound passenger service (709C) and set up a similar route to that of 707D, that is a route past 55 points, along the Up Main line through Revesby and across 51 points (refer to Figures 1 and 5).

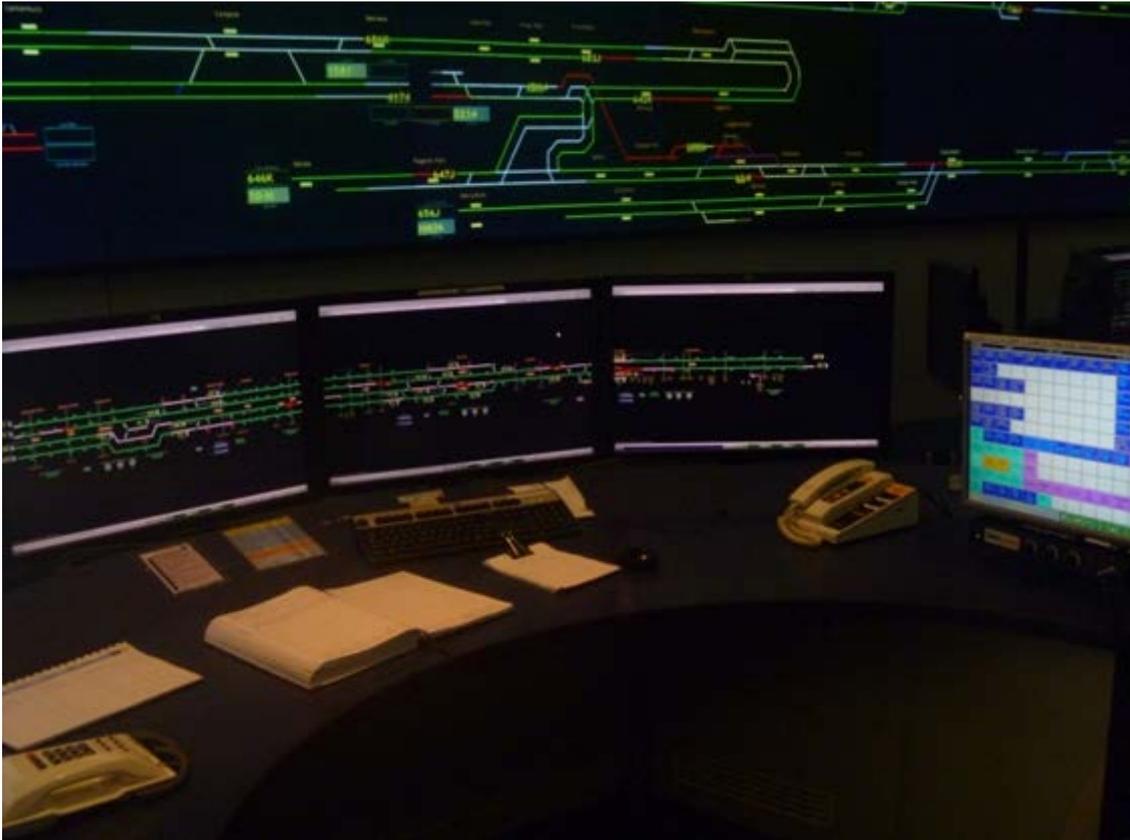
Figure 3: Sydenham signal complex – Revesby control panel

The Advanced Train Running Information Control System (ATRICS) is used throughout much of the Sydney Trains network and has been in use at the Sydenham signal complex since 2002. It provides a diagrammatic display which allows controllers to interact directly with the rail network by controlling signals, points and other signalling equipment through a computer mouse. It is a non-vital¹³ centralised traffic control system which enables real time monitoring and control of the signals and points. The area controller's area of responsibility is displayed over multiple LCD monitors. The Revesby control panel is shown in Figure 3.

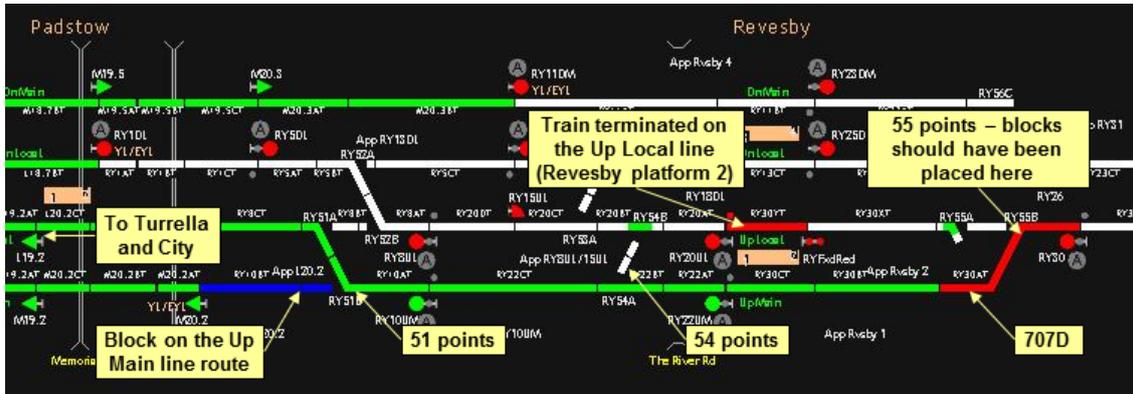
Figure 4: ATRICS replay at 1020, showing position of train 707D when LPA in force

The ATRICS system has a replay capability which investigators used to review the operation of the system and trains on the day of the incident. Figure 4 shows train 707D approaching Revesby station at 1020 when the LPA commenced and the blocked route protecting entry to the Up Main line beyond 51 points.

Figure 4 shows that the area controller had set up routing for train 707D via the Up Main line back through 51 points so that the train could bypass a train that had terminated on the Up Local line (Revesby platform 2). This particular routing of 707D would not have been possible if blocks were placed according to STN 1003: that is, clear of 55 points and preventing entry to the Up Main line.

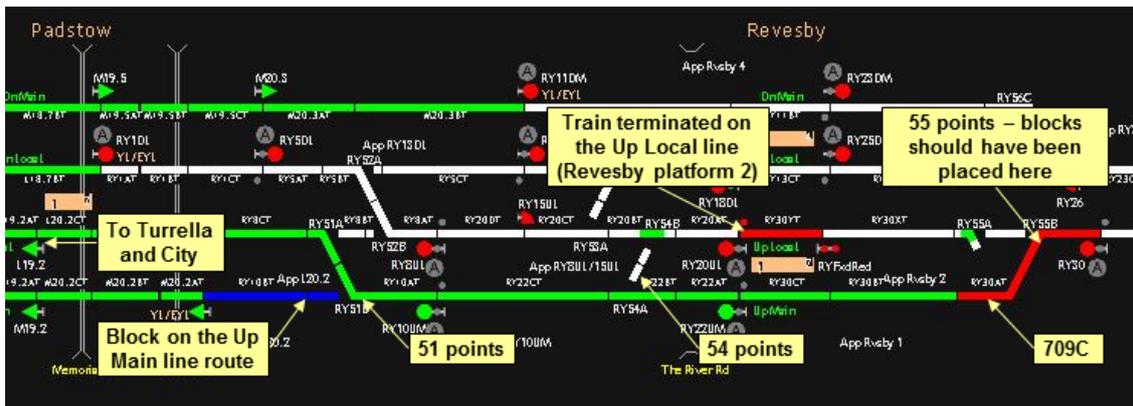
Figure 5: ATRICS replay at 1049, showing train 709C when it struck LPA possession protection detonators

Figure 5 shows train 709C approaching Revesby station at 1049 and the same blocked route protecting entry to the Up Main line beyond 51 points.

Examination of the ATRICS replay revealed that when the area controller utilised a command in ATRICS to block the route/track, the track beyond 51 points, in the usual direction of travel, changed from white/green to blue, indicating a block on the route. The colour changes demonstrate there is recognition of physical changes to the track conditions at the software level.
