# Safety Investigation Report

## Double overrunning of signals by an international train Antwerpen-Luchtbal - 1 November 2015

| <b>Basic facts:</b> | at the exit of the Antwerpen-Centraal tunnel, the E9227 train overran the signals G-R.12 and J-R.12, in a closed position, on the L.25. No route was defined towards the L.12: the train continued its journey on the L.4 where it came to a standstill after the intervention of surveillance staff from Block 12 Antwerpen-Berchem. |

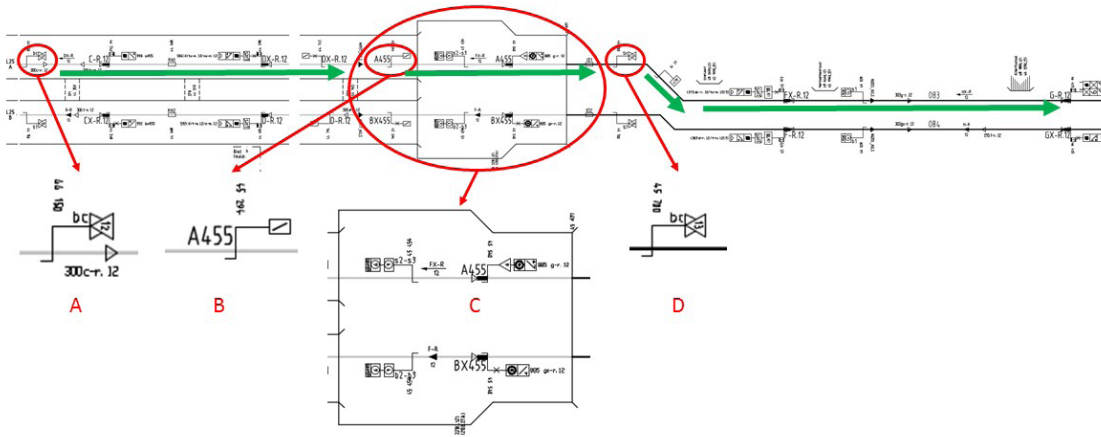
Line 25: SSD (Schematic Signalling Diagram) between Antwerpen-Centraal and the Luchtbal junction

The signalling between Antwerpen-Centraal and Antwerpen-Luchtbal is explained using the schematic signalling plans below. The route followed and the route to be followed are shown using arrows.

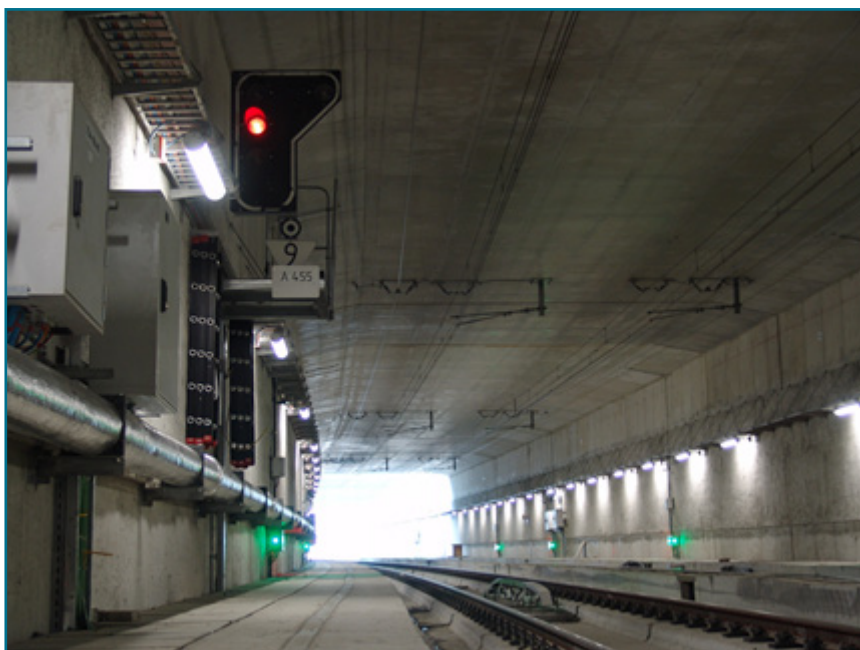
### Signal A455

The signal A455 is located at the end of the tunnel, where the tunnel goes into a partially open-air shaft.

The visibility of the signal A455 is good but its position after a bend means that its aspect may be seen late.

To correct this problem, the signal is repeated before the bend (see after).

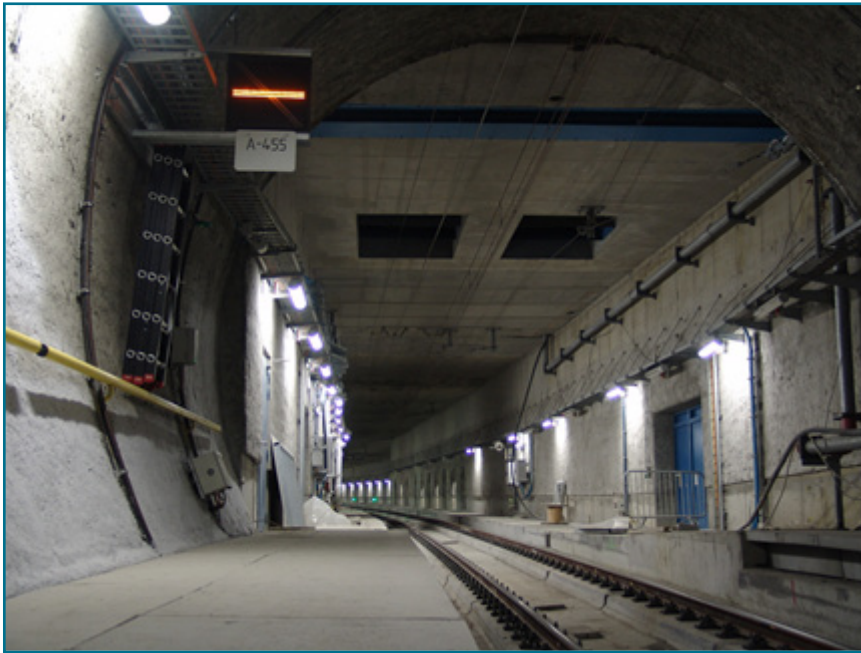
The repeating signal A455 is located in the tunnel, 250 m before the A455 signal.

The visibility of the repeating signal is good.

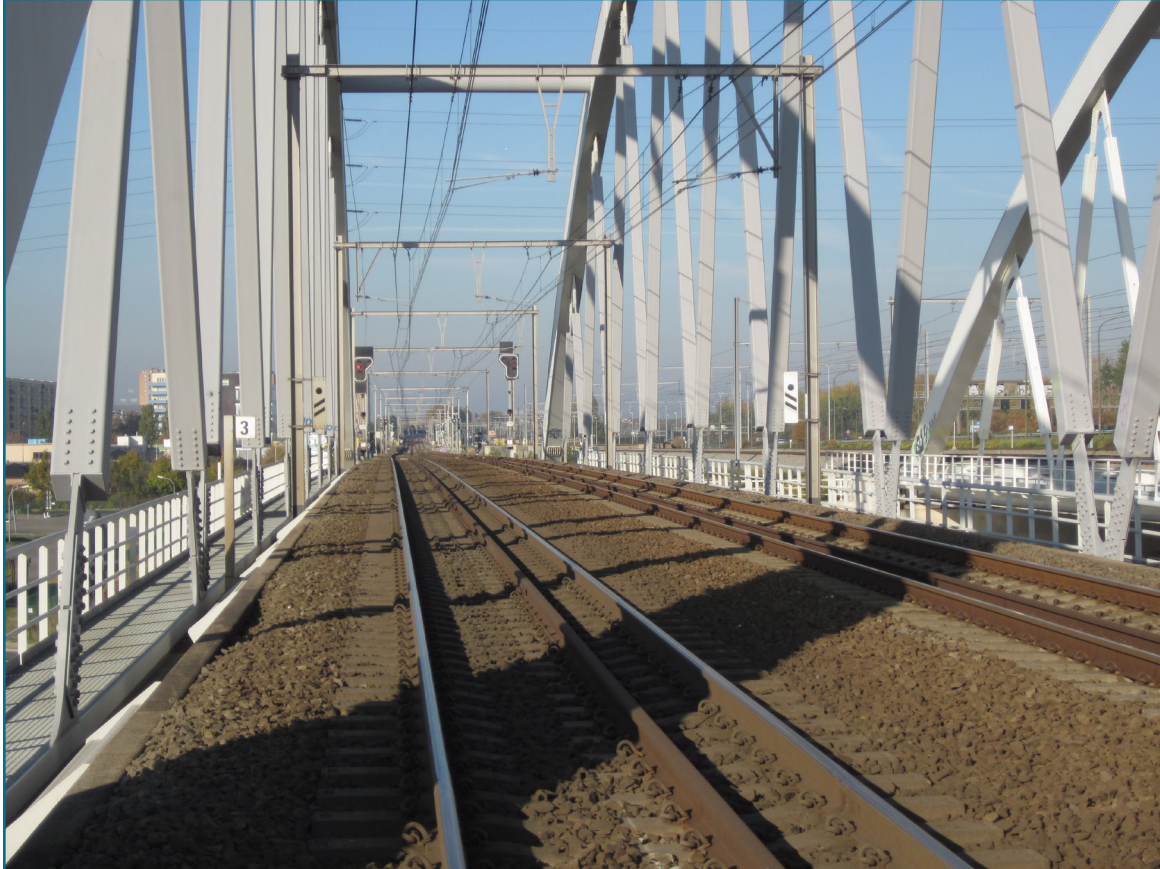
The signal G-R.12 is located 885 m after the signal A455 and 100 m after the end of the bridge on the Albert Canal.

The visibility of the signal G-R.12 is good.

Coming from Antwerp, the track goes up to this bridge. After the bridge, the track descends in the direction of the Netherlands. The signal G-R.12 is oriented towards the south and is raised so as not to be hidden by the “crest of the bridge”.

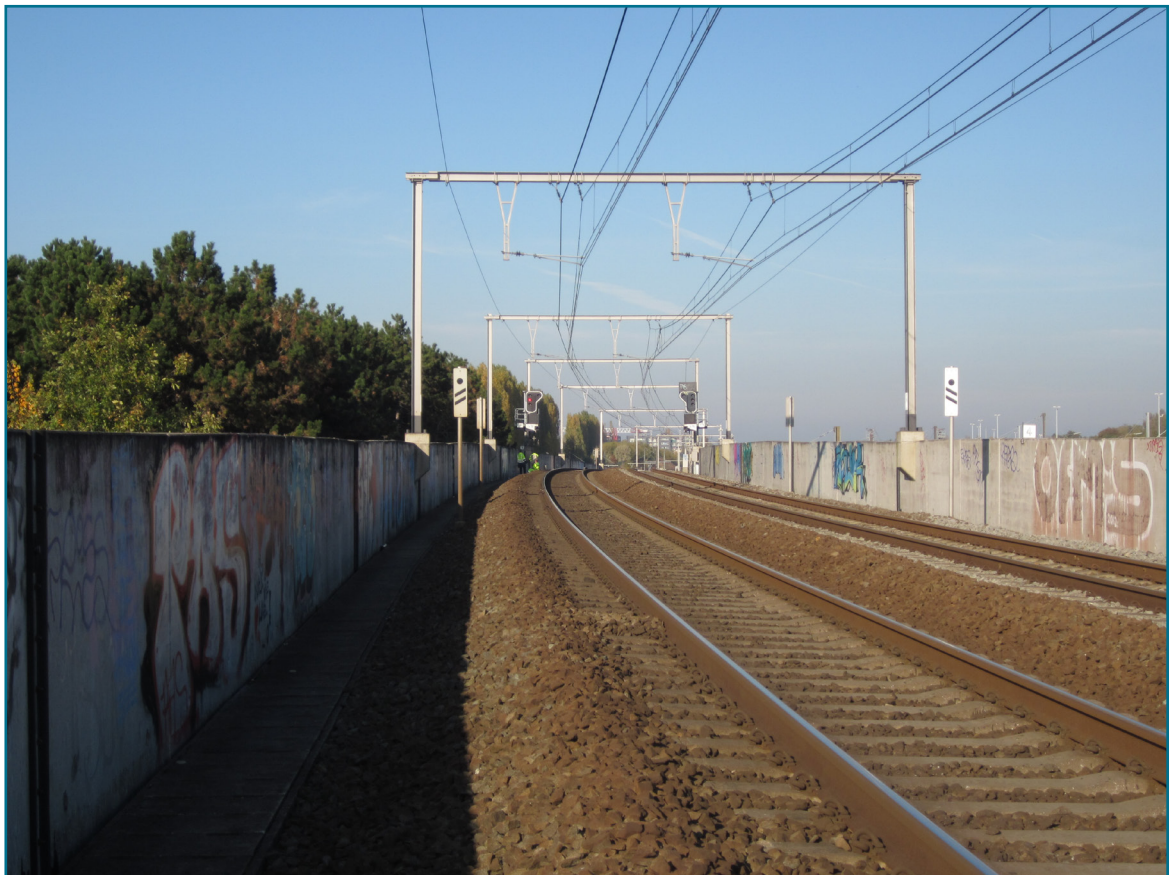
### **Signal J-R.12**

The signal J-R.12 is found at 1074 m after the signal G-R.12, on the outside of the bend. The visibility of the signal J-R.12 is good.

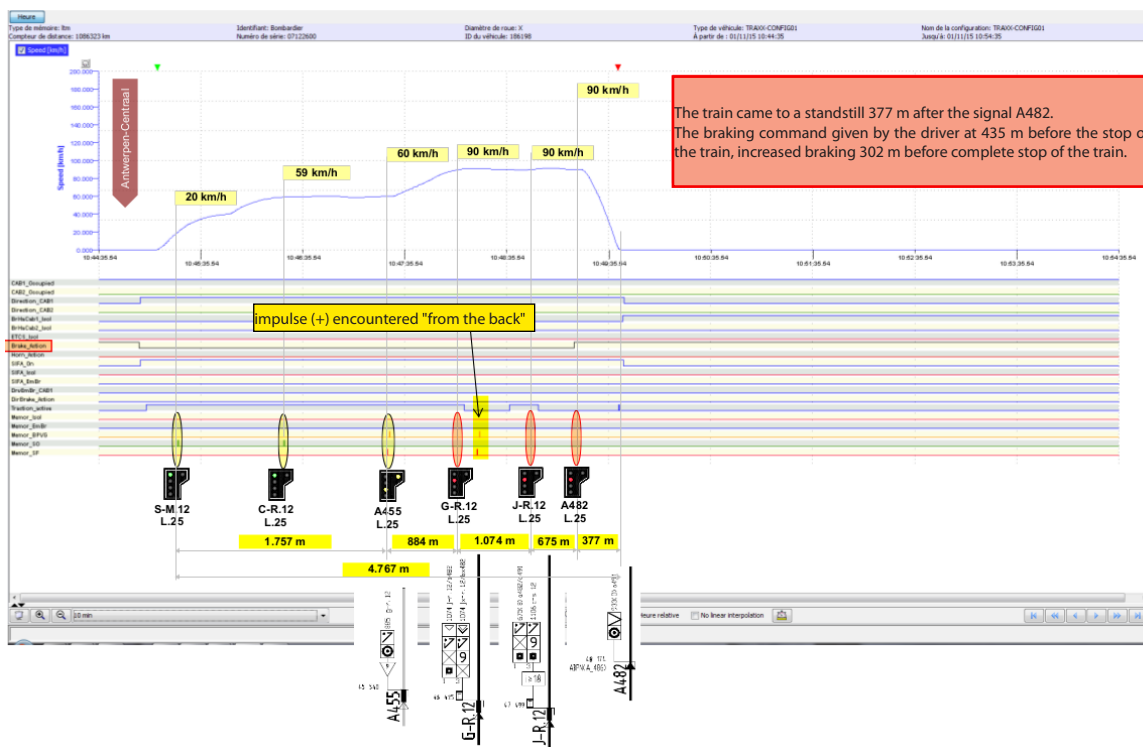
The first part of the route between Bruxelles-Midi and Antwerpen-Centraal was without incident. After a regular stop at Antwerpen-Centraal, the train left in direction of the border with the Netherlands. The details of the last part of the route are given below.

In the tunnel, the train driver increased the speed of the train in two stages up to 59 km/h and maintained this speed until the signal A455. The signal A455 showed a double yellow aspect. The train driver acknowledged belatedly<sup>5</sup> and accelerated up to 90 km/h at the moment of leaving the tunnel.
