Safety report

SIGNALISATION INCIDENT

OTTIGNIES - 28 JULY 2014

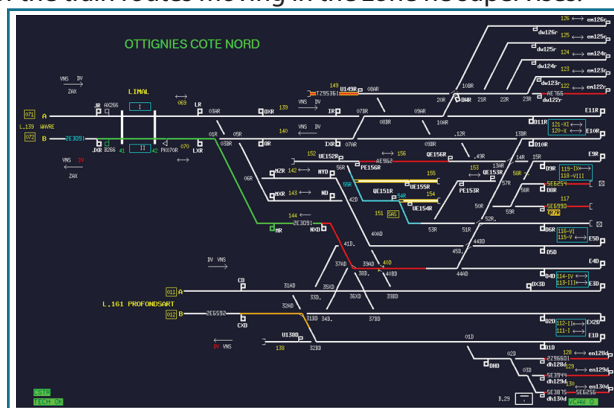
When a route has been interlocked, i.e. confirmed for a train, these zones change colour to green. According to the movement of the train, the zones occupied by the train change to red. If a train is occupying a non-interlocked route, occupation is described as unauthorised and the image of the corresponding section turns brown/orange, a message appears on the screen and the EBP system automatically engages certain protection measures: this is what the operator sees for the train E6592 following release of the second part of its route.

On the ground, nothing allows the driver to see that the zone he is in is not interlocked and he therefore continues his route. The train leaves the Ottignies grid.

The irregular overrunning by a train of a non automatic signal protecting a non-interlocked zone is detected by the system as an anomaly known as DOBMI (detection of an unauthorised train movement) and is recorded by the computer system in the signal box.

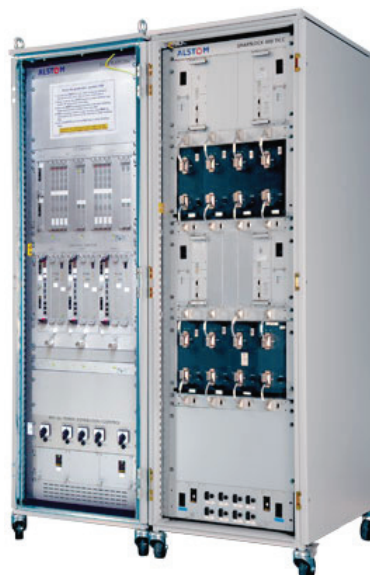
Illustration of a SmartLock system

In Ottignies, the interlocking level is assured by an electronic/computer interlocking of a SmartLock type: it is in this computer system that the safety rules and manoeuvring incompatibilities are programmed.

Management of the interface between the two subsystems, EBP and SmartLock, allowed the simultaneous sending of normal commands and emergency commands: this management of the interface between the EBP system and the SmartLock system is one of the indirect causes of the incident.

The analyses carried out by Infrabel following the incident in Ottignies have shown that this method of management allowed route setting commands to interfere with safety commands resulting from the NT function initiated by the signal operator. This interference of route setting commands and safety commands caused the automatic release of the second train's route when that route had already been travelled.

Interlocking systems of a SmartLock type replace another type of computer interlocking, the Solid State Interlocking (SSI) system. The analyses carried out by Infrabel for this replacement had not revealed the existence of a potential problem following the introduction of this new protocol between the EBP system and the interlocking system: the management of interfaces between the SSI interlocking and the EBP system does not allow the sending of normal commands as long as the emergency commands have not all been carried out, this was not the case for the SmartLock interlocking.

The conditions for appearance of the problem encountered in Ottignies are exceptional; however, in any railway safety system, it is necessary to rapidly make a correction to an identified dysfunctionning. The study carried out jointly by Siemens and Infrabel has confirmed the need to adapt the EBP programming to avoid the interlocking system dealing with safety commands interfering with the route setting commands.

This programming has been modified, tested and implemented at a local level and extended to the whole network. The measure taken by the infrastructure manager prevents the identified problem being repeated.
