# Summary - Safety Investigation

## Collision between 2 SNCB/NMBS passenger trains

### Binche - 13 january 2016

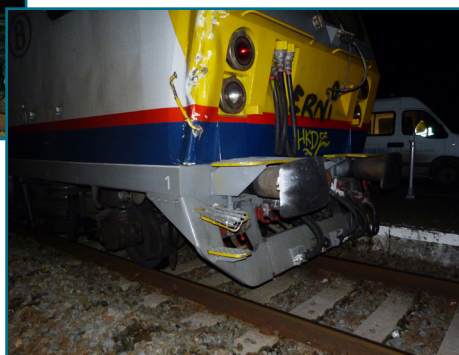
The first findings at the scene showed that the rear of the struck train was still in the gauge of the track that the other train had been travelling on.

The collision between the two passenger trains was made possible due to the position of an insulated connection on a track circuit ensuring the detection of trains: while the train E3440 had released one part of its route by passing this connection, the train was still in the track gauge of the adjacent track II.

The track circuit being released, the movement of the train ME3421 onto track II was authorised: the front of the train ME3421 collided with the rear of the train E3440.

### **Recommendation No 1**

The IB recommends that the infrastructure manager ensures that its internal procedures reflect the experience acquired and the formalising of results of risk analysis in documents so that they allow every step of studies, works and tests carried out to be validated in the context of the alteration of signalling installations.
