Safety Investigation Report

Collision between a passenger train and the rear of a freight train Hermalle-sous-Huy - 5 June 2016

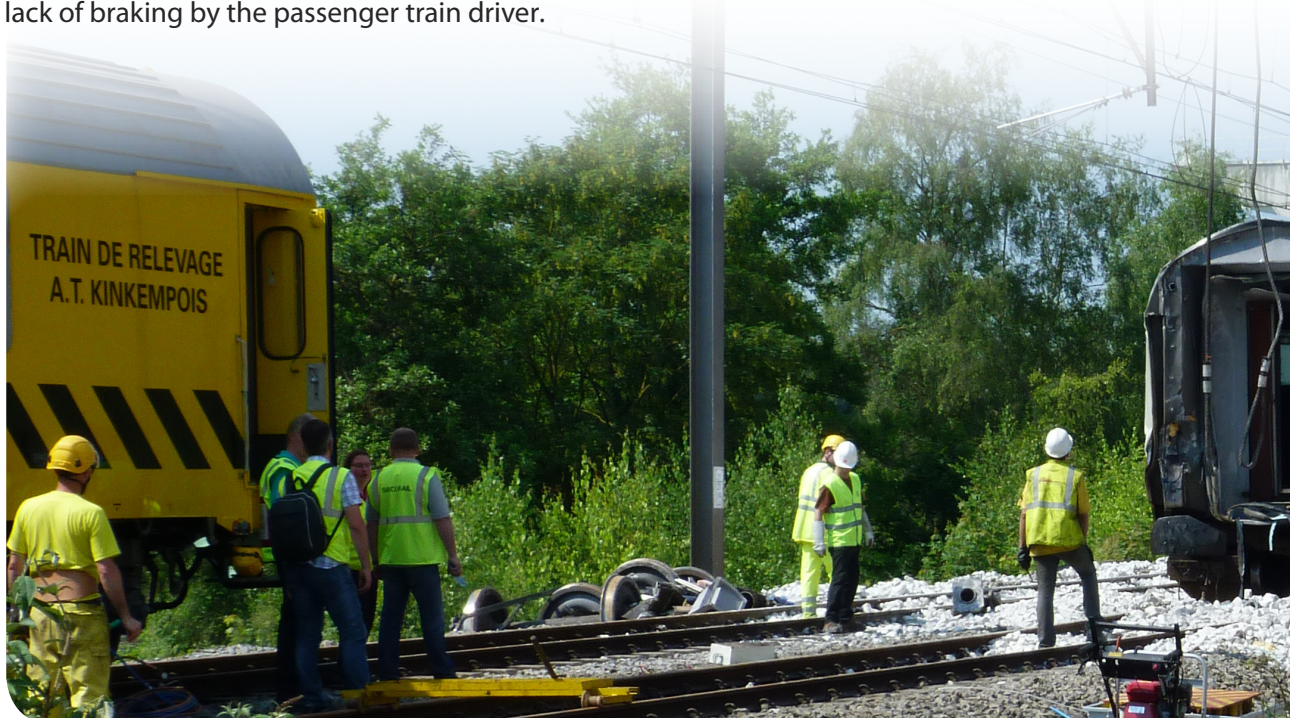
The train E3820 arrived at signal B222 at a speed of 112 km/h. As provided in the operation of the signals, and in accordance with the closed aspect of signal B222, the crocodile associated with the signal did not emit an electrical current: the E3820 train passed the closed B222 signal without the driver being warned by the equipment aboard the train. The train continued to move.

By the time the E3820 driver probably saw the tail signal of the freight train, he began an emergency braking while the train was travelling at about 118 km/h. The E3820 train travelled a distance of approximately 178 meters before colliding with the rear of train E48535 at a speed of approximately 88 km/h.

The catch-up collision was due to having passed a signal that showed a closed aspect after the lack of braking by the passenger train driver.

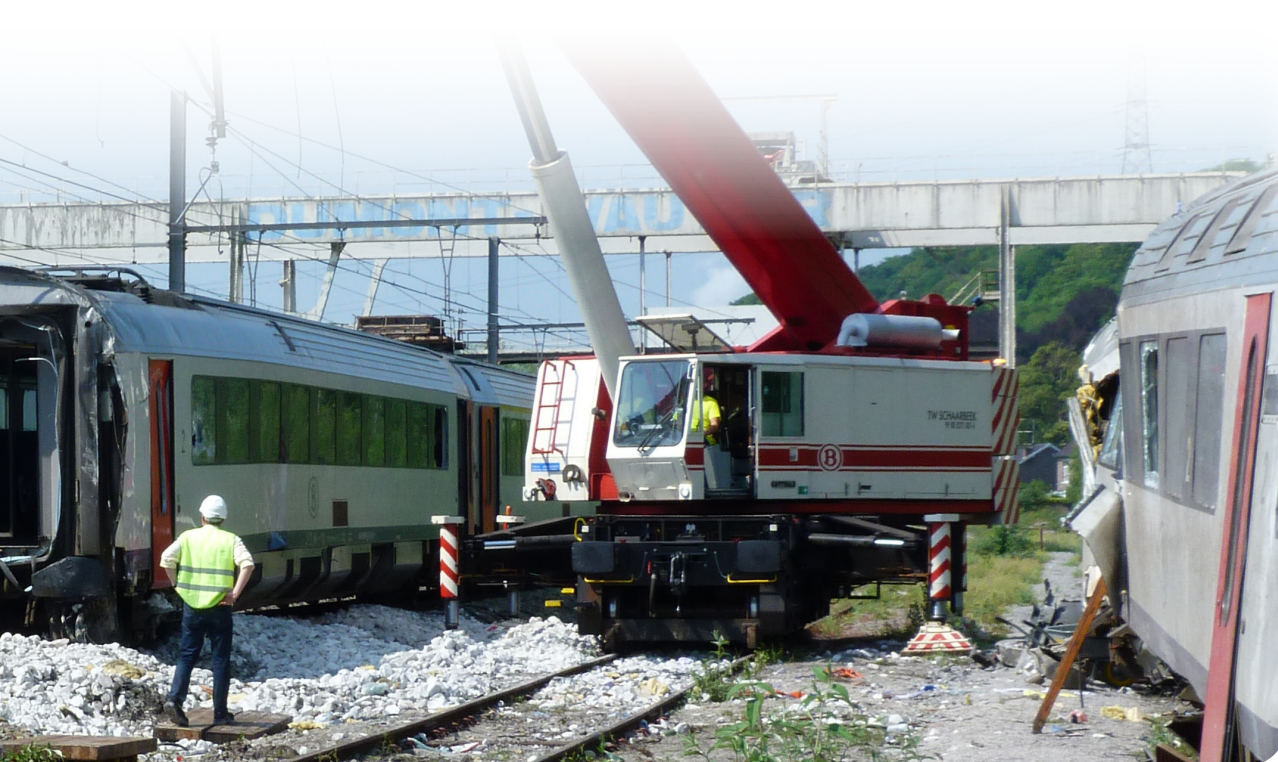
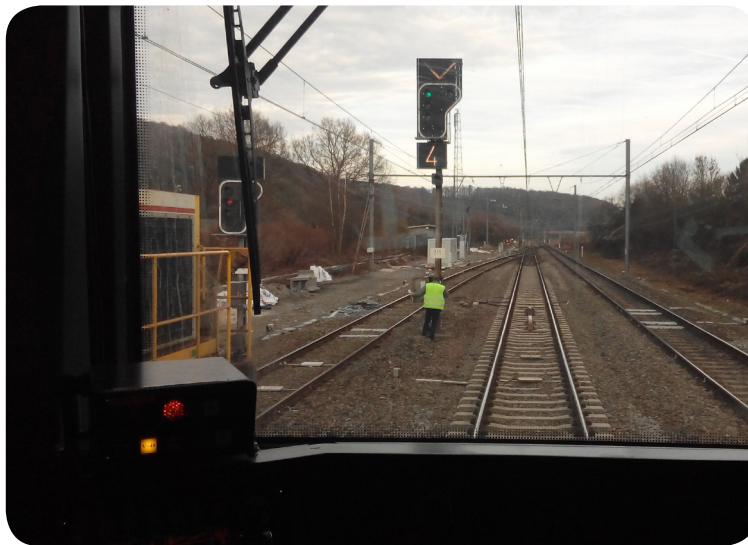
The driver's cab of an AM96 railcar offers good visibility of the signals. The visibility distance of the warning signal (double yellow D11) gives the driver time to apply the expected professional actions. The signal B222 (red) is correctly visible and its salience is good despite the urban luminous environment. The driver did not start braking when approaching signal B222 which showed a closed aspect.
