Safety Investigation Report

Face to face between two SNCB/NMBS-trains
Schaerbeek - 10 October 2014

SUMMARY

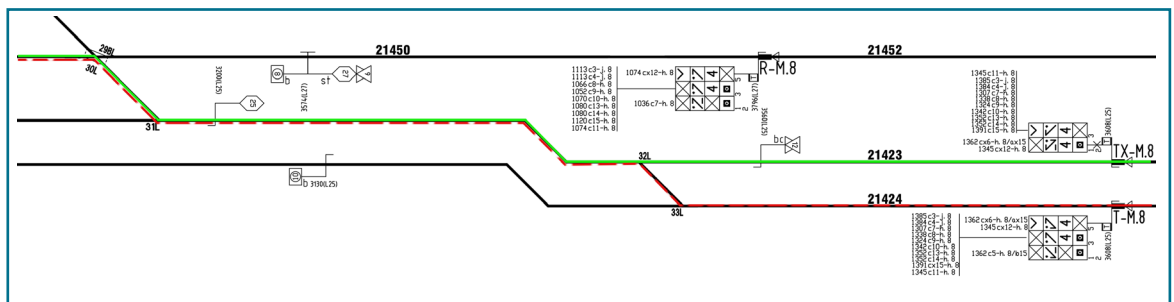
Despite the automatic emergency brake, the train E3340 passed the signal at danger T-M.8 and points 33L.

Illustration: schematic signalling plan showing the foreseen journeys for trains E3340 and E4519

- The system does not remove the risk of reaching a dangerous point: the incident in Schaerbeek has highlighted one of the TBL1+ limits. The speed of the train at the TBL1+ beacon placed 300 metres before the signal at danger did not allow the train to be stopped before the signal, or before the points which constitute a dangerous zone.
