RAILWAY INVESTIGATION REPORT R08W0058

MAIN-TRACK COLLISION AND DERAILMENT

**CANADIAN PACIFIC RAILWAY
FREIGHT TRAINS 498, 497, AND 292
MILE 97.5, WEYBURN SUBDIVISION
CENTENNIAL STATION, NEAR RALPH, SASKATCHEWAN
07 APRIL 2008**

Report Number R08W0058

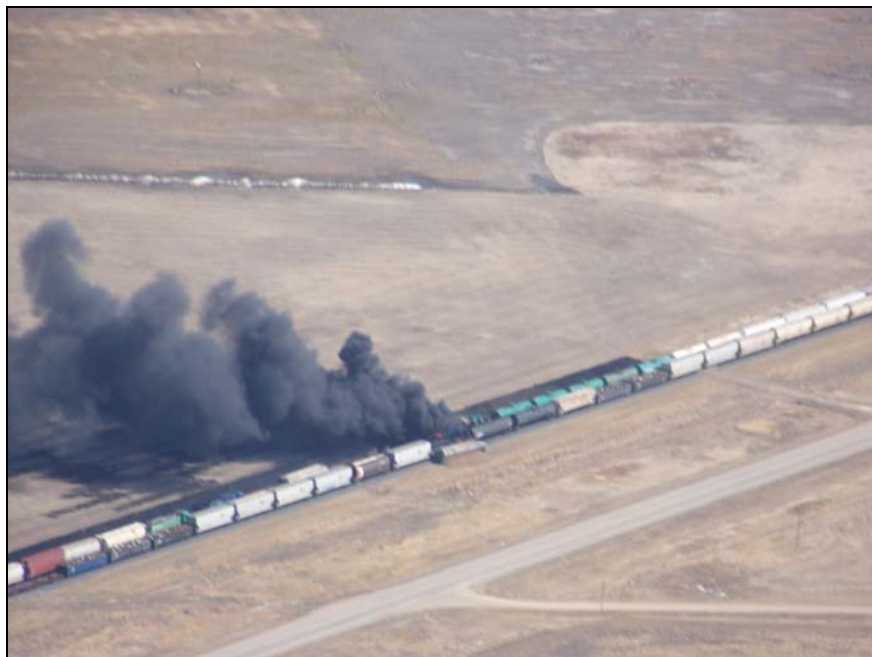
Subsequent to the derailment, the locomotive engineer from train 498 initiated an emergency call. As a result of the damage to the cars, a fire erupted at the tail end of train 292 (see Photo 1). Five cars were involved in the fire: two loaded tank cars containing glycol (UN 3082), a tank car containing vinyl acetate (UN 1301), a residue liquefied petroleum gas (UN 1075) tank car, and one bulkhead flat car. The crews on train 498 and train 497 evacuated from the immediate derailment area. There were no injuries to any of the crew members.

Photo 1. Resulting fire after collision (Source: CPR)

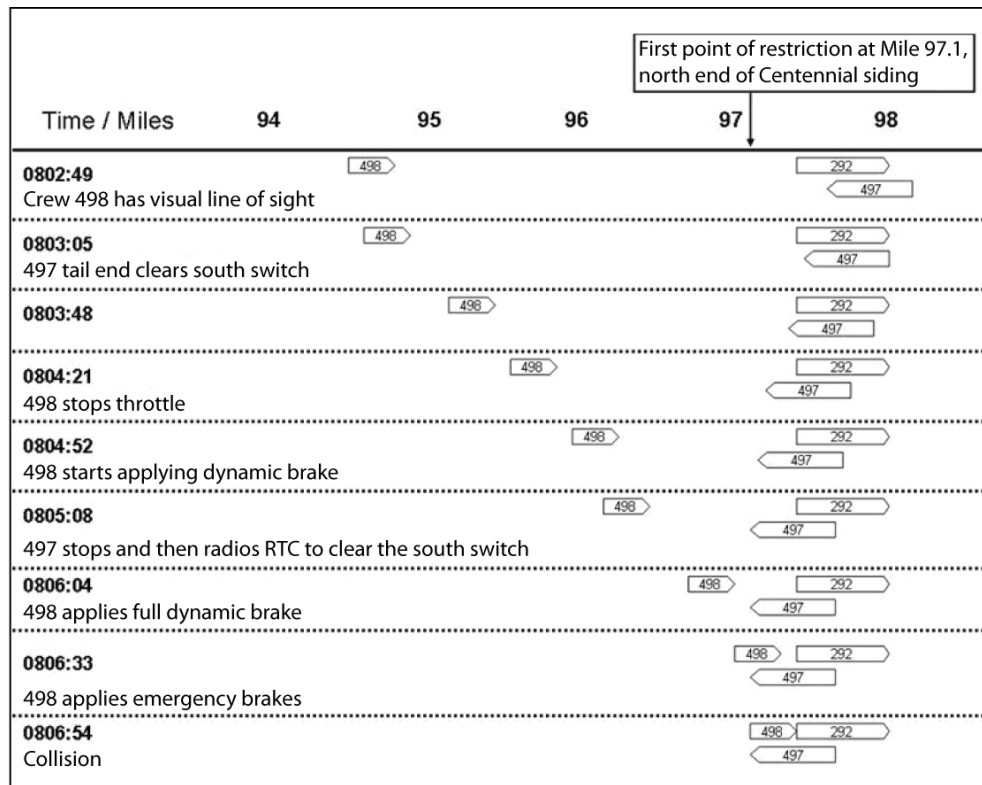
Figure 3. Relative positions of the trains

Figure 3 displays the relative positions of the three trains at various times within a four-minute period just prior to the collision.

1. When the crew of train 498 had a visual line of sight of Centennial siding, train 497 was moving northward (towards train 498) in the siding alongside train 292 which was stopped on the main track.

2. Approaching Centennial siding from the north, the crew of train 498 could see the tail end of train 292 and the front end of train 497, but no other portions of these trains. Only after they moved further along the track would the crew have seen other landmarks such as Mile Post 96 and the north end of Centennial siding.

3. When train 497 came to a full stop, the front end of train 497 was approximately 2500 feet past the tail end of train 292.
4. Prior to the accident, the relative positions of train 498 and train 497 in relation to train 292 were not changing at the same rate. Train 498 was moving southward at approximately 40 mph while train 497 was moving northward at approximately 16 mph.

6. The locomotive engineer on train 498 thought that train 292 was moving and that it would soon clear the south switch in spite of 498's restriction at the north switch Centennial and the arrangements made to close-up.
