**RAILWAY INVESTIGATION REPORT  
R11E0063**

**MAIN-TRACK COLLISION**

**CANADIAN NATIONAL RAILWAY COMPANY  
FREIGHT TRAIN Q10131-21  
MILE 262.76 WAINWRIGHT SUBDIVISION  
EDMONTON, ALBERTA  
23 JUNE 2011**

Report Number R11E0063

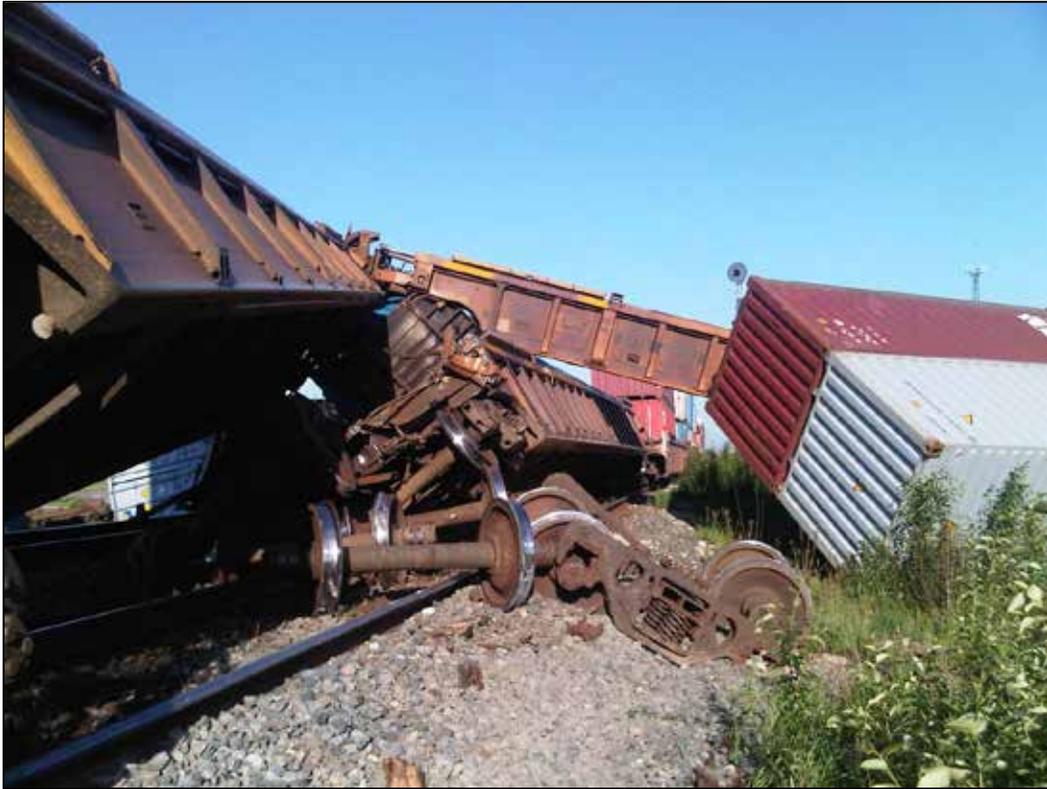
On 23 June 2011, at approximately 0625 Mountain Daylight Time, Canadian National Railway Company (CN) freight train Q10131-21, proceeding westward at 25 mph on the Wainwright Subdivision, collided with the tail end of stationary CN freight train A41751-23 at Mile 262.76 in Edmonton, Alberta. The collision resulted in 2 derailed intermodal flat cars (3 car bodies) and 1 damaged locomotive CN 2234. There were no dangerous goods involved and no injuries.

**Photo 1.** Derailed cars from train A417 looking east

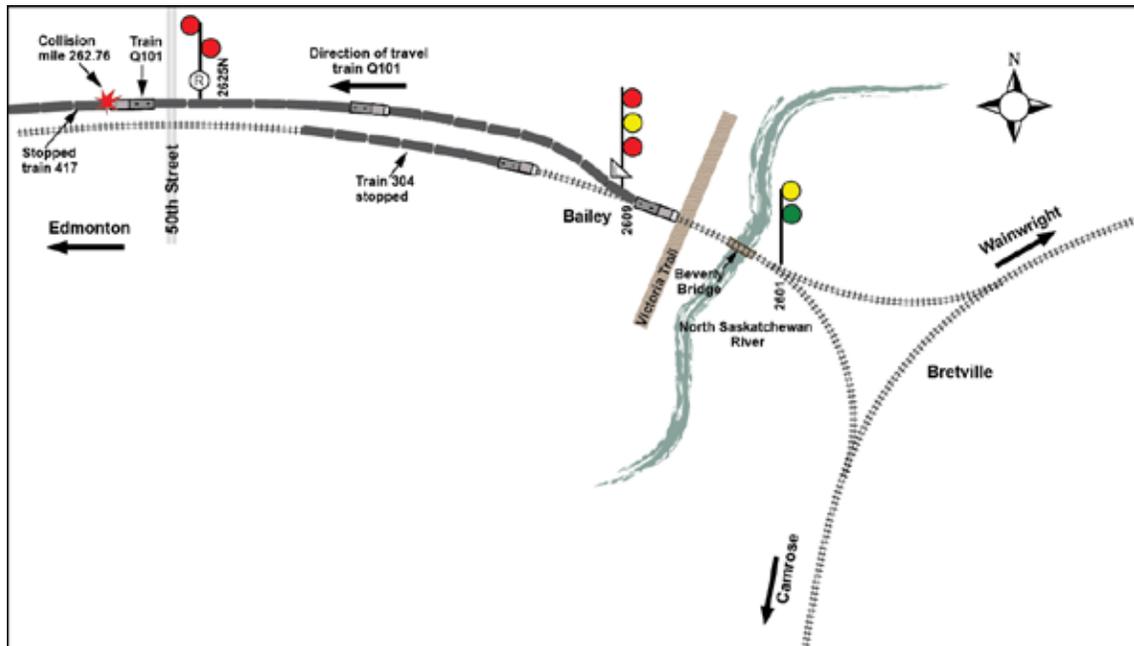
Train A417 originated in Clover Bar Yard in Edmonton and was travelling westward on the north main track to Walker Yard, also in Edmonton. As it had stopped for instructions from the Yardmaster, the tail end of train A417 was situated just west of the 50th Street overpass. Signal 2625N was situated just east of the overpass (Figure 2).

**Figure 2.** Track and signal layout at the collision/derailment location (map not to scale)

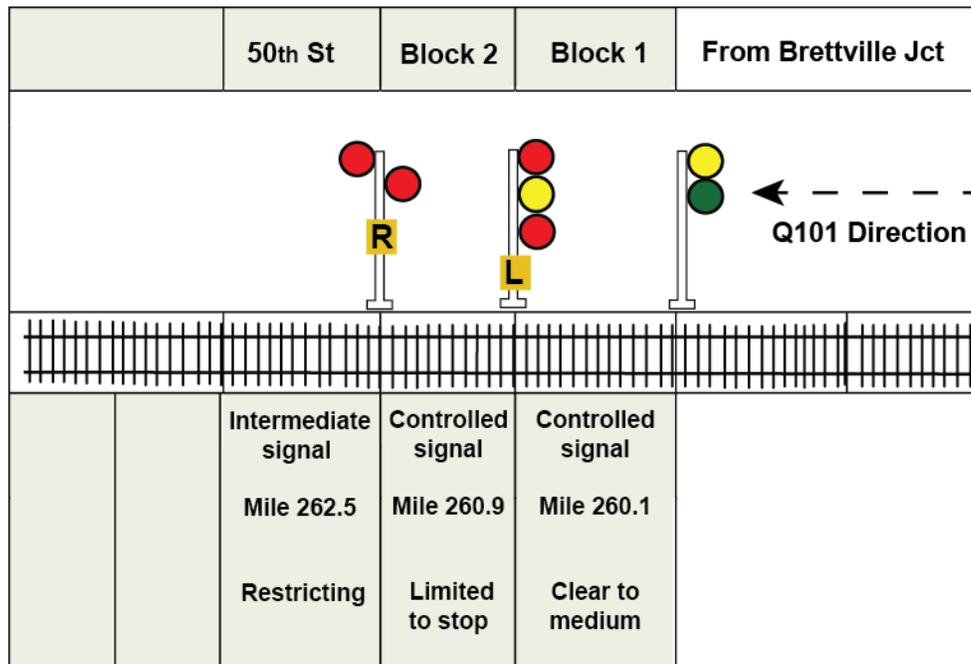
track switch at Bailey was lined for a westbound train to enter the north track, and there was a simulated track occupancy just west of signal 2625N, the signal indications would have been displayed as follows (Figure 3):

- the controlled signal, 2601, at Brettville Junction displayed a Clear-to-medium indication (yellow over green);
- the controlled signal, 2609, at Bailey displayed a Limited-to-stop indication (red over yellow over red with an L letter plate on the mast); and
- the intermediate signal, 2625N, just east of the 50th Street overpass displayed a Restricting signal (red over red staggered, with an R letter plate on the mast).

Figure 3. Signal indications encountered by train Q101 before the collision
