COMMISSION OF INQUIRY HINTON TRAIN COLLISION

REPORT OF THE COMMISSIONER
THE HONOURABLE MR. JUSTICE RENÉ P. FOISY
DECEMBER, 1986

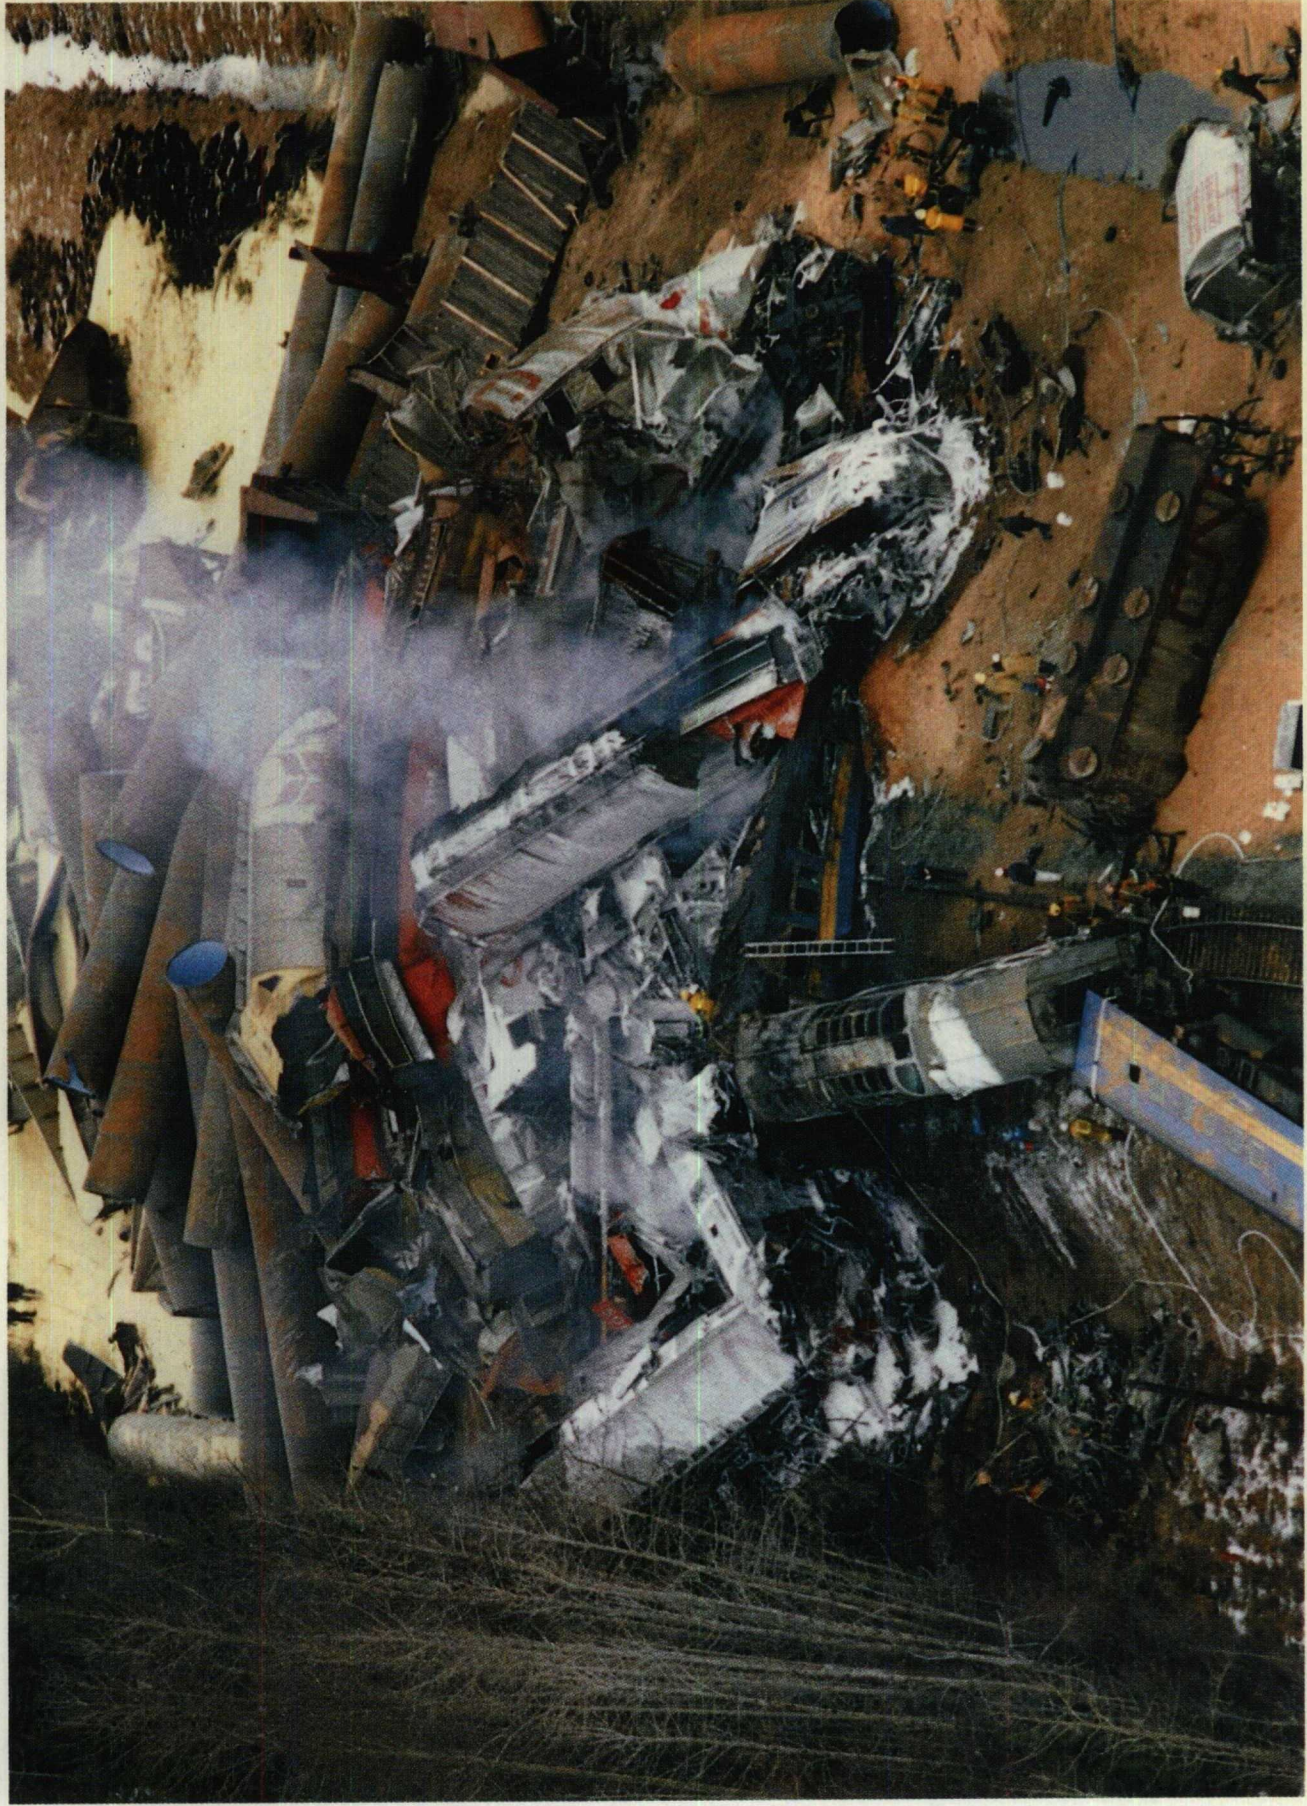
Photo 1: Collision Site Looking East. Credit: The Edmonton Sun.

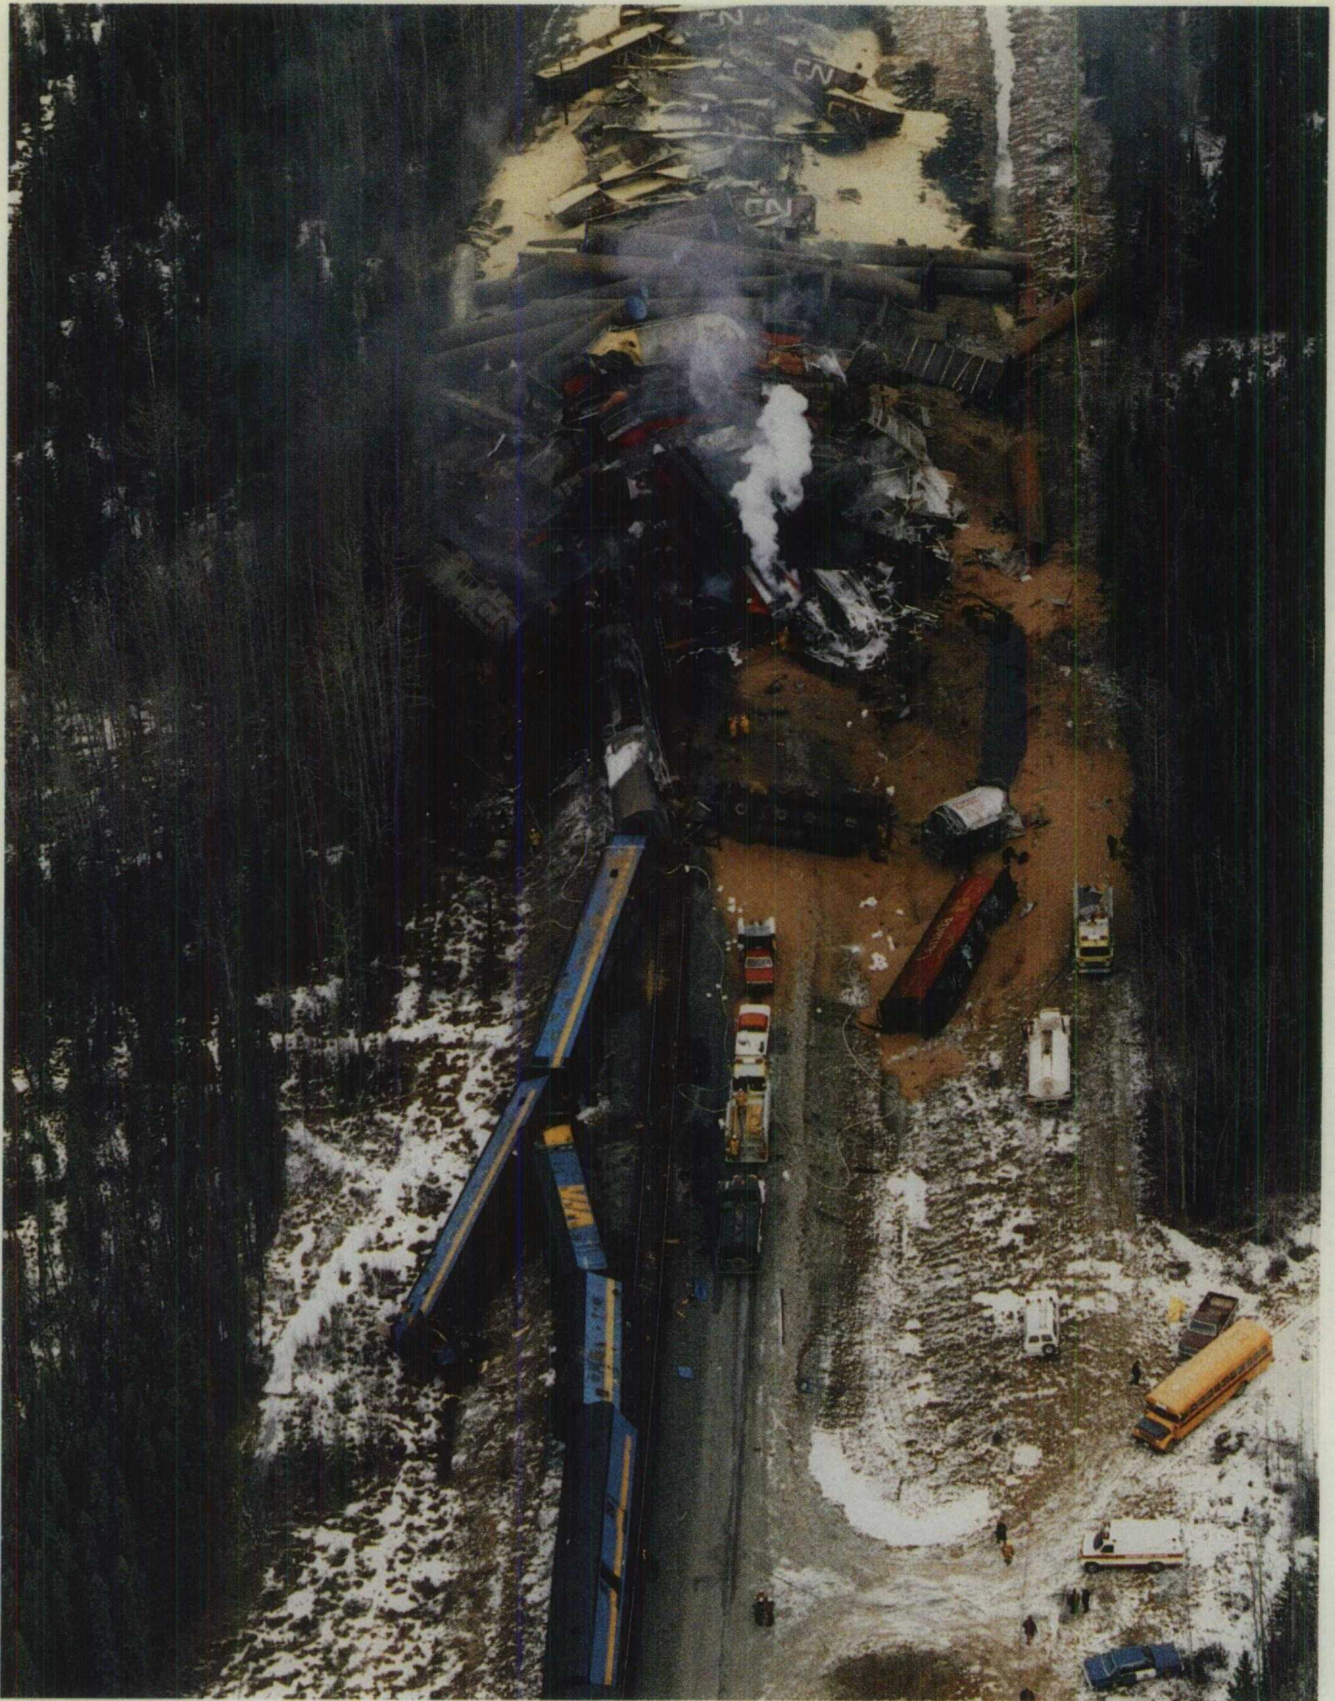
Photo II: Collision Site Looking East. Credit: Jim Cochrane, The Edmonton Journal.

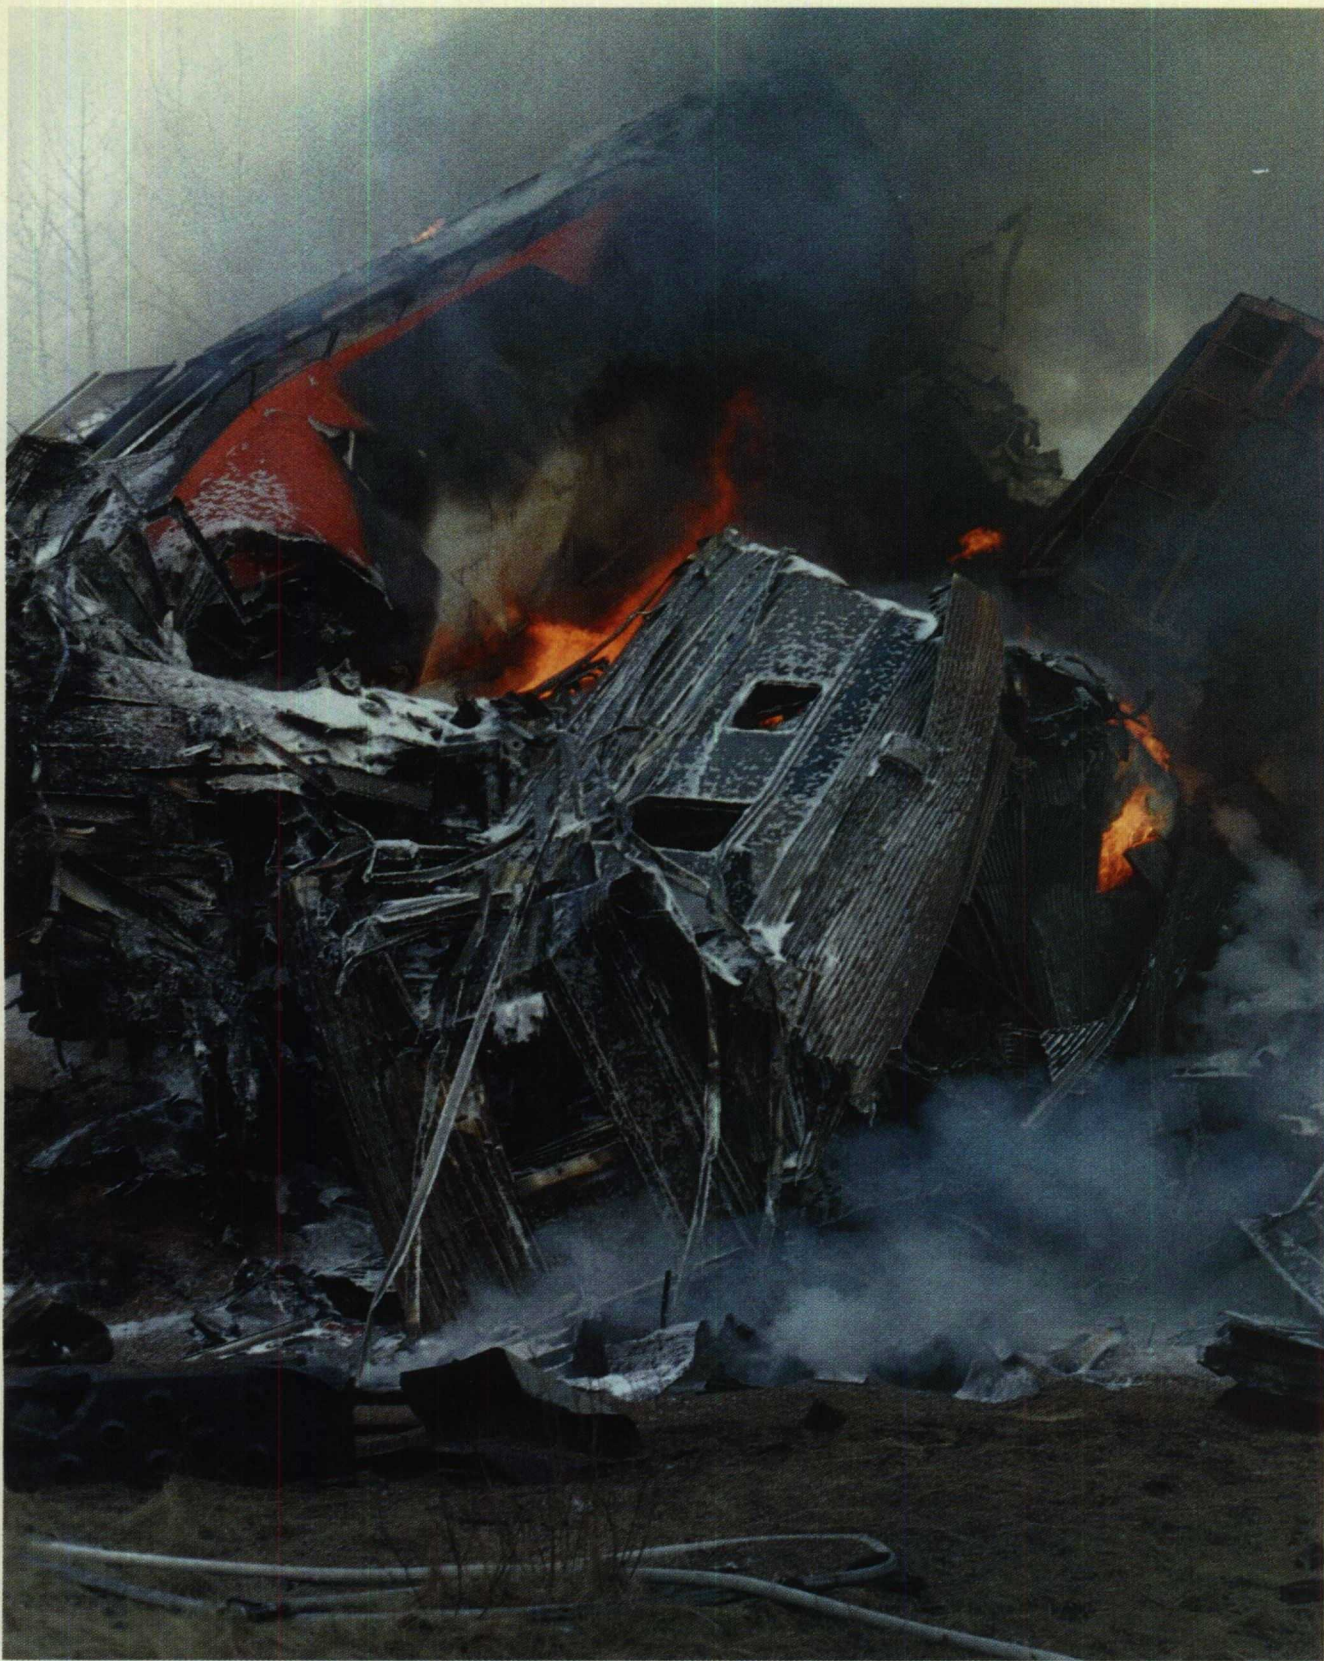
Photo III: Ground Level View of the Wreckage.

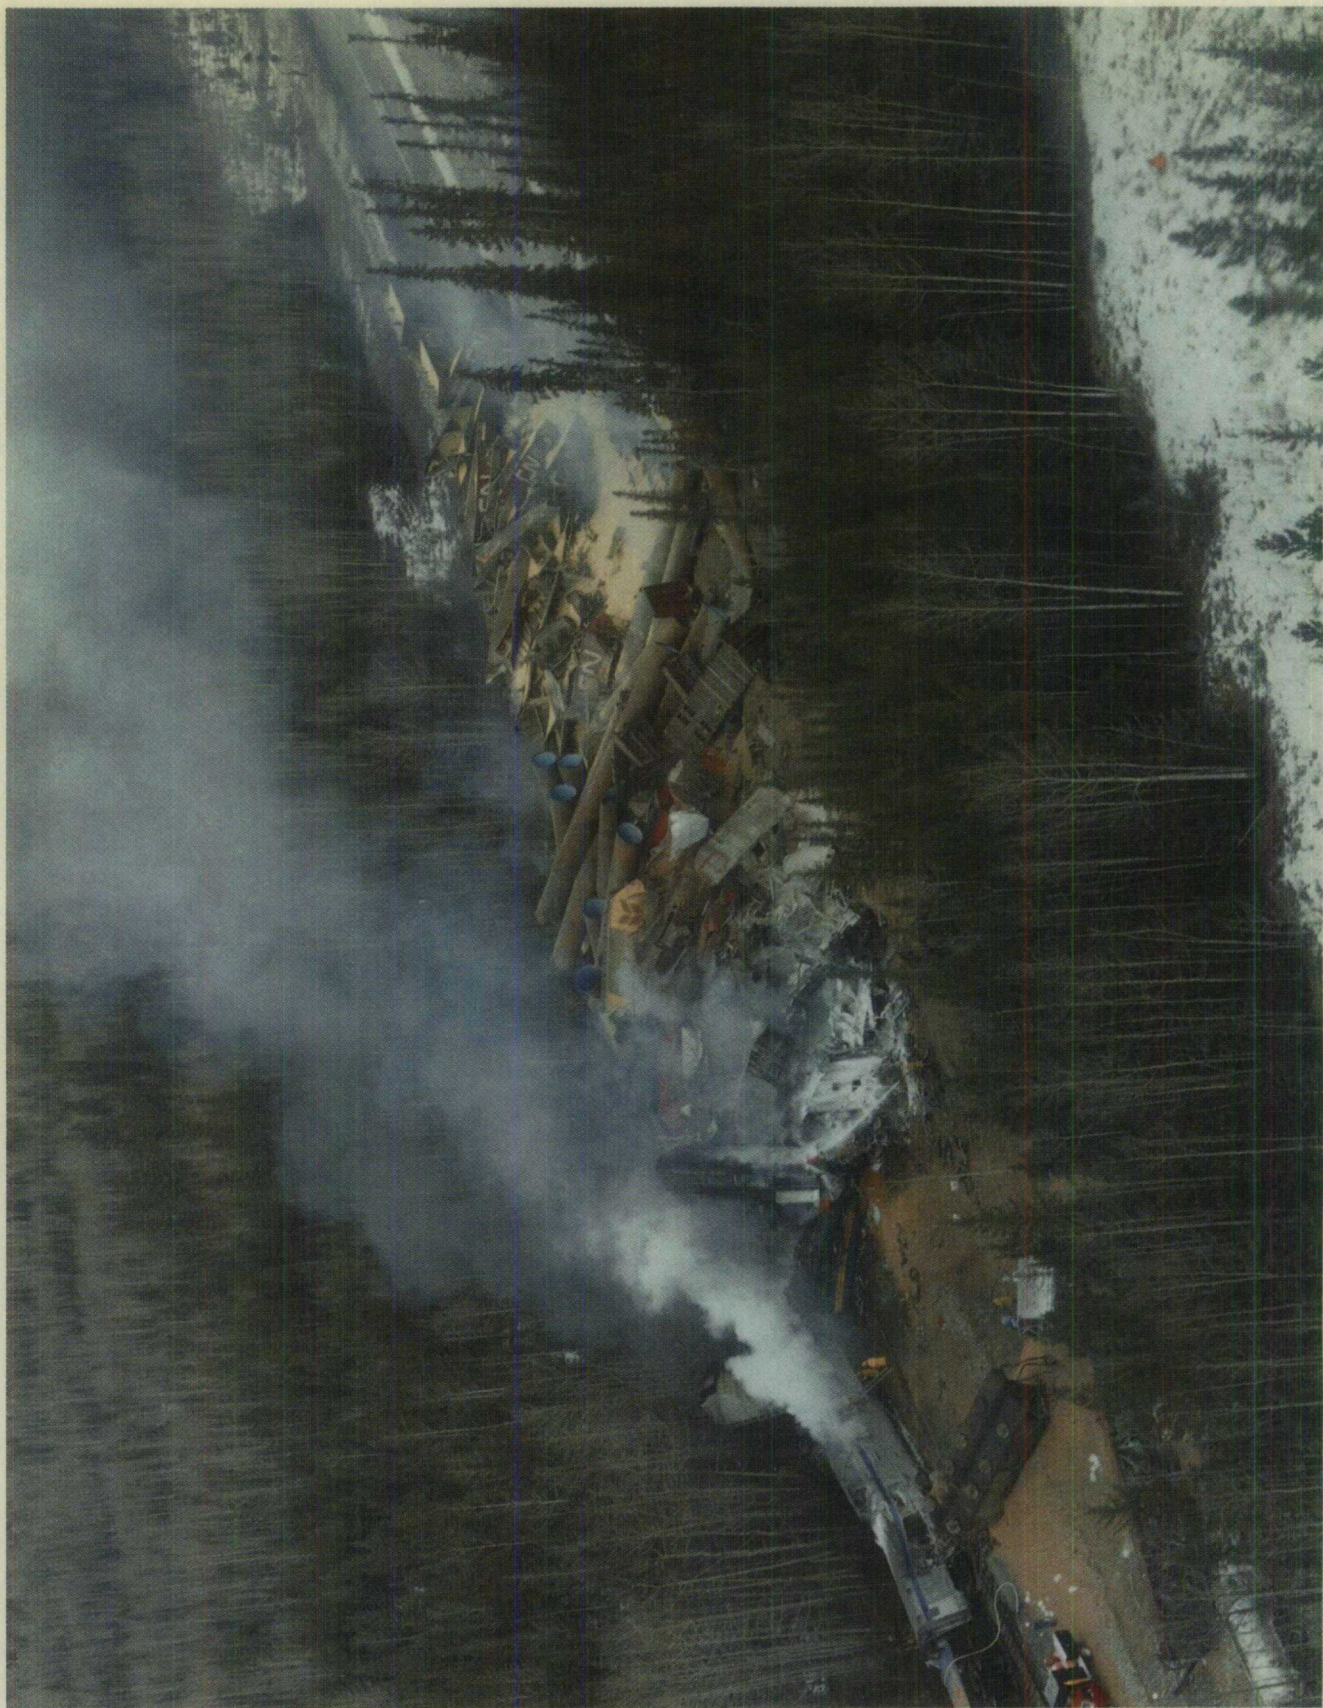
Photo IV: Collision Site Looking North.

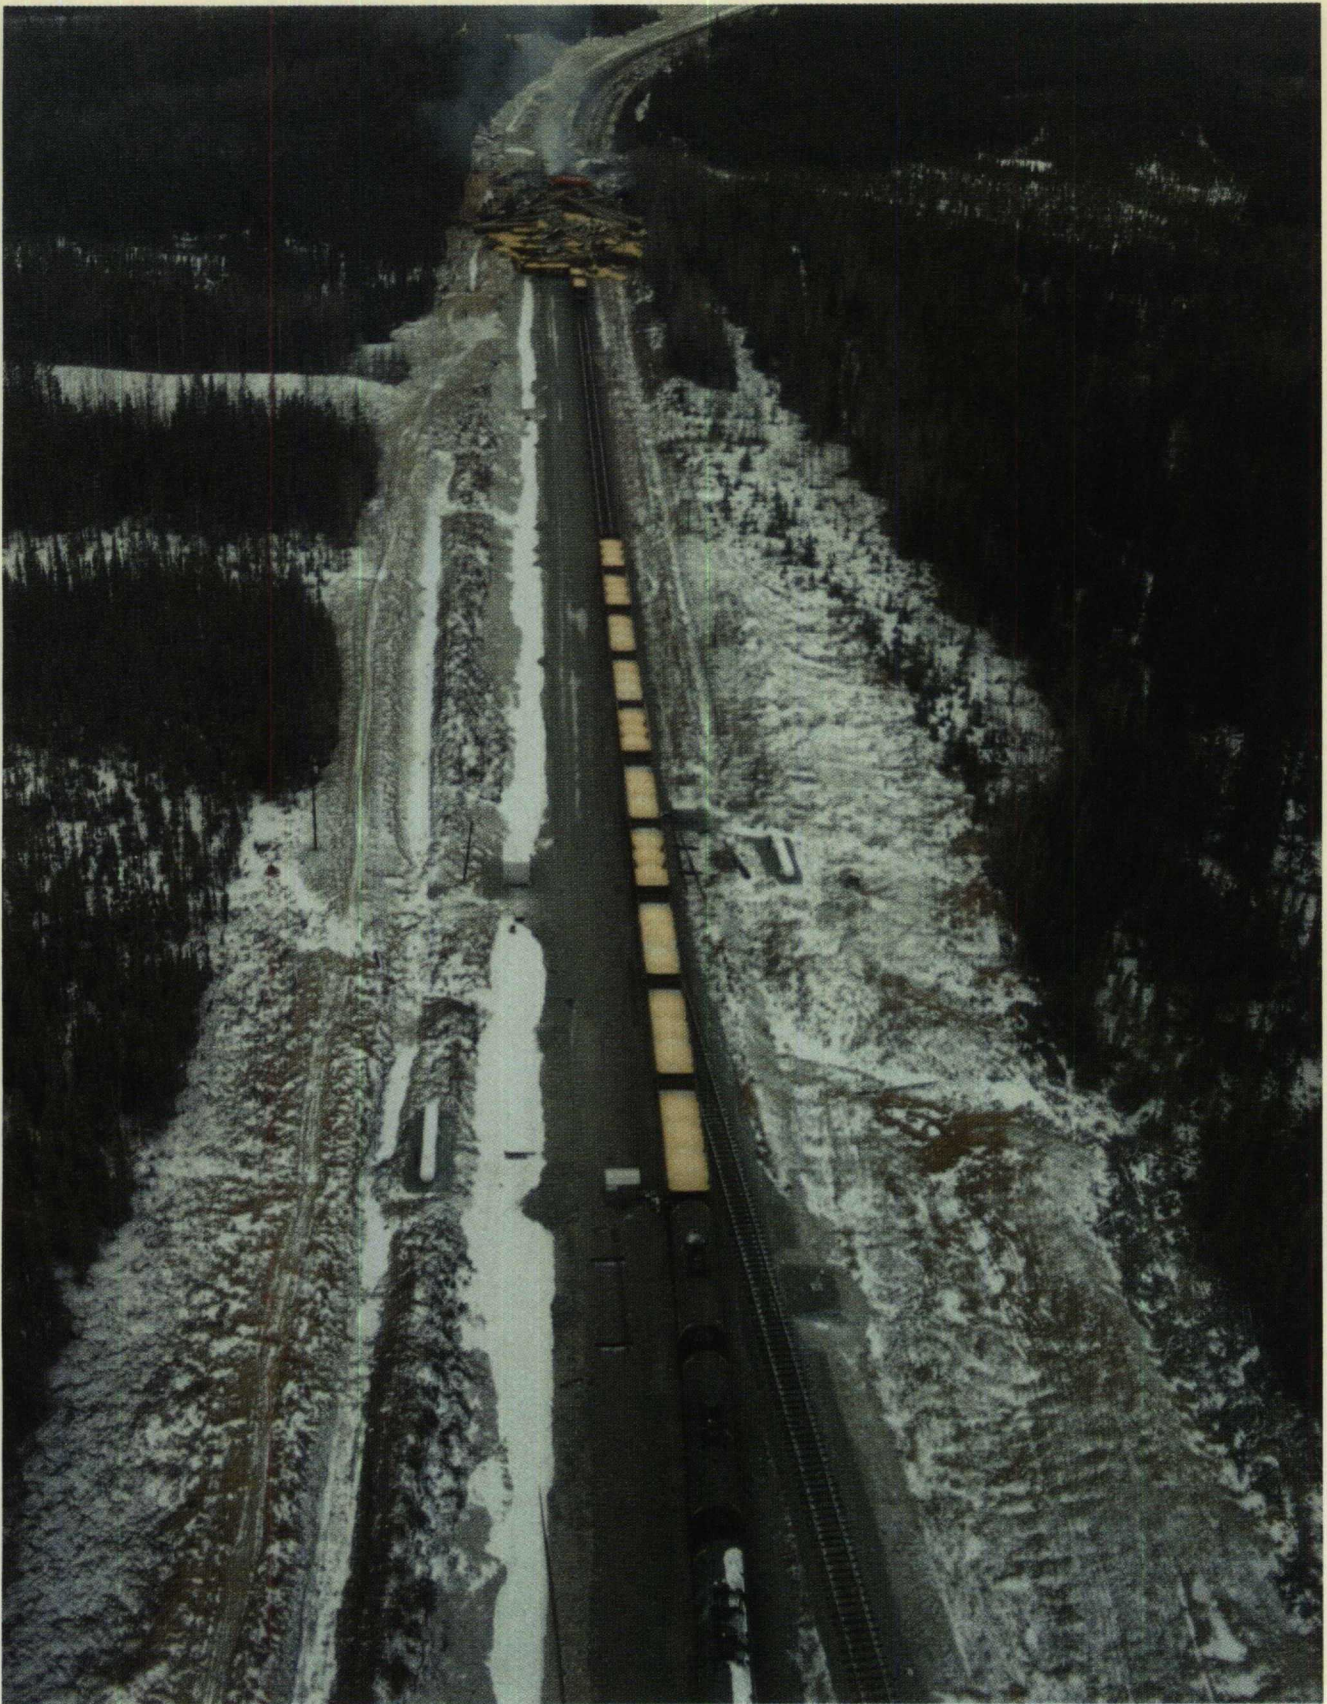
Photo V: View of Collision Site Looking West and Showing Section of Main Line Double Track in Foreground.

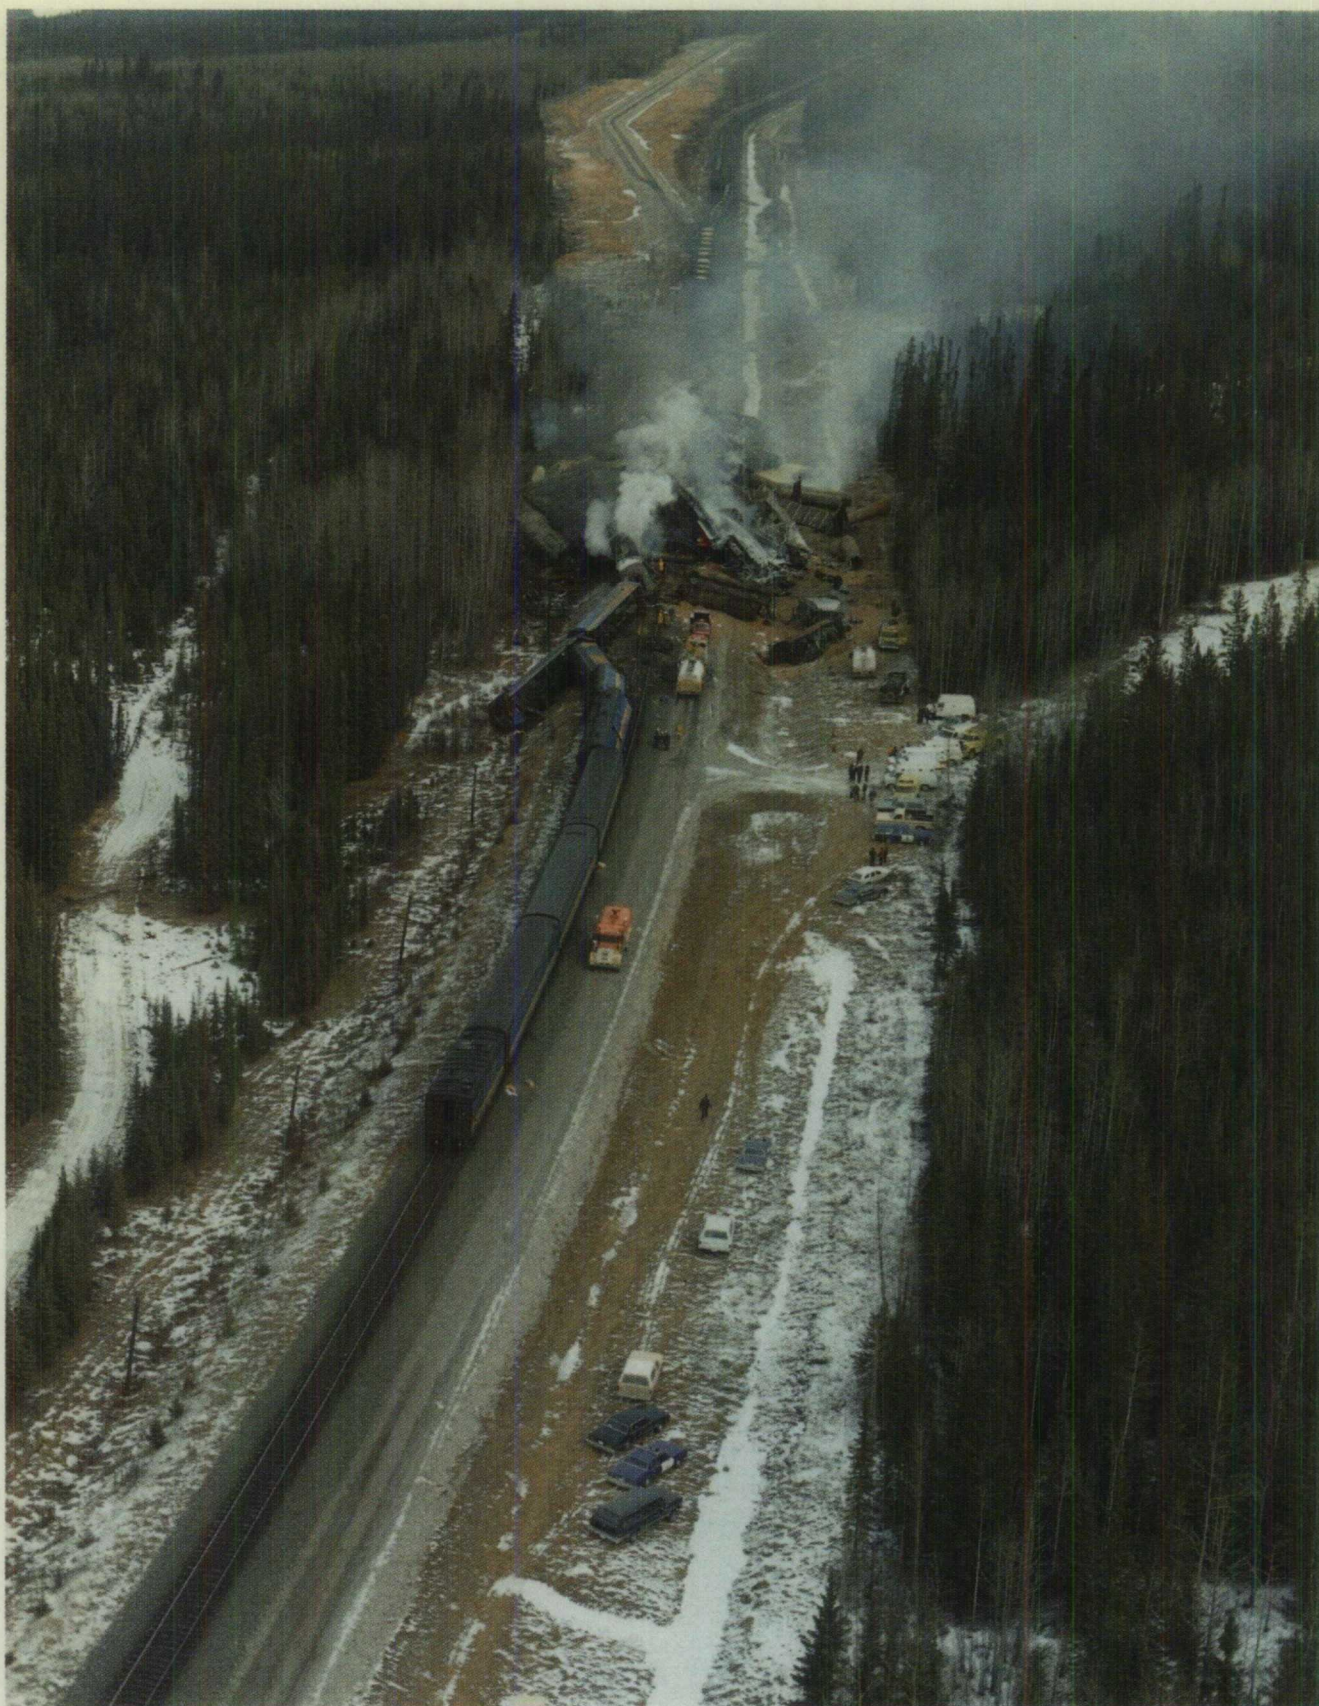
Photo VI: Collision Site Viewed Looking East and Showing Section of Main Line Double Track and Spur Line to the North.

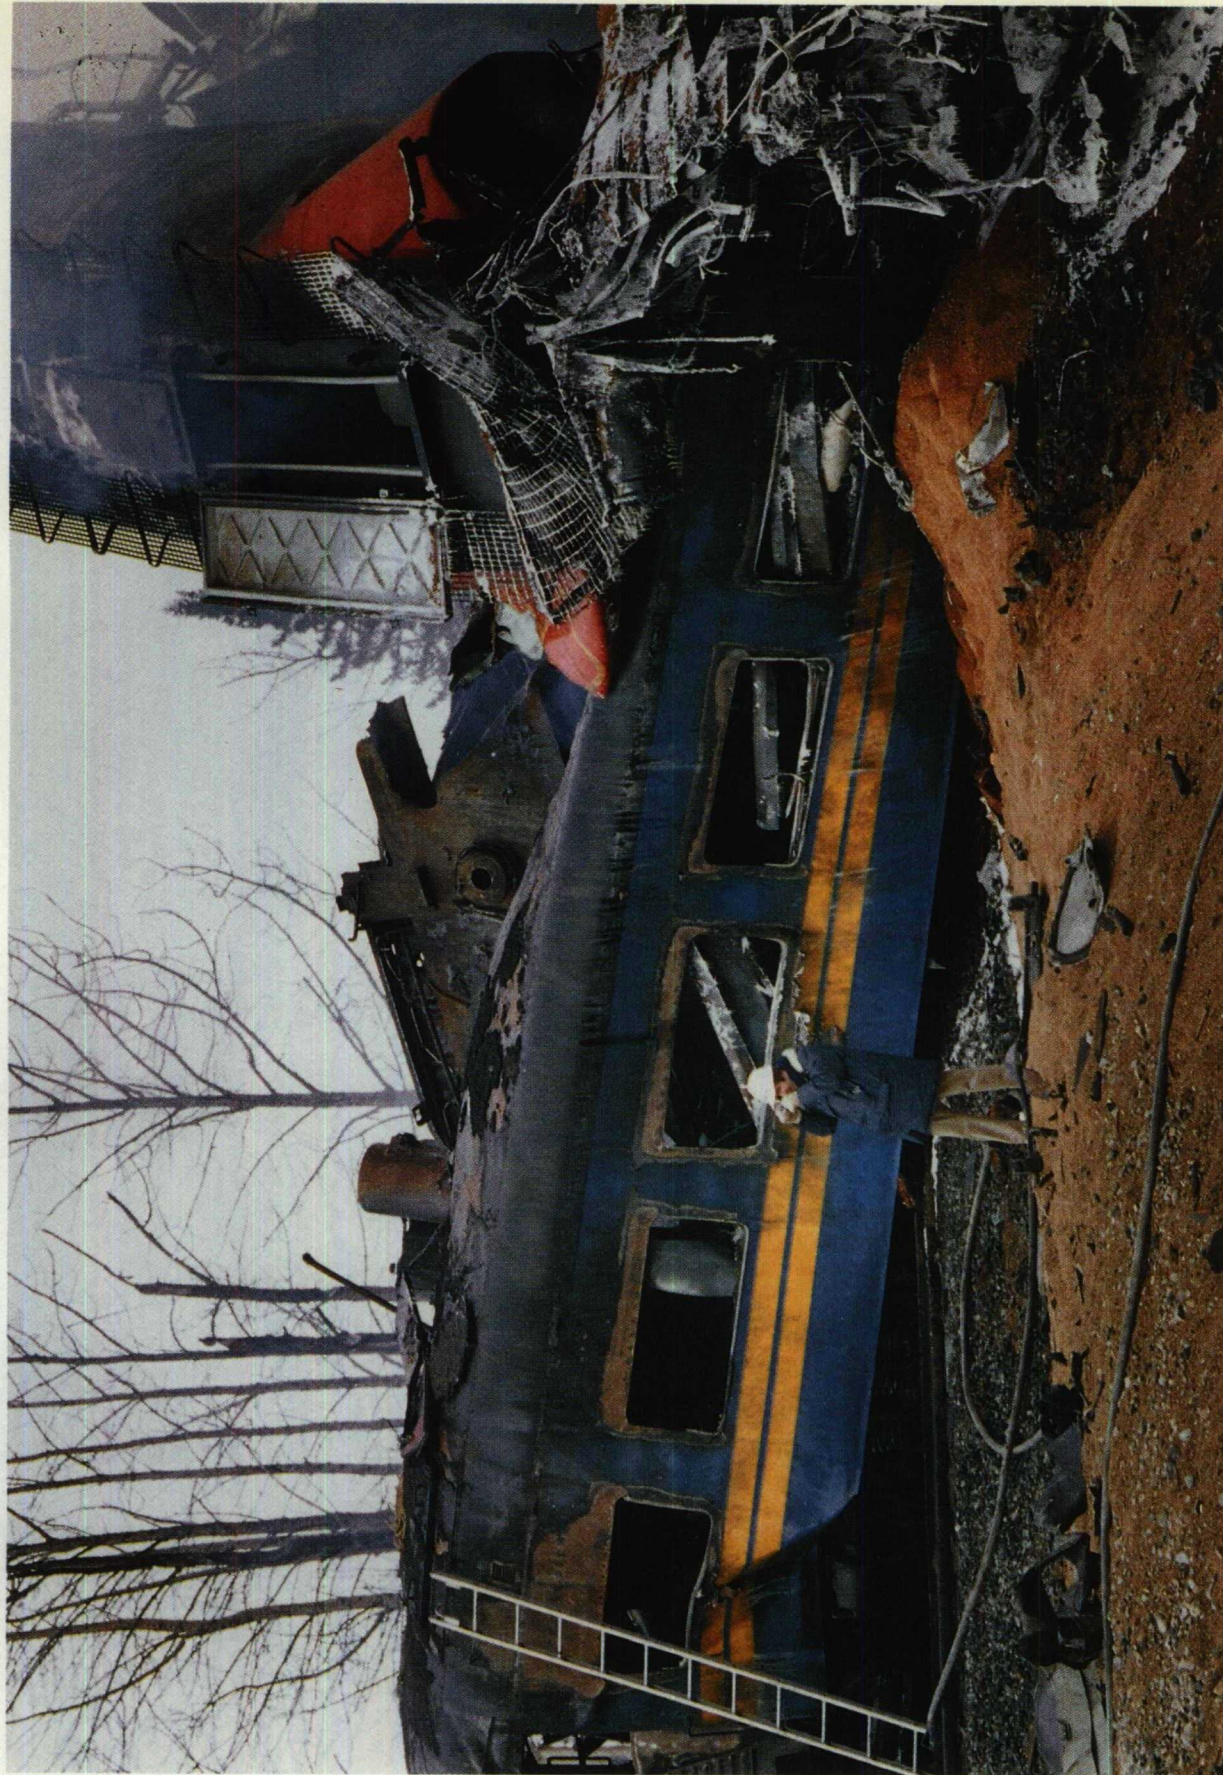
Photo VII:

Via Passenger Car. Credit: The Edmonton Sun.
