## RAILWAY INVESTIGATION REPORT

R00V0206

**COLLISION**

**MILE 65.05, CANADIAN NATIONAL ASHCROFT SUBDIVISION**

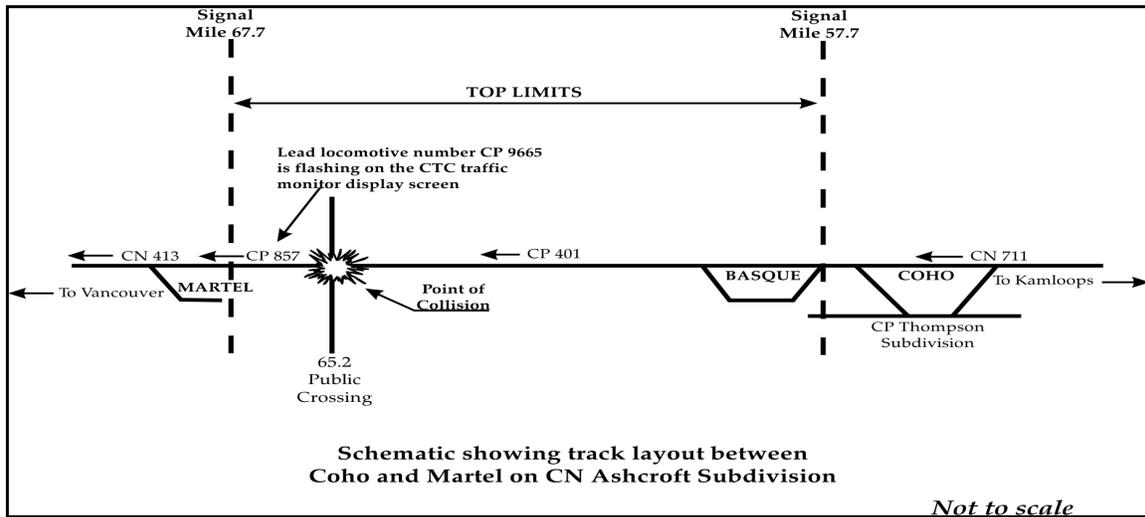
Figure 2. Schematic indicating TOP limits

TOP was copied and repeated by the foreman and made complete by the RTC at 1227. All four MOW crew members, including the foreman, read and initialled the TOP, indicating that they understood its contents. Figure 2 depicts the area covered by the TOP limits.
