RAILWAY INVESTIGATION REPORT
R09V0230

MAIN-TRACK TRAIN COLLISION
CANADIAN PACIFIC TRAIN NO. 355-429 AND
CANADIAN PACIFIC TRAIN NO. 110-30
MILE 58.10, MOUNTAIN SUBDIVISION
REDGRAVE, BRITISH COLUMBIA
30 OCTOBER 2009

Report Number R09V0230

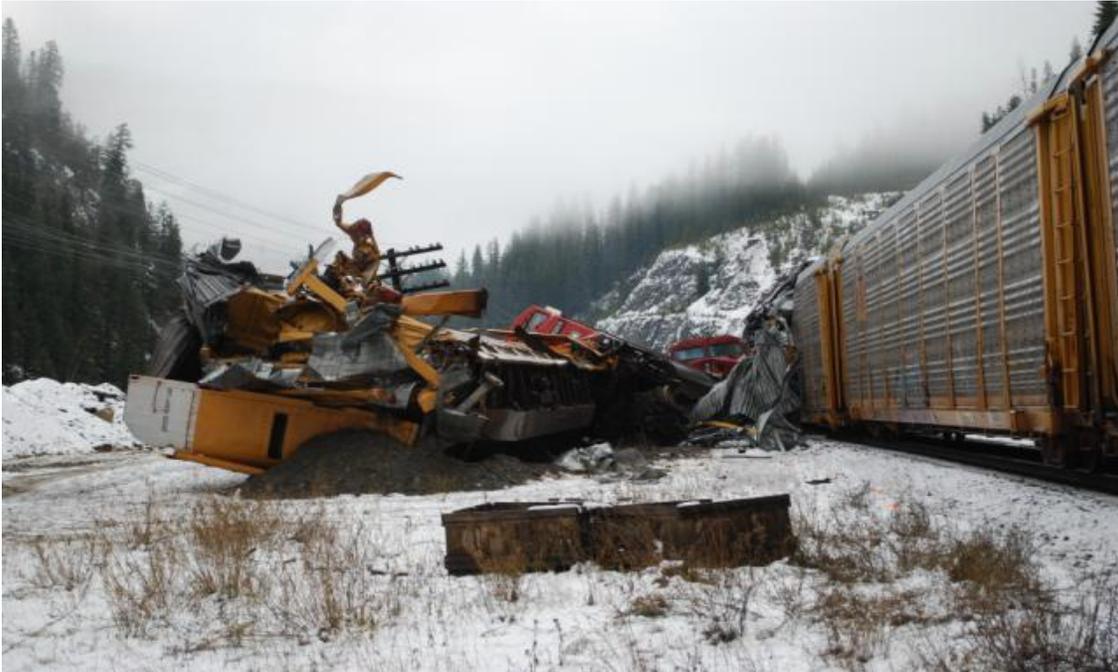
Train 355's lead locomotive, CPR 8869, came to rest leaning at a 45-degree angle to the north. The second locomotive, CPR 9779, derailed upright, and 3 cars, the 3rd to 5th (loaded grain hoppers), derailed upright. Three cars from Train 110, the 78th to the 80th, derailed. Two cars on the north side of the main track, and one on the south side. The derailed cars from Train 110 were multilevel auto carriers (see Photo 1). Both crew members of Train 355 were taken to hospital in Golden, British Columbia, and were released early the next day.

Photo 1. Derailment damage of auto cars from Train 110 and locomotives from Train 355

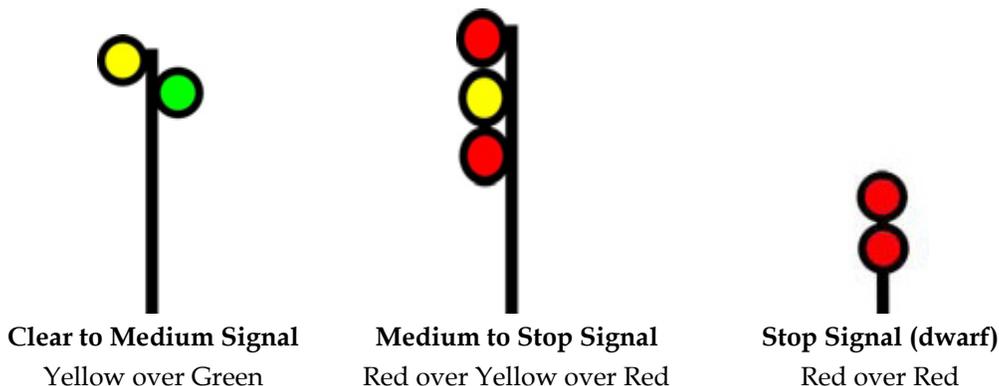
1. a Clear to Medium (yellow over green) indication was displayed on Signal 543 (that is, the advance signal to Redgrave East);
2. a Medium to Stop (red over yellow over red) indication was displayed at controlled Signal 565 at Redgrave East; and
3. a Stop (red over red) indication was displayed on Signal 581D, the signal governing westward movements from the siding to the main track, at Redgrave West.

Figure 3. Signal aspects
