**RAILWAY INVESTIGATION REPORT
R14T0294**

SIGNAL PASSED AT STOP

**VIA RAIL CANADA INC.
PASSENGER TRAIN NO. 62**

**MILE 278.4, CANADIAN NATIONAL KINGSTON SUBDIVISION
NEWTONVILLE, ONTARIO**

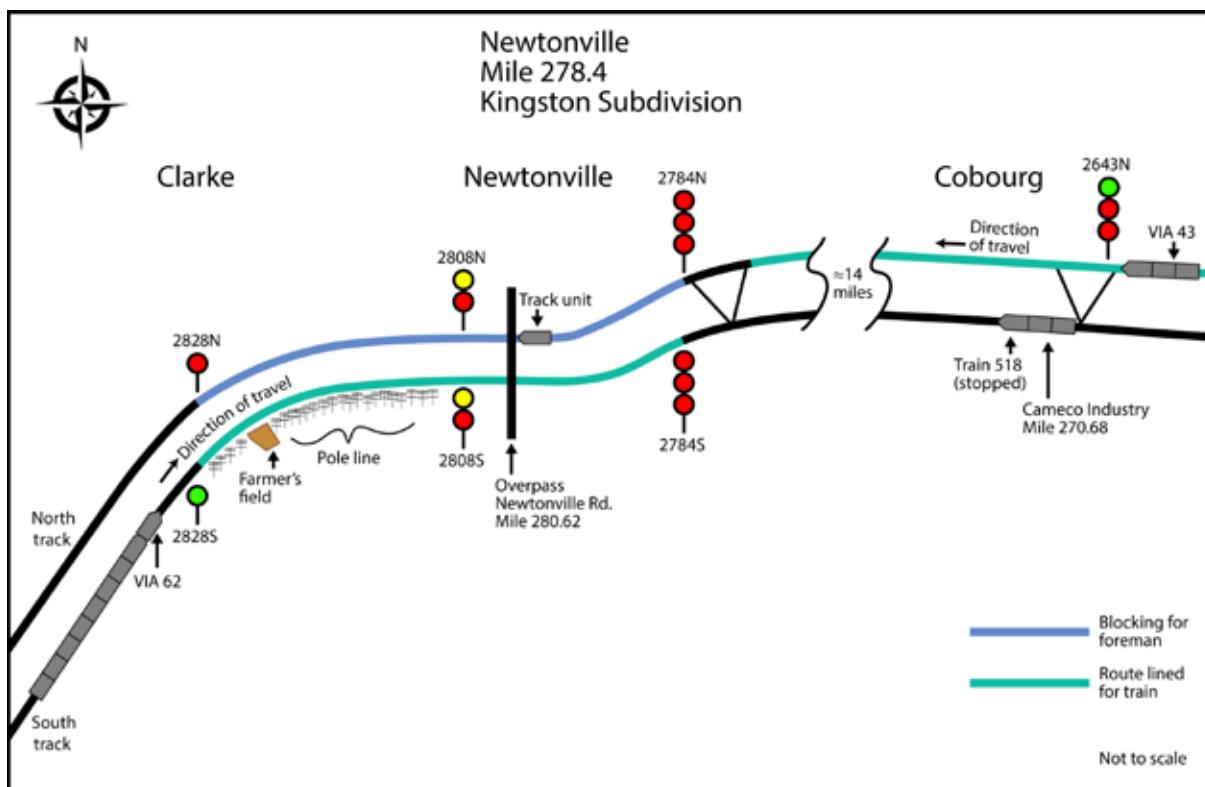
Figure 2. Site diagram

At about 1013 as VIA 62 was approaching the next signal (2808S), the track supervisor's hi-rail vehicle was visible beyond the signal on the north track just east of the overpass at Newtonville Road. VIA 62's crew noted that the advance signal³ (2808N) to the controlled location at Newtonville for eastward trains on the north track was displaying a Clear to Stop (yellow over red) indication. Shortly afterward, in the vicinity of the Bellamy Road crossing (Mile 281.13), VIA 62's crew identified their advance signal (2808S) to the controlled location at Newtonville as a Clear signal (green over red) (Figure 2).

At 1014:49, while VIA 62 was travelling at about 88 mph traversing a 1-degree right-hand curve, the crew observed the Stop signal and immediately initiated an emergency brake application. At 1015:11, while travelling at 68.3 mph, VIA 62 passed the Stop signal at Signal 2784S. At about 1015:15, VIA 62's crew broadcast an emergency call announcing that they had passed the Stop signal. At 1015:35, VIA 62 came to a stop approximately 900 feet past the Stop signal. VIA 62 stopped in a distance of about 3100 feet.

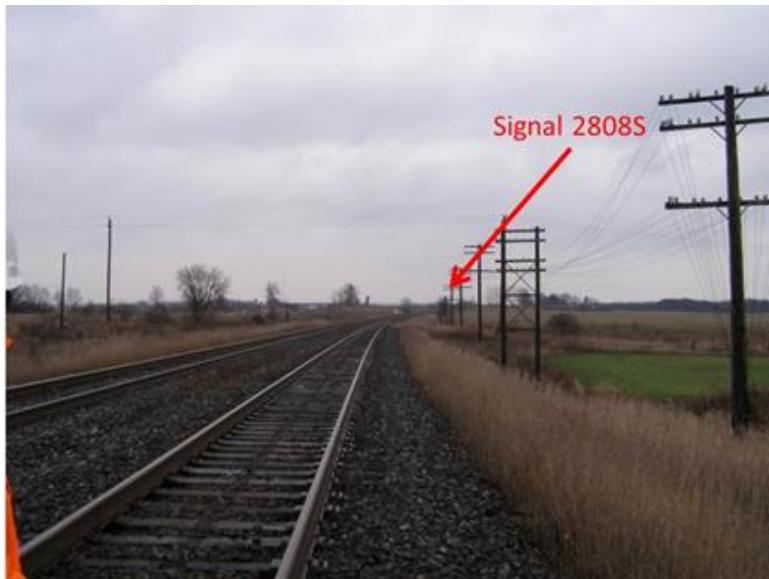
Figure 3. View of advance signal through the pole line

- The advance signals on the north and south tracks for the controlled location at Newtonville (Mile 280.8) become visible, and then are intermittently masked through a pole line⁵ that is no longer in use, located south of the south track on the 1-degree right-hand curve (Figure 3).

During the TSB re-enactment of the incident, the momentary presence of a green hue was noted when the green glass insulators from the decommissioned pole line were intermittently in the direct line of sight with the advance signals. This phenomena occurs when the advance signal is viewed from the locomotive cab while rounding the curve and can briefly affect the colour of the individual lights of Signal 2808S. In this occurrence, it is

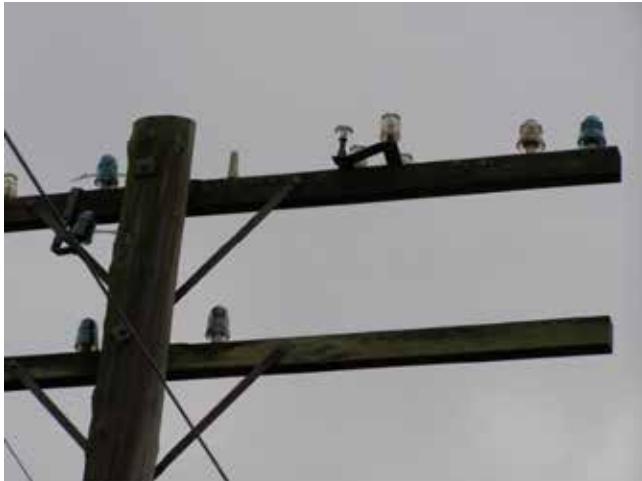
Photo 1. Coloured glass insulators on pole line

The TSB Engineering Laboratory conducted tests⁸ on the glass insulators from the pole line recovered from the occurrence site (Photo 1). When a white light was placed behind a green insulator (Photo 2), the light appeared to be a green colour. Similarly, when a white light was placed behind an amber insulator, the light appeared to be an amber colour.

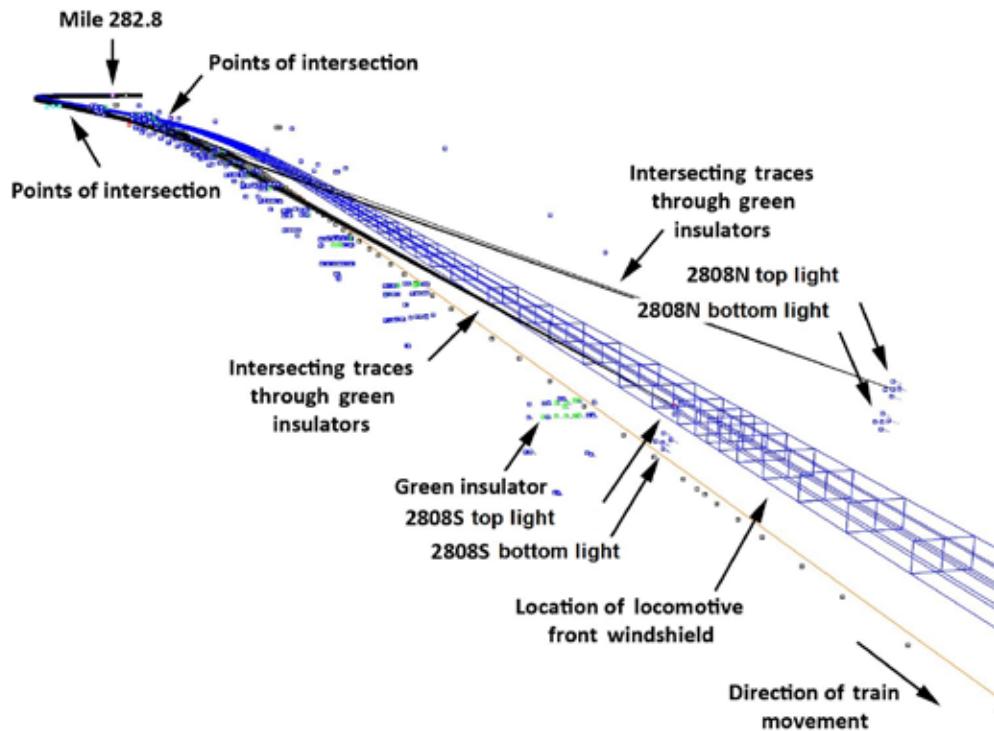
Figure 4. Intersecting traces (with green insulators) within the direct lines of sight for the 2 advance signals (2808N and 2808S)

- Between Signal 2808S and Mile 281.4 (i.e., the approximate location where the signal indication was identified and communicated by the train crew), there were 116 green insulators on the pole line.
- For an eastbound train traversing the right-hand curve, there were 17 green insulators in the direct line of sight of the advance signal for the south track (2808S).
- For an eastbound train traversing the right-hand curve, there were about 5 green insulators in the direct line of sight of the advance signal for the north track (2808N).
- The 22 green insulators within the direct lines of sight for the 2 advance signals were located between Mile 281.1 and 281.4 (Figure 4).

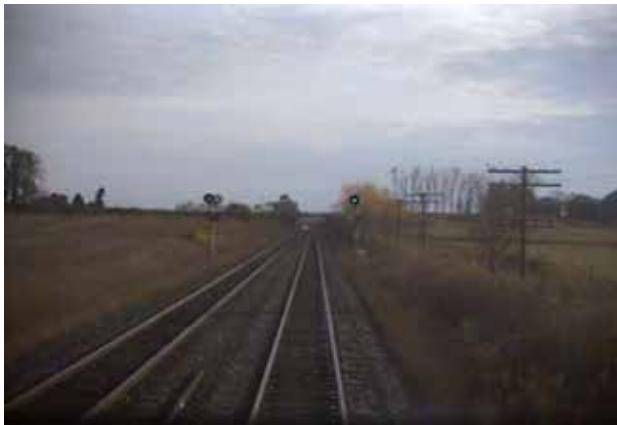
The forward-facing video on the lead locomotive was reviewed. On the video recording, a flashing effect of the signals produced intermittent changes to the perceived colour of the top light of the signal. Specifically, the top light would sometimes appear to be green, and at other times would appear to be yellow (Photo 3 and Photo 4).

Photo 3. Still frame of locomotive forward-facing video at 10:13:21 (Note: Top light appears to be green.)

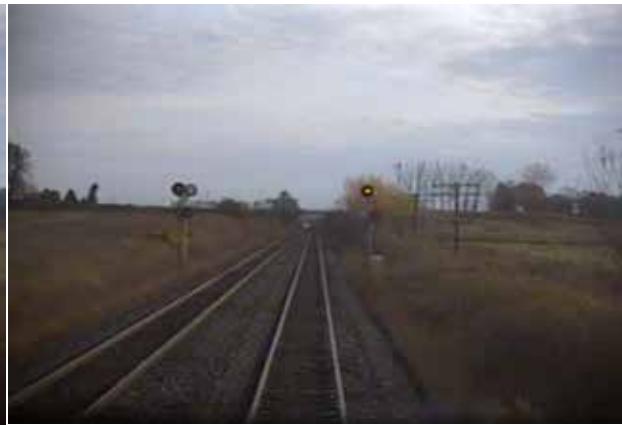
Photo 4. Still frame of locomotive forward-facing video at 10:13:22 (Note: Top light appears to be yellow.)
