**RAIL INVESTIGATION REPORT
R15T0245**

**RISK OF COLLISION
VIA RAIL CANADA INC.
PASSENGER TRAIN NO. 65
MILE 304, GO TRANSIT KINGSTON SUBDIVISION
WHITBY, ONTARIO
25 OCTOBER 2015**

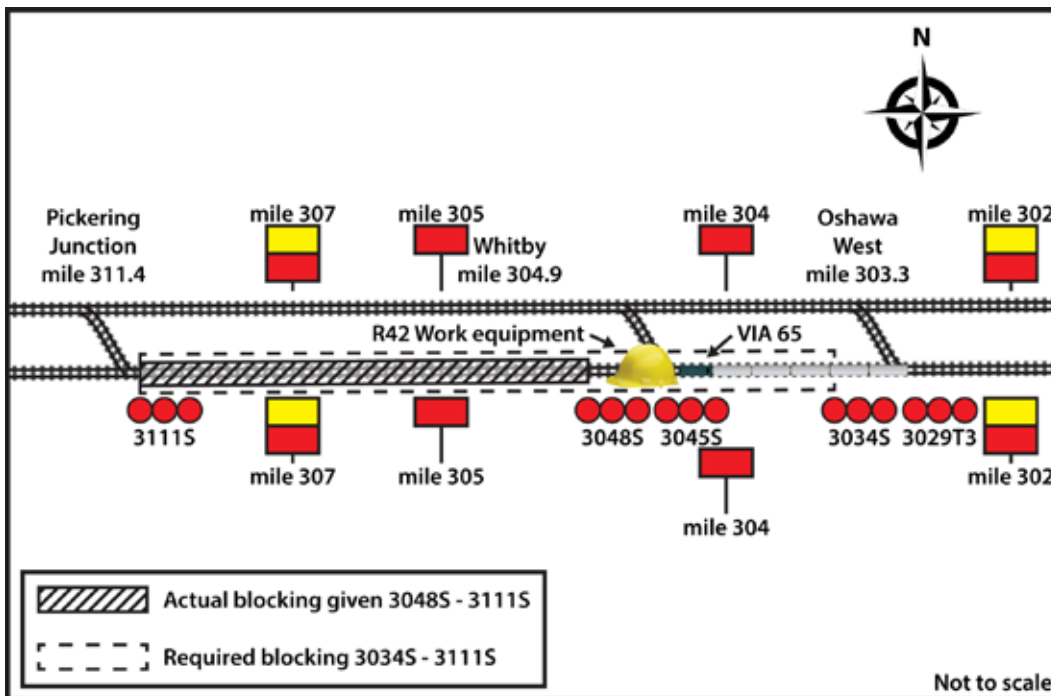
Figure 2. Site diagram

To protect the situation, the RTC had to block the south track between Signal 3034S (Mile 303.4, Oshawa West) and Signal 3111S (Mile 311.1, Pickering Junction). However, the RTC incorrectly entered signal blocking between Signal 3048S (located at Mile 304.8 at Whitby) and Signal 3111S on the south track. The RTC advised the foreman that the south track had been blocked between Whitby and Pickering Junction, excluding the crossovers on each side. The foreman did not make a record of this information, nor was he required to do so (Figure 2).

The signal blocking meant that the train could be and was lined by Signal 3029T3 (Oshawa West) on the south track into the Rule 42 limits until Whitby, where it was then lined to cross to the north track. Recognizing that their train was being routed through the Rule 42 limits on the south track, the train crew contacted the foreman again to indicate that they would be crossing over at Whitby. However, it was not specified that the train would be approaching the foreman's limits on the south track. The foreman responded affirmatively to the train crew, still not realizing that the train was lined on the south track to Whitby.
