RAILWAY INVESTIGATION REPORT R15V0183

Main-track train collision

Canadian Pacific Railway
Freight trains 602-242 and 113-01
Mile 62.0, Mountain Subdivision
Beavermouth, British Columbia
06 September 2015

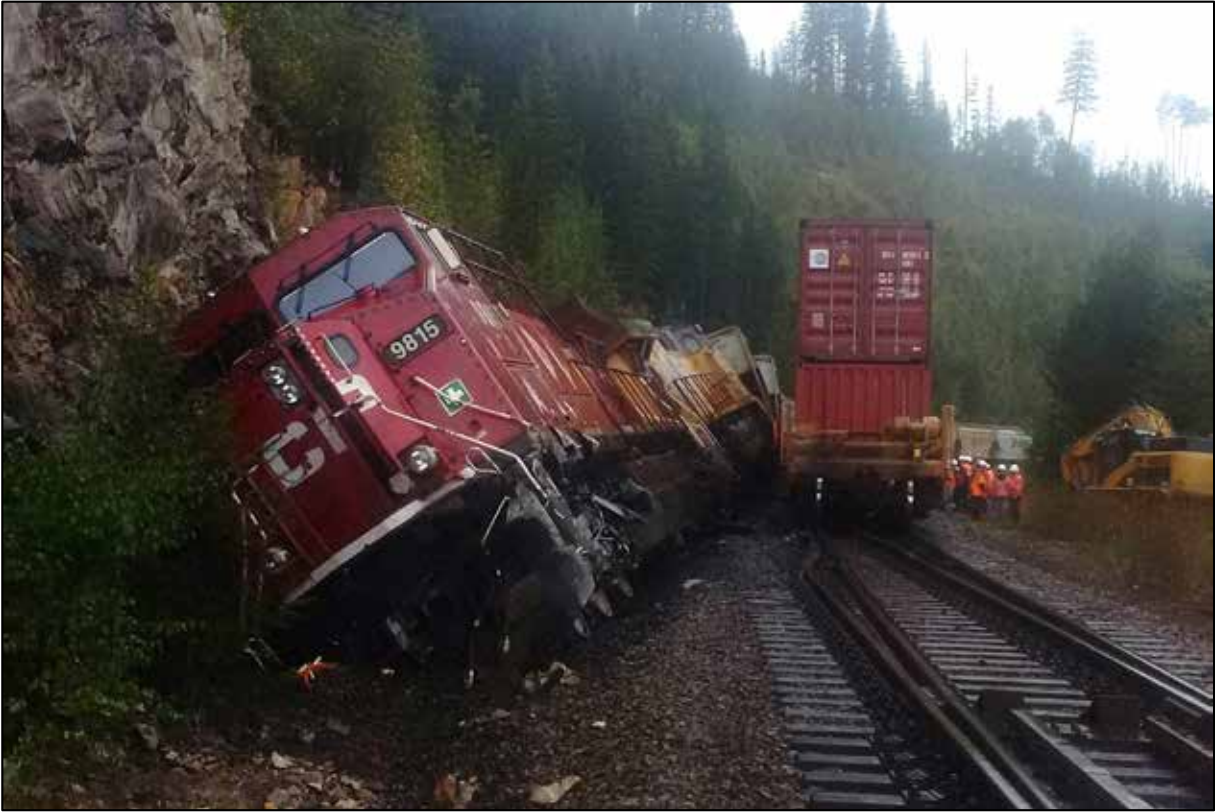
As a result of the collision, the 2 lead locomotives from train 602 (CP 9815 and UP 5528) came to rest at a 45° angle, leaning to the south against the rock face, immediately adjacent to the east siding switch (Photo 1). The first car (CITX 151053) behind the 2 locomotives derailed upright and was also leaning to the south. On train 113, one set of trucks on the 64th car (DTTX 759813) derailed (Figure 3). The conductor of train 602 received a serious injury. No dangerous goods were released.

Photo 1. Both locomotives of train 602 derailed at east end of Beavermouth siding (facing west)
