KÖZLEKEDÉSBIZTONSÁGI  
SZERVEZET  
TRANSPORTATION SAFETY  
BUREAU

**FINAL REPORT**  
**2008-0446-5**  
**SERIOUS RAILWAY ACCIDENT**  
**Monorierdő**  
**6 October 2008**

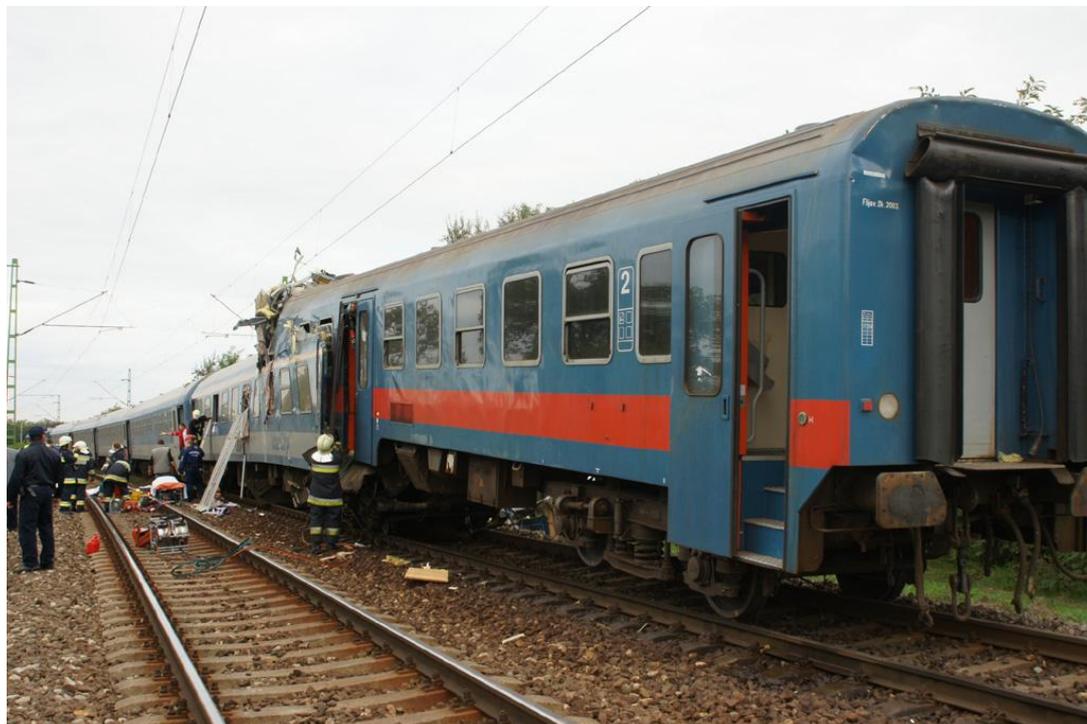
As a consequence of the collision, the control car penetrated into the last carriage of the IC on an approximately 11-metre length (See Figure 4). The passenger train got disengaged and its second carriage derailed. Three people travelling in the last carriage of the IC train lost their lives at the site and another person died in the hospital (3 passengers and 1 crew). Four people suffered serious injuries and further 40 were injured.

Figure 4: the site of the accident

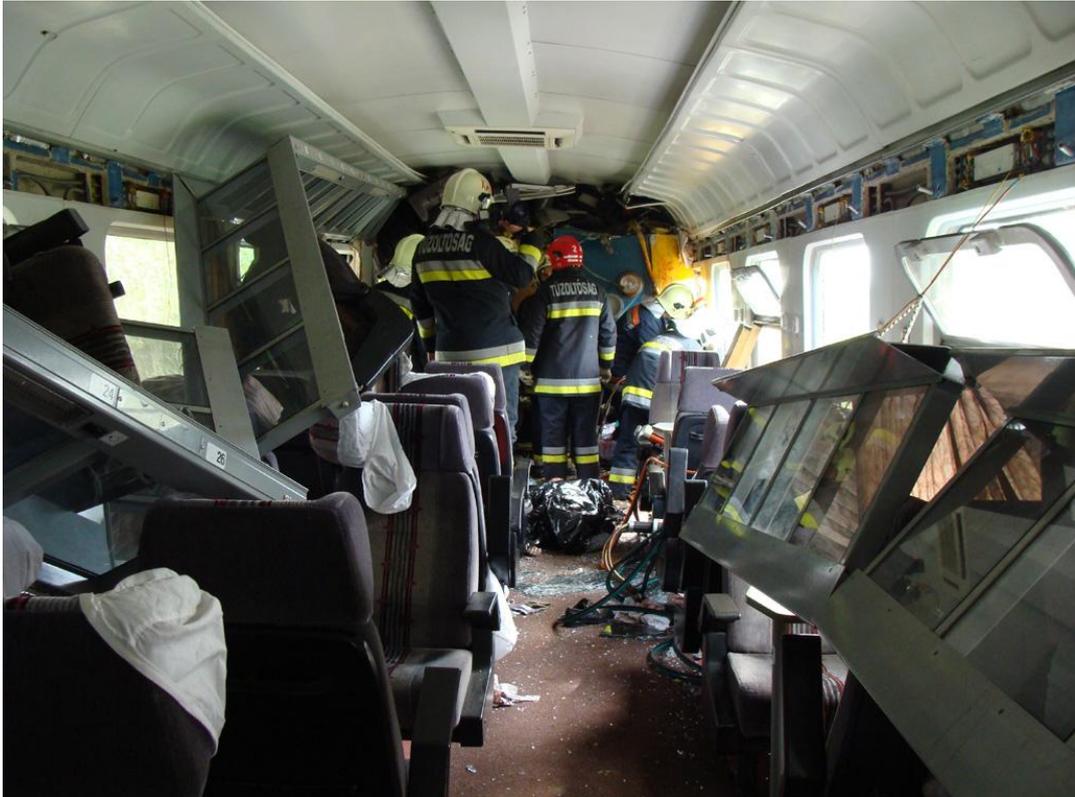
In the course of the site survey, the IC established that the overhead luggage-racks in the seriously damaged last carriage broke off, even in parts of the compartment whose carriage-body was not damaged.

**Figure 5: The inside of the last carriage of train no. IC 560-1 with the torn off luggage-racks**

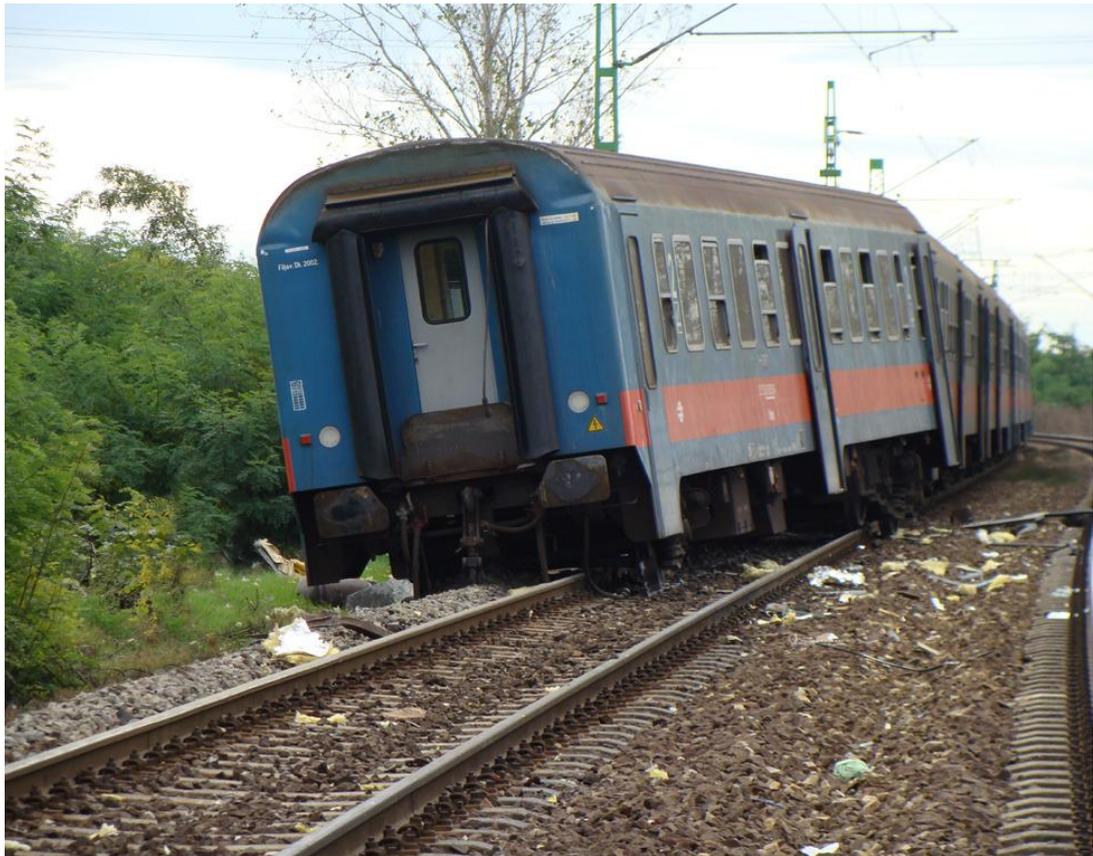
The railway vehicles sustained various damages. The control car in the front became unserviceable; its driver's cab and luggage carriage (for carrying bicycles on the train) were destroyed and the second carriage derailed.

**Figure 6: The derailed second carriage of the passenger train and some scattered debris**

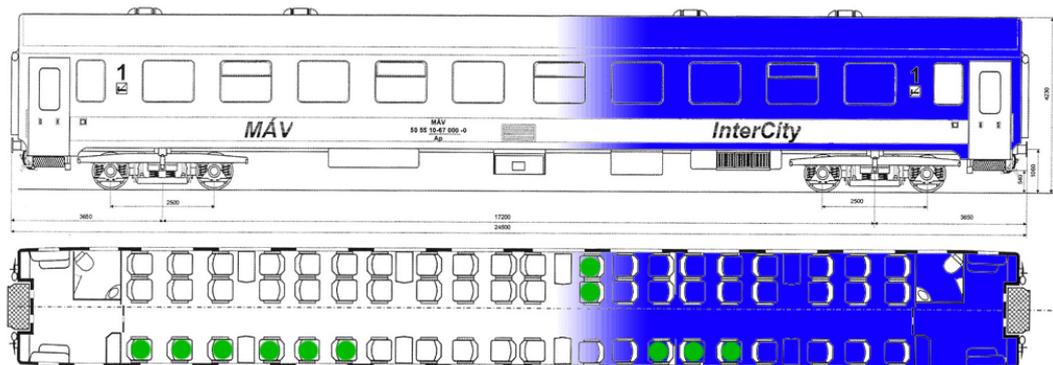
**Figure 11: The last carriage of train IC 560-1; the destroyed part of the passenger compartment indicated with blue and the sold seat tickets are indicated with green colour**

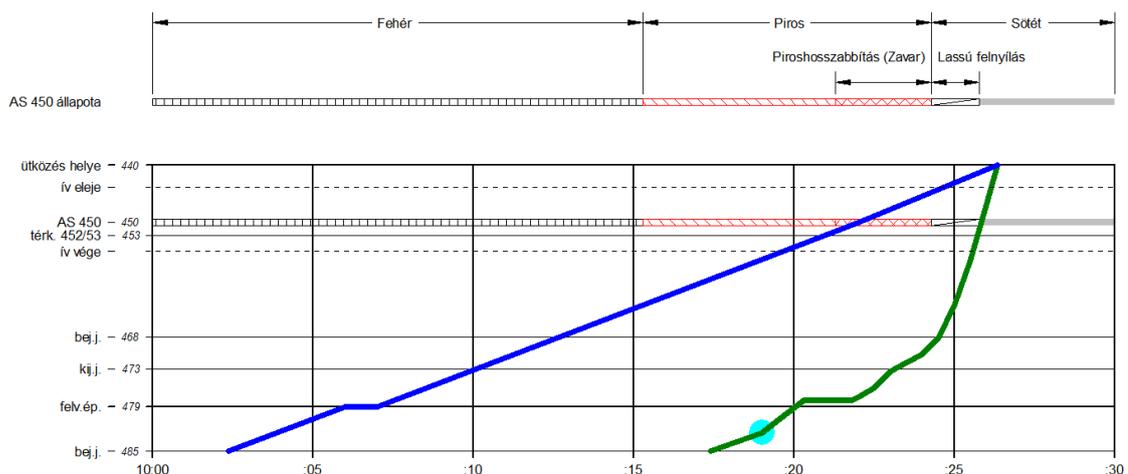
**Figure 13: the distance-time diagram until the collision and the state of LC AS 450 (bej.j.: entry signal, kij.j.: exit signal, felv.ép.: station office, térk.: block signal, AS: LC on the open track; green: train 2537, blue: train IC 560-1; light blue dot: EÉVB place of deactivation)**

The light blue dot in Figure 13 indicates the moment when the EÉVB of the control car was deactivated. It is visible from the breakage of the green line that after deactivating the control function, the train ran on with higher speed.

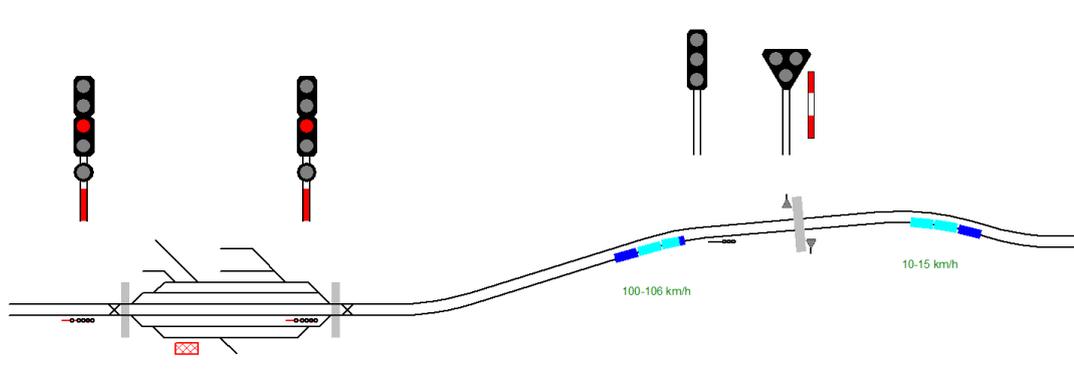
**Figure 17: 10:25 hrs**

At 10:25 hrs: the passenger train passed the dark block signal with high speed and was on its way towards the LC which by this time had become inoperative (was in failure state). It also sounded its horn. Unfortunately, the IC train had just left the straight section of the track before the passenger train arrived there, therefore the engine-driver of the passenger train had no chance to notice the danger.

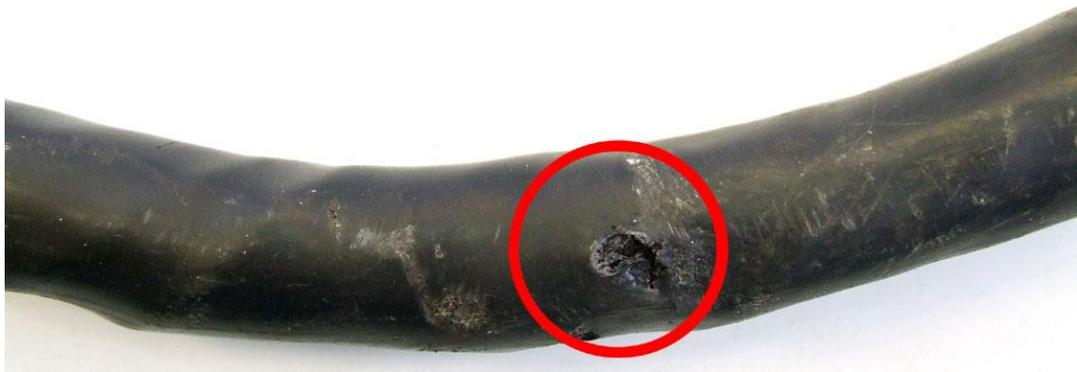
The failure was caused by the short circuit of the cables supplying 75 Hz, however, the cause of the short circuit was not found. The insulation of the wires in the cable was damaged to such an extent that it was impossible to determine whether the damage was a consequence of the short circuit or it had been damaged earlier.

Figure 19: the burn mark on the surface of the faulty cable

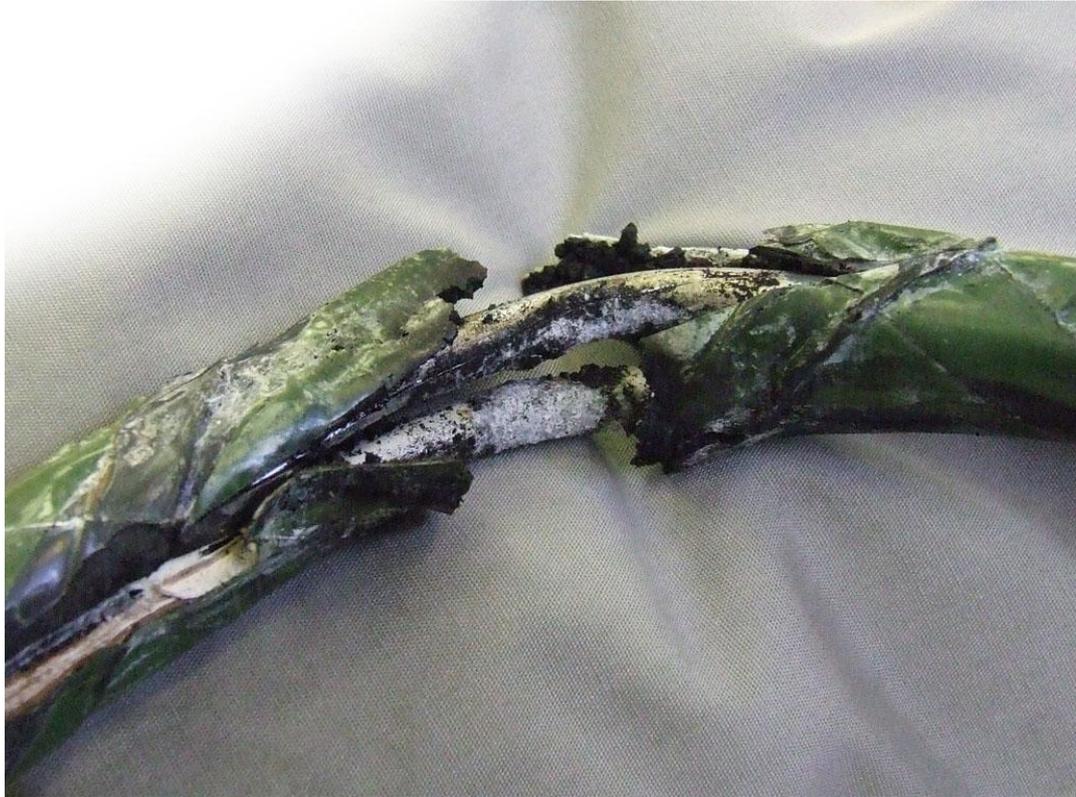
- After opening the cable, the expert and the members of the IC established that the short circuit of the 75 Hz cable was generated from inside - without outer mechanical input - and was probably caused by inadequate cable core insulation at production

**Figure 20: the wires of the opened cable with the burnt insulation**

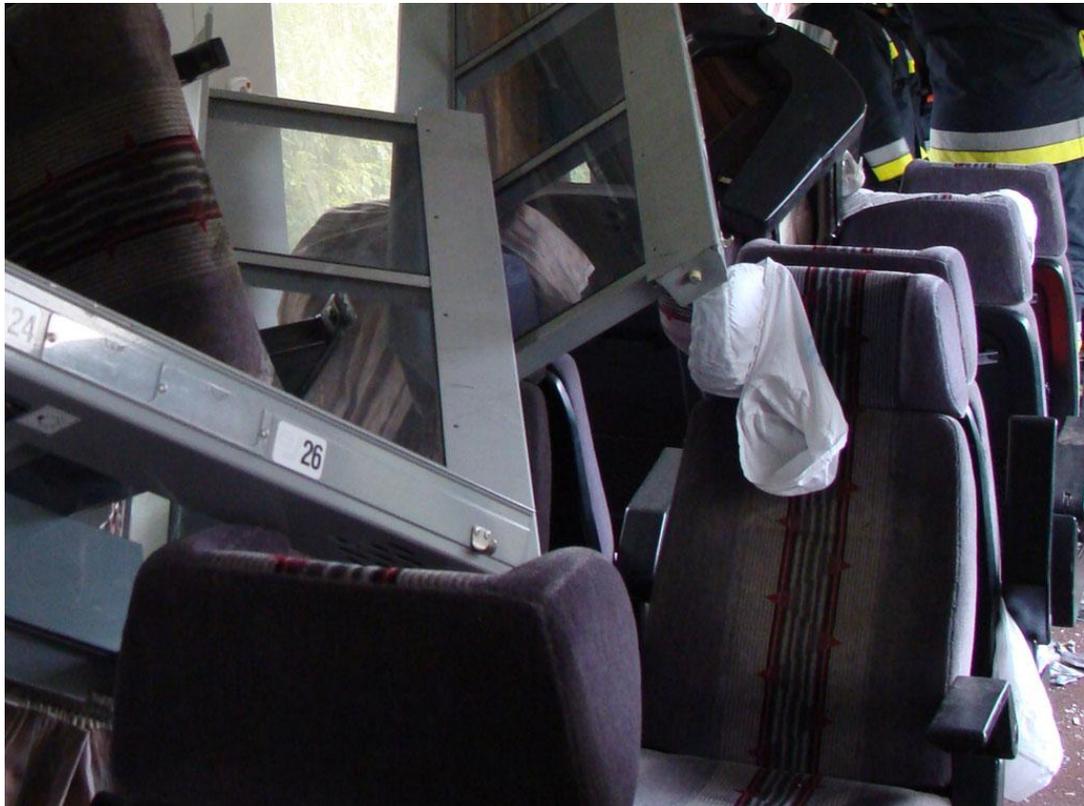
In the course of the site survey, the IC established that in the last carriage of train IC 560-1, the overhead luggage racks broke off, separated from each other and their parts/pieces fell in between the seats (Figure 18). These may have caused further injuries to the passengers. Some injuries most probably caused by the sharp edge of the fallen luggage racks were life-threatening.

Figure 24: Torn down, broken luggage racks in between and on top of the seats

- to revise the speed limit of 15 km/h to be observed under subsidiary signal;
- to put more emphasis on passive safety during the design of construction and furnishings of passenger rail carriages;
- to develop regulations and rules which provide basis for making decisions on when can / should block signals be considered inoperative,
- to focus on decision-making during staff training.

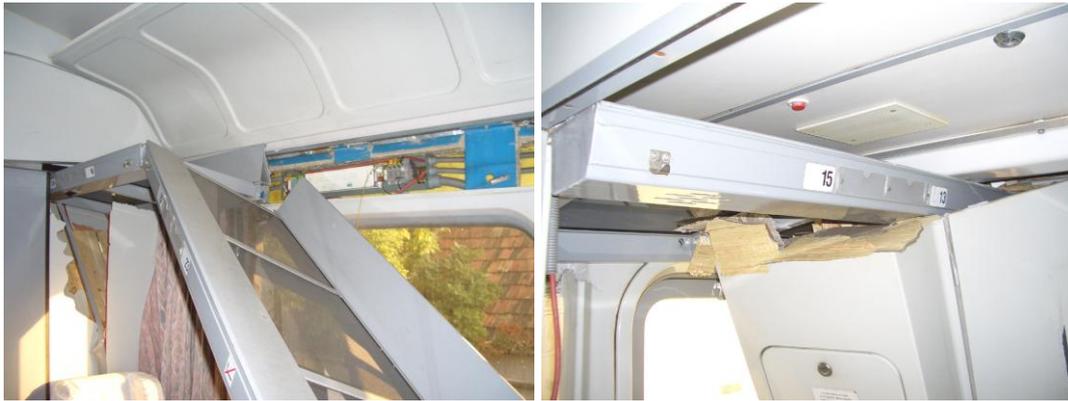
**Figure 25: the luggage rack penetrating the wall of the toilet**

It is visible in Figure 5 and 25 that the luggage racks fell as a result of the collision, however, they themselves remained in one piece, were not damaged or broken.
