Railway Accident Investigation Unit

INVESTIGATION REPORT

Operational incidents at
Ardrahan on the 23rd October 2015
& Spa on the 28th November 2015

RAIU Report Number: R2016 – 03
Published: 20th October 2016

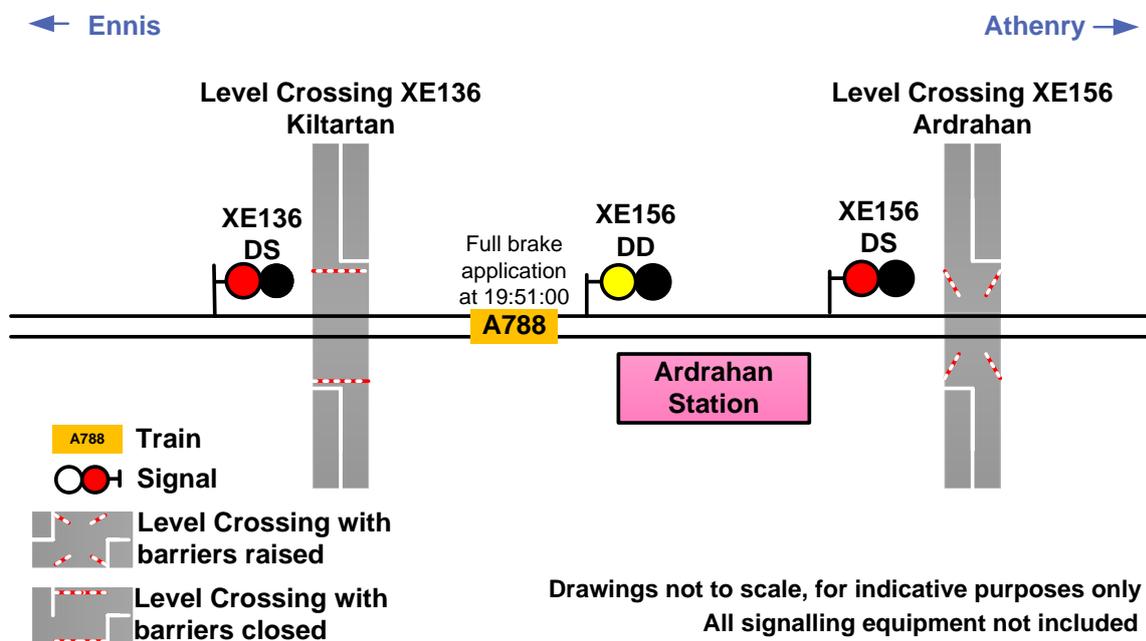
Figure 12 – Initial brake application at 19:50:56 & full brake application at 19:51:00

- 52 Driver A788 felt that the train was not slowing as normally expected, and four seconds after the initial brake application, Driver A788 made a full brake application, at 19:51:00. At this stage the train was approximately 1158m from Ardrahan Station platform (and approximately 753m from XE156DD) travelling at a speed of 101 km/h, see Figure 12.

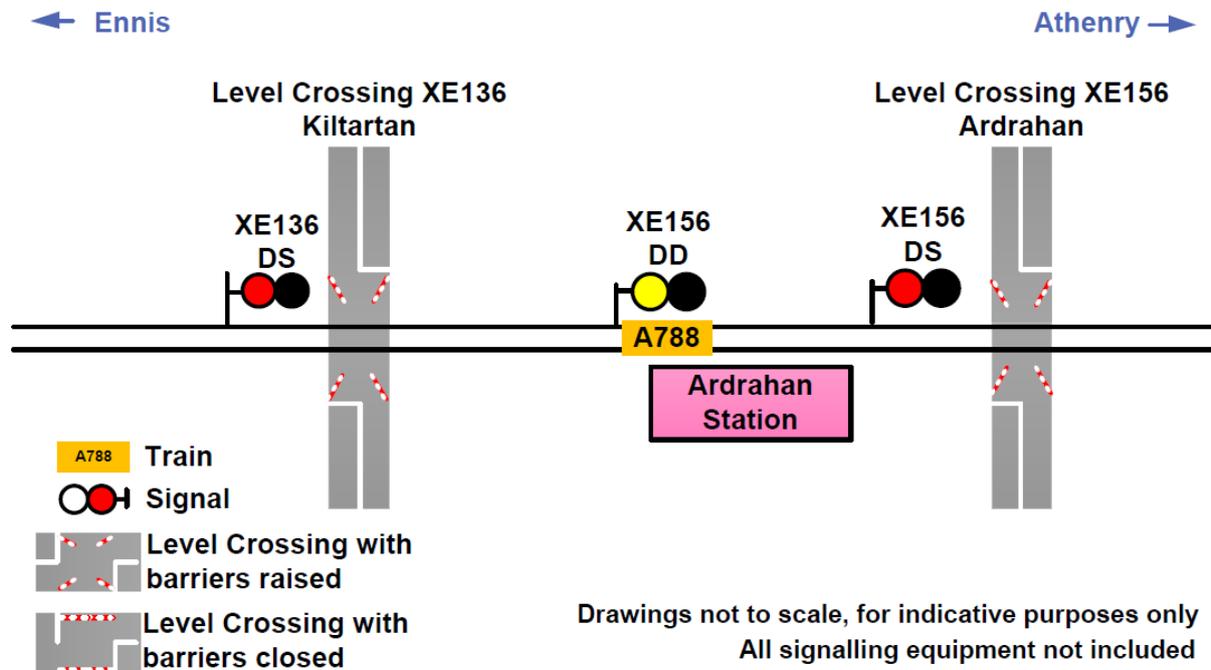
Figure 13 – Train A788 passed Signal XE156DD indicating that the next signal, Signal XE156DS is at danger

53 Train A788 continued its approach to Ardrahan Station, and approached the down distant signal, XE156DD for Level Crossing XE156 Ardrahan indicating next signal (Signal XE156DS) was at danger. However, the train was not slowing and passed Signal XE156DD at yellow at 19:51:27, see Figure 13. At this time, the On Train Data Recorder (OTDR) download showing brakes applying and releasing due to operation of WSP system trying to prevent the train sliding.

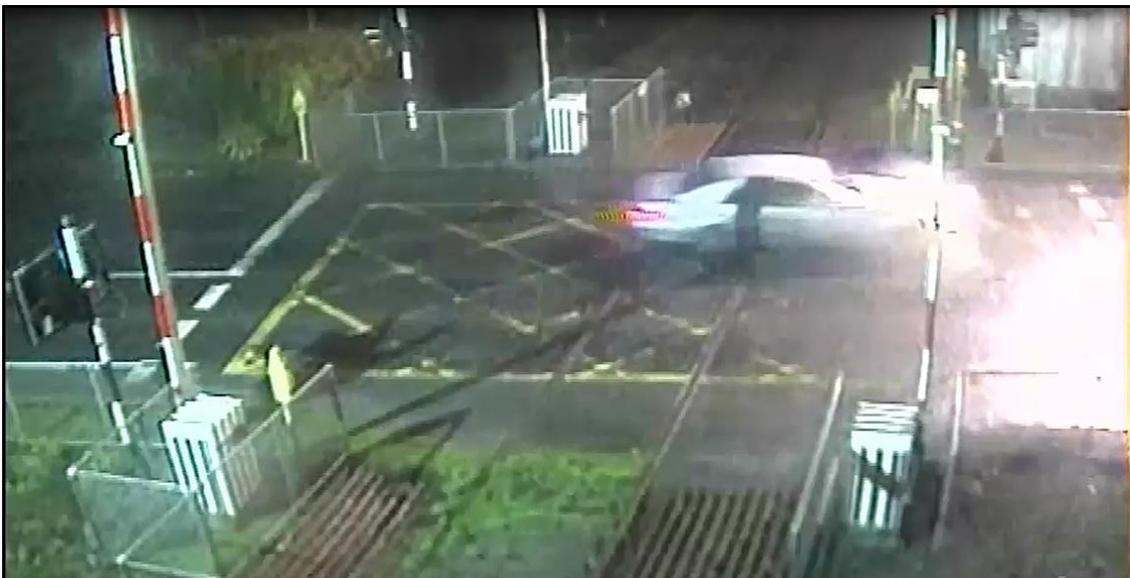
Figure 15 – CCTV screenshot at 19:52:10 showing a road vehicle travelling over the level crossing, with Train A788 nineteen seconds from reaching the level crossing.

57 At 19:52:10 a road vehicle crosses Level Crossing XE156 Ardrahan, see Figure 15. The train was approximately 280m away.

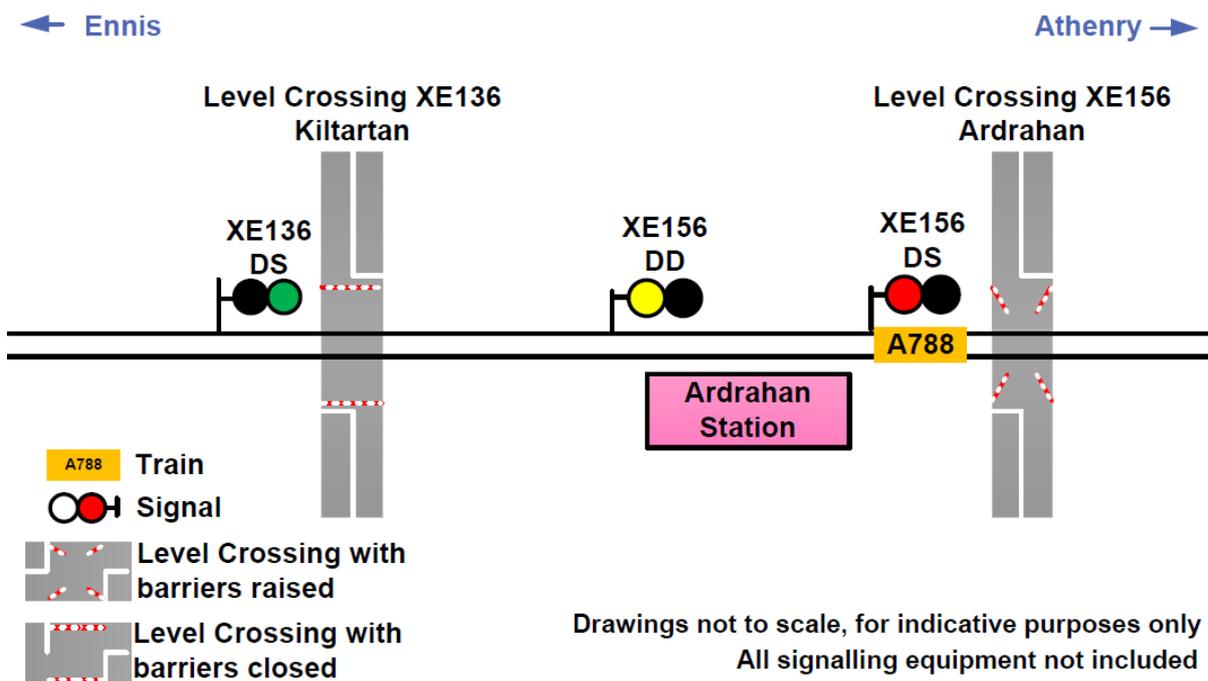
Figure 16 – Train A788 passing Signal XE156DS at danger

58 At 19:52:15 the train passes Signal XE156DS at danger, see Figure 16. This cancels the four minute auto-initiation sequence for barriers, which starts flashing red lights on Level Crossing XE156 Ardrahan to warn road traffic to stop immediately; the count had reached 3 minutes 52 seconds.

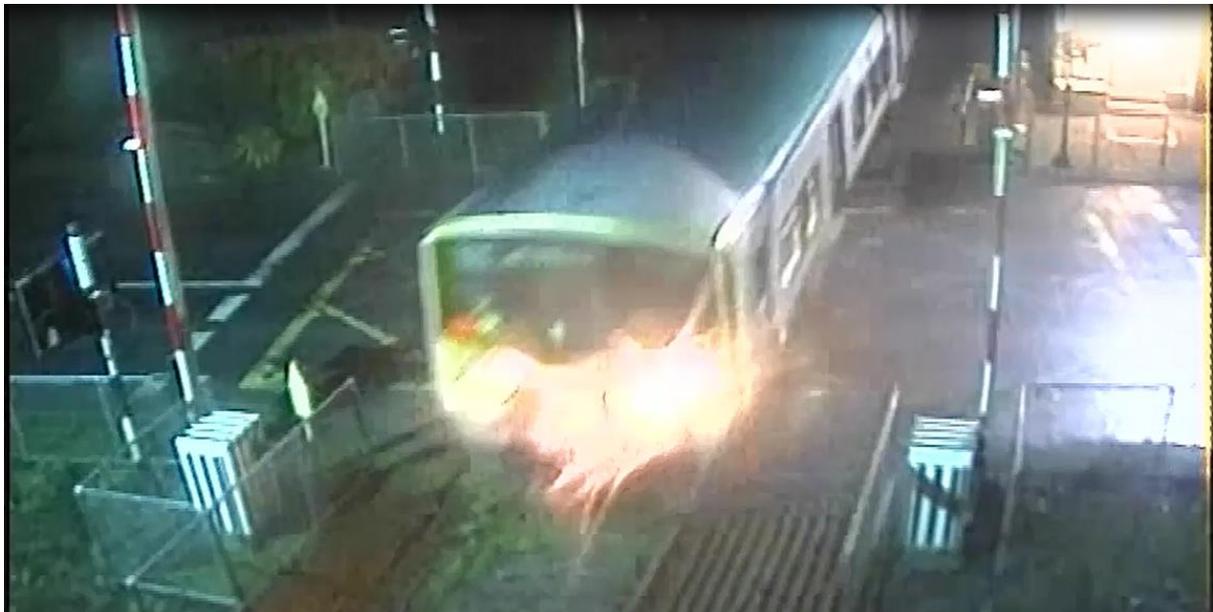
Figure 17 – Train A788 passing through Level Crossing XE156 Ardrahan with the barriers raised to road traffic.

59 At 19:52:29 the train passes over Level Crossing XE156 Ardrahan with barriers raised for road traffic. In the 138 seconds before the train crossed, thirty-one cars used Level Crossing XE156 Ardrahan, see Figure 17.

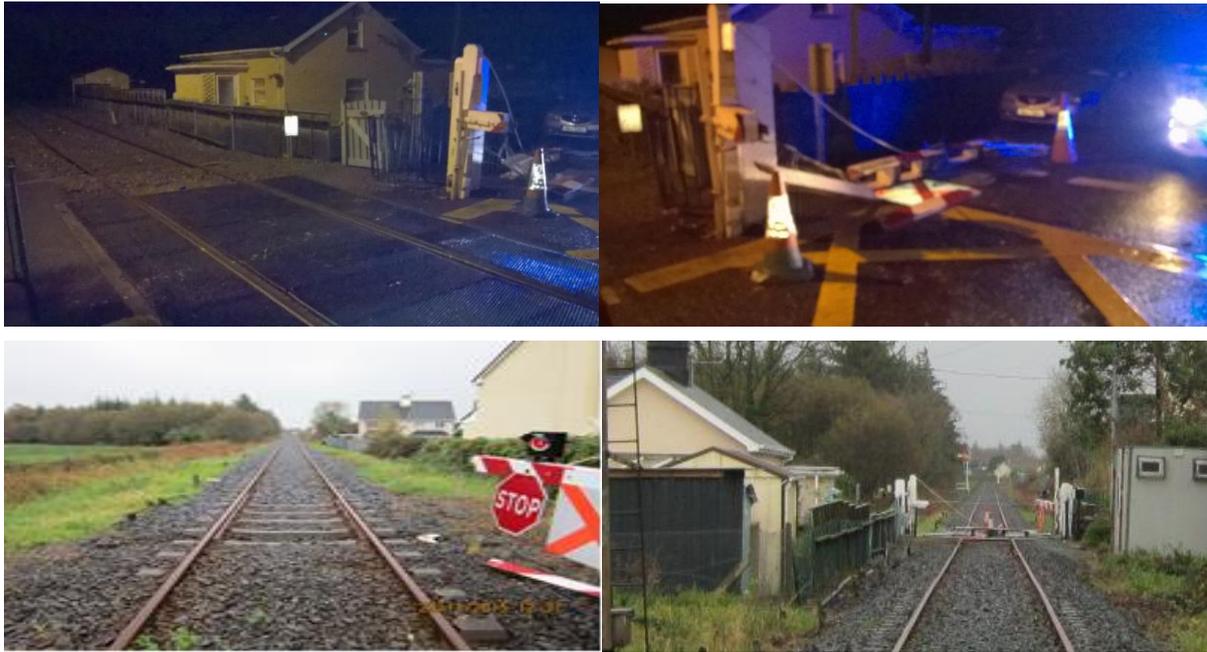
Figure 22 – Damage to gates at Level Crossing XN159 Spa

88 The gates at XN159 were beyond repair and required replacement as a result of the collision, see Figure 22. The units involved, units 2601 and 2602 showed wheel flats on all wheels. This unit required wheel turning.

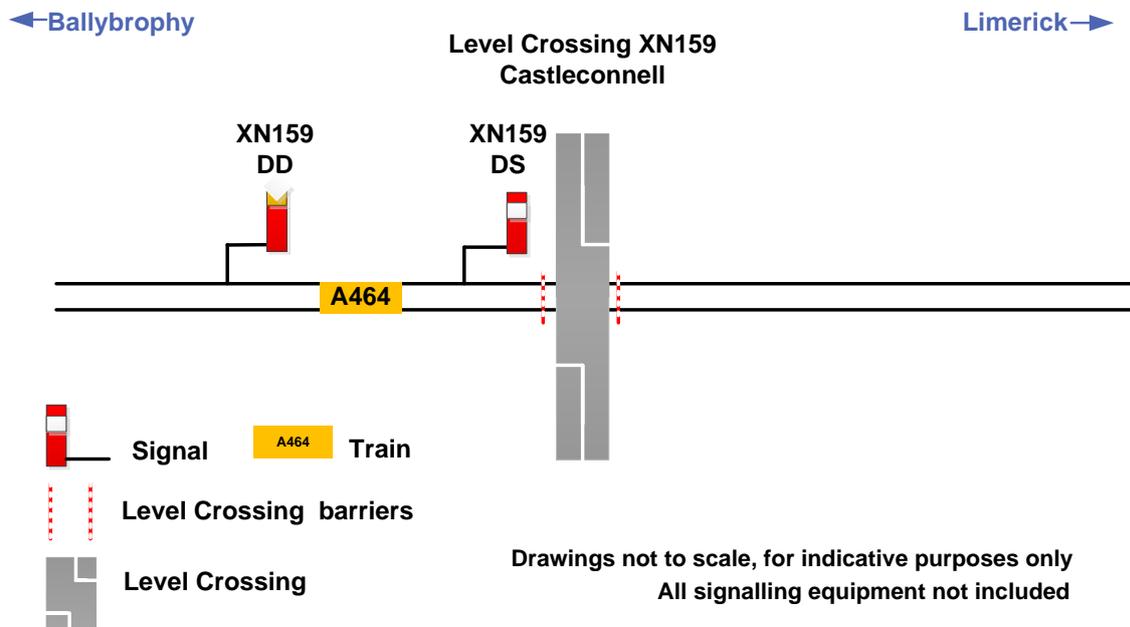
Figure 24 – Train A464 passing Signal XN159DD

98 At 21:16:31, the brake handle is placed into a braking position. The train speed is 68 km/h (42 mph). This resulted in severe wheel slide and WSP activity which is recorded on OTDR, see Figure 24.

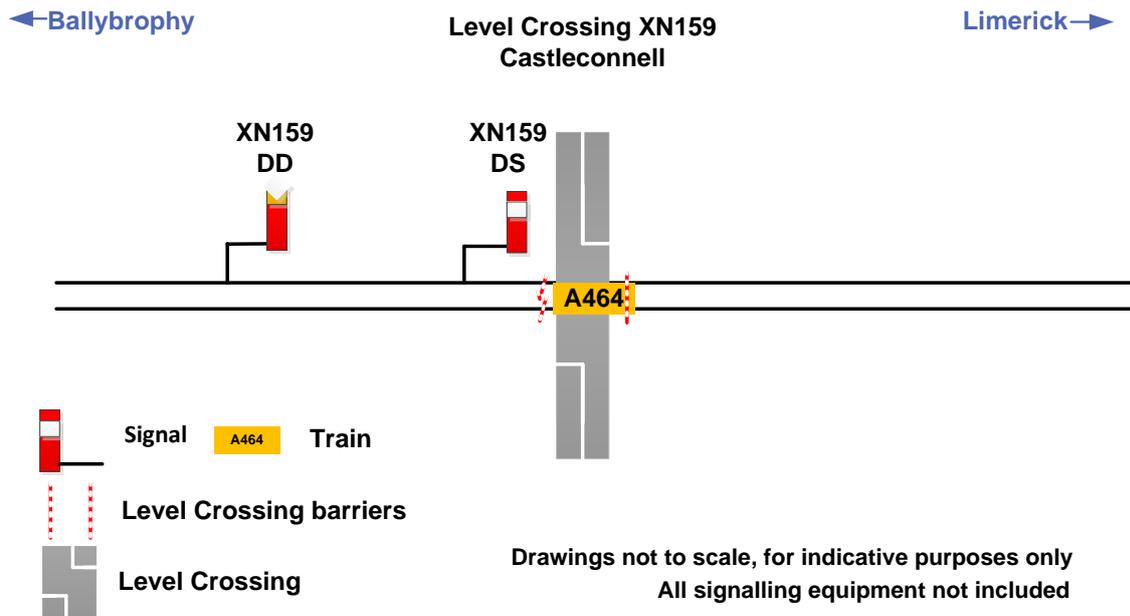
Figure 25 – Train A464 passing through Level Crossing XN159 Spa

104 At 21:17:43 the train passes through the Level Crossing XN159 Spa with gates closed against train, see Figure 23. The approximate speed that the train is travelling at is 16 km/h (10mph).

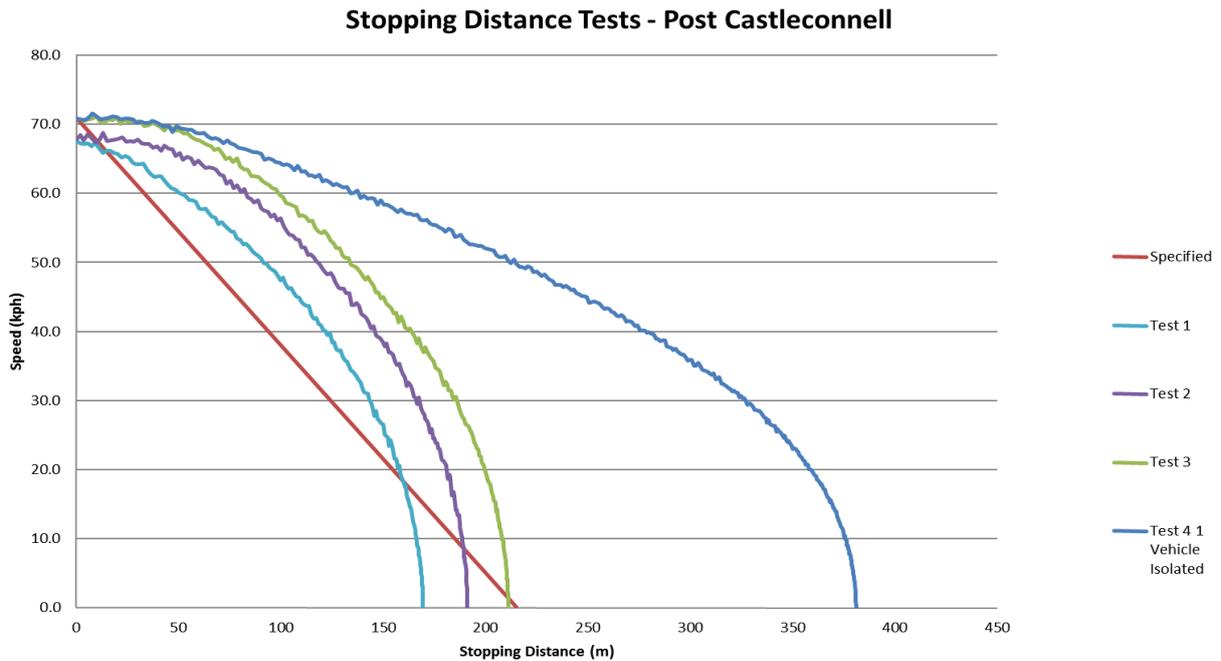
Figure 28 – Results of IÉ dynamic brake testing

161 The tests were carried at speeds of approximately 112 km/h (70 mph), which was line speed. The ‘Specified’ stopping distance, as per the design of the train, is illustrated as the red line, Figure 28, it is a distance of approximately 215 m. Test 1, Test 2 and Test 3 show similar stopping distances of approximately 170 m, 190 m and 210 m, respectively. This demonstrates a reasonable level of consistency of all tests meeting the requirements of the ‘Specified’ stopping distance. There was also no indication of WSP activity or poor performance during the testing, indicating the unit performed as designed.
