# Railway Accident Investigation Unit

## INVESTIGATION REPORT Dangerous occurrence between Ballybrophy and Portlaoise 12<sup>th</sup> September 2015

RAIU Report No: R2016 – 002  
Published: 6<sup>th</sup> September 2016

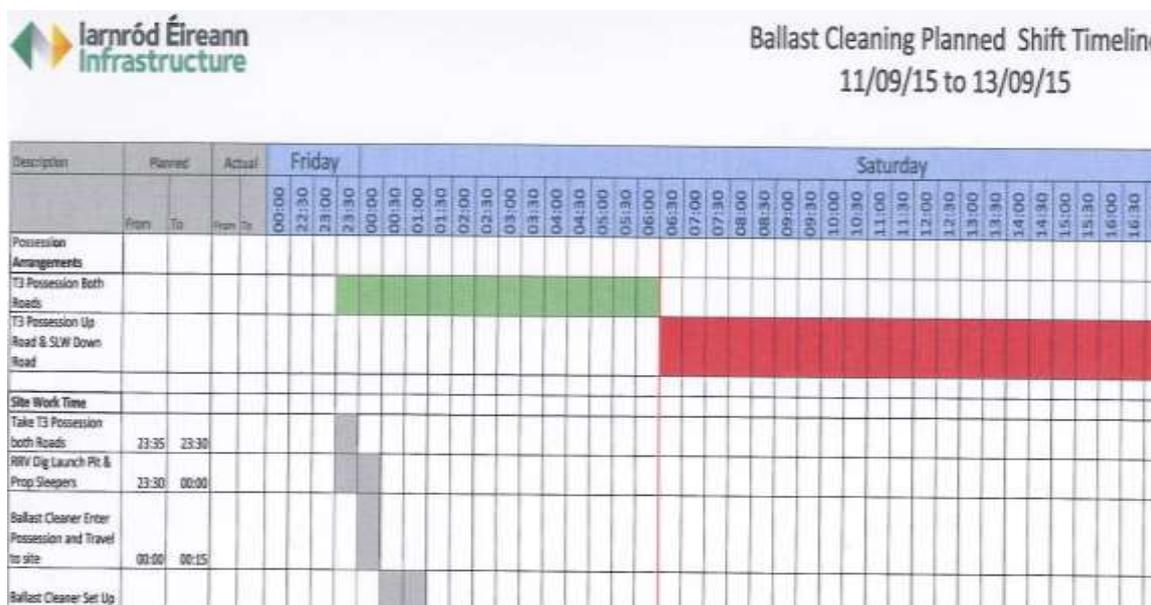
Figure 6 – Worksite Timeline taken from the Method Statement

56 Appendix B of the Method Statement, Worksite Timeline, has included a timeline for the work (see Figure 6). This timeline is incorrect as it shows that 'T3 Possession – Both Roads' is to continue until 06:00 hrs with the 'T3 Possession Up Road & SLW Down Road' to commence at 06:00 hrs.
