***Collision between two passenger trains in Dordrecht  
28 November 1999***

*The Hague, May 2001*

# COUNCIL FOR TRANSPORT SAFETY

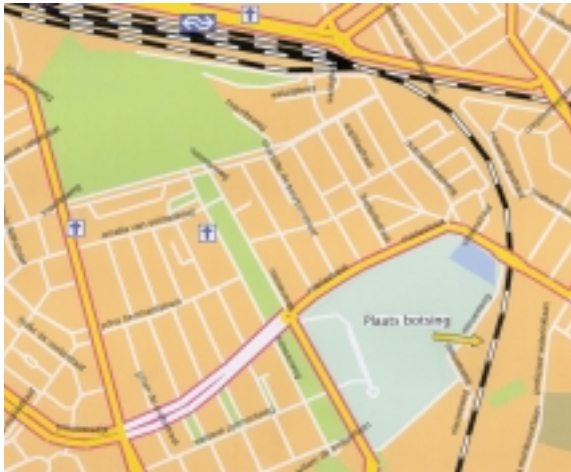
Figure 1. Dordrecht station and surrounding area. The arrow indicates the location of the collision.

The collision between the two trains took place at the station complex in Dordrecht. The station and its direct environment appear in figure 1. The tracks on the left lead to Rotterdam. The track on the right of the station goes to Geldermalsen. The track which bends down to the South runs to Lage-Zwaluwe, and is in a tight curve, with a speed limit of 80 kilometres per hour.

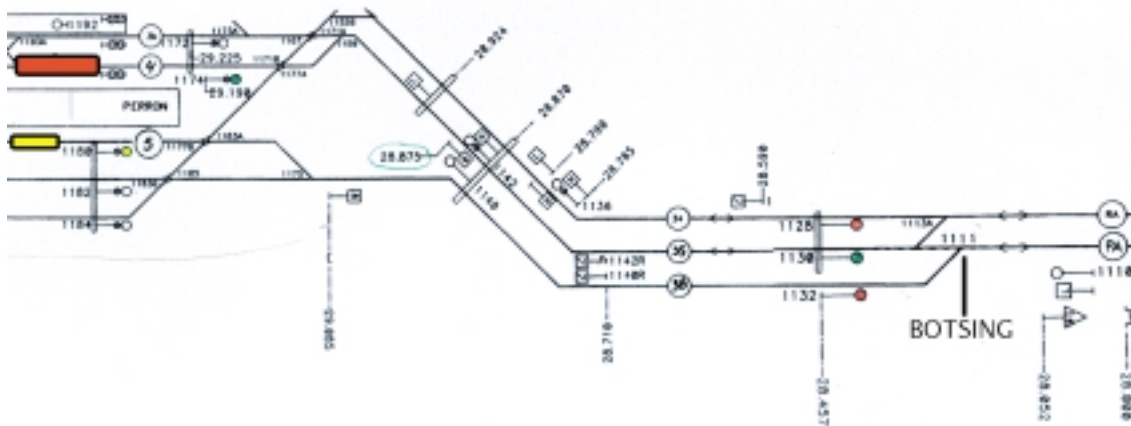
Figure 2. Diagrammatic representation of the southern section of the station complex. The station buildings are not shown. Parts of the platforms do appear on the drawing. The figures at right angles to the track indicate the kilometre measurements. The figures parallel to the track indicate the numbers of signals or points. Before track 36 was constructed, the trains travelled from track 5 via points 1177b and 1177a, over track 35.

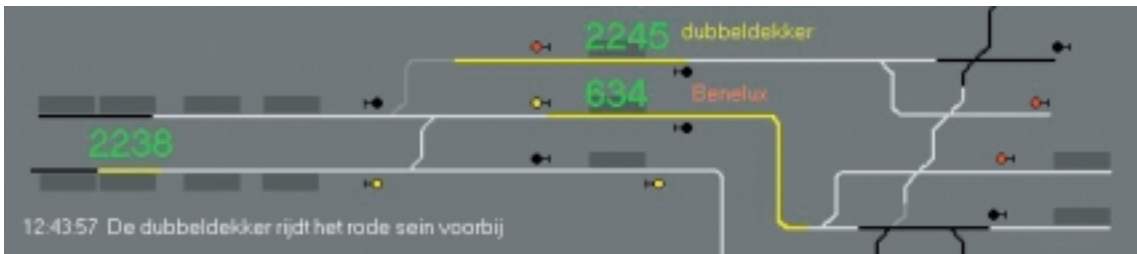
The driver of the double-decker missed signal 1132, which was at red. The double-decker wrongly passed signal 1132, and occupied the section after the signal, at 57 seconds after 12.43. The Automatic Train Influencing system did not intervene, because this system does not function at speeds of 40 kilometres per hour and lower. The Benelux train, which was travelling faster and faster, at 14 seconds after 12.44 passed signal 1130, which is located next to signal 1132, and which was showing green, at a speed of 60 kilometres per hour.

Figure 3. All changes in the system: the occupation of sections, changes of signals, etc. are all automatically recorded. On this basis, it is possible to precisely determine what happened in Dordrecht. The figures indicate the train numbers. The grey rectangles have no relevance in this figure. The light-grey lines indicate the sections of set routings. The yellow lines indicate the sections occupied by a train. At the indicated moment, the double-decker passed the signal at red. The section after the signal issued a track occupied message. The Benelux train is at that moment still in front of the signal, on the routing set for it. This course of events is visible on the train controller's monitor. Train number 2238 is the train approaching on the adjacent track.

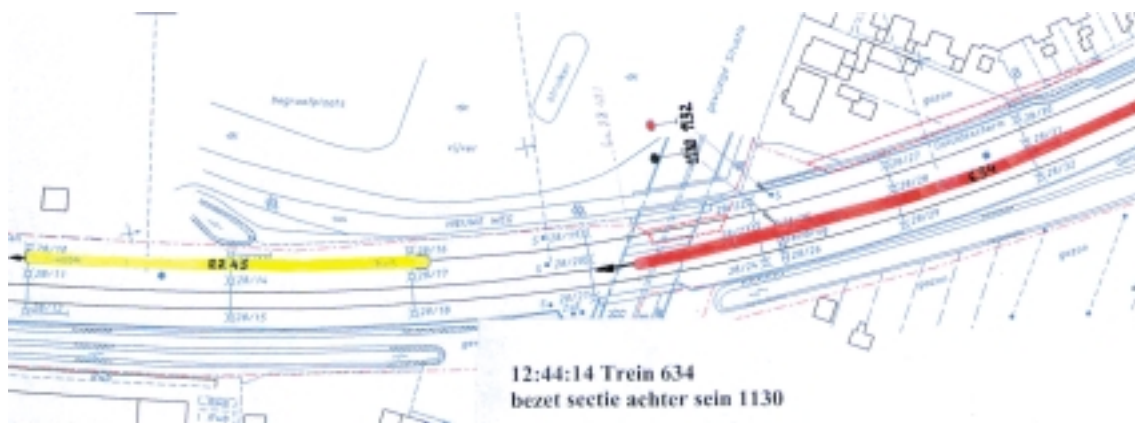
Figure 4. The Benelux train passes signal 1130, which shows green, 17 seconds after the double-decker passes the red signal 1132.

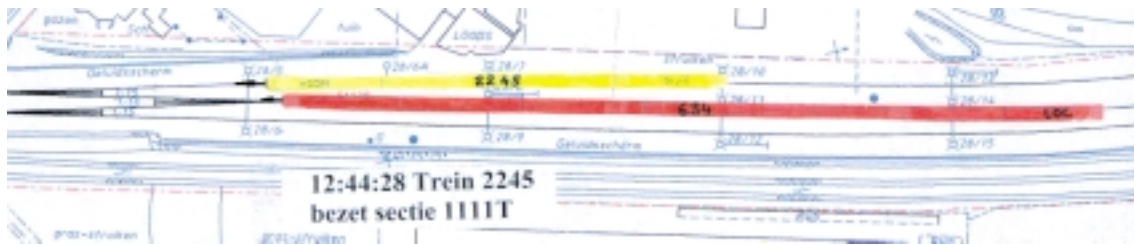
Figure 5. The Benelux train is still behind the double-decker, 21 seconds after the double-decker has passed signal 1132.

This is 17 seconds after the double-decker incorrectly passed signal 1132. The train controller is able to observe this latter fact on his monitor. The Benelux train continued along its route over switch 1111. At that moment, train speed is 70 kilometres per hour.

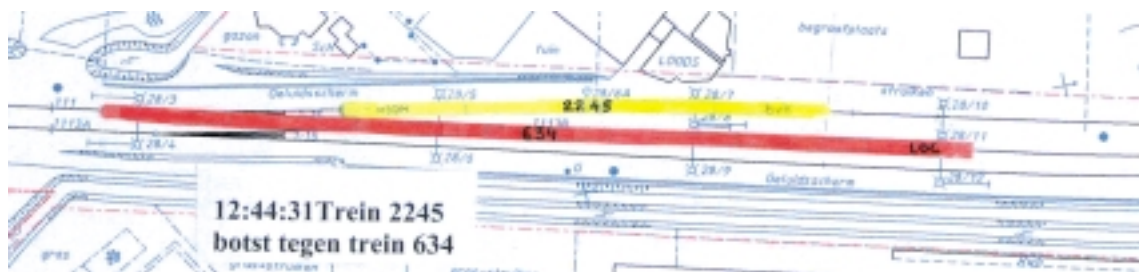
When the second and third carriages of the Benelux train were above the points, 31 seconds after 12.44 (34 seconds after the passing of the red signal by the double-decker), they were hit in the flank.

Figure 6. 34 seconds after passing the red signal, the collision takes place.

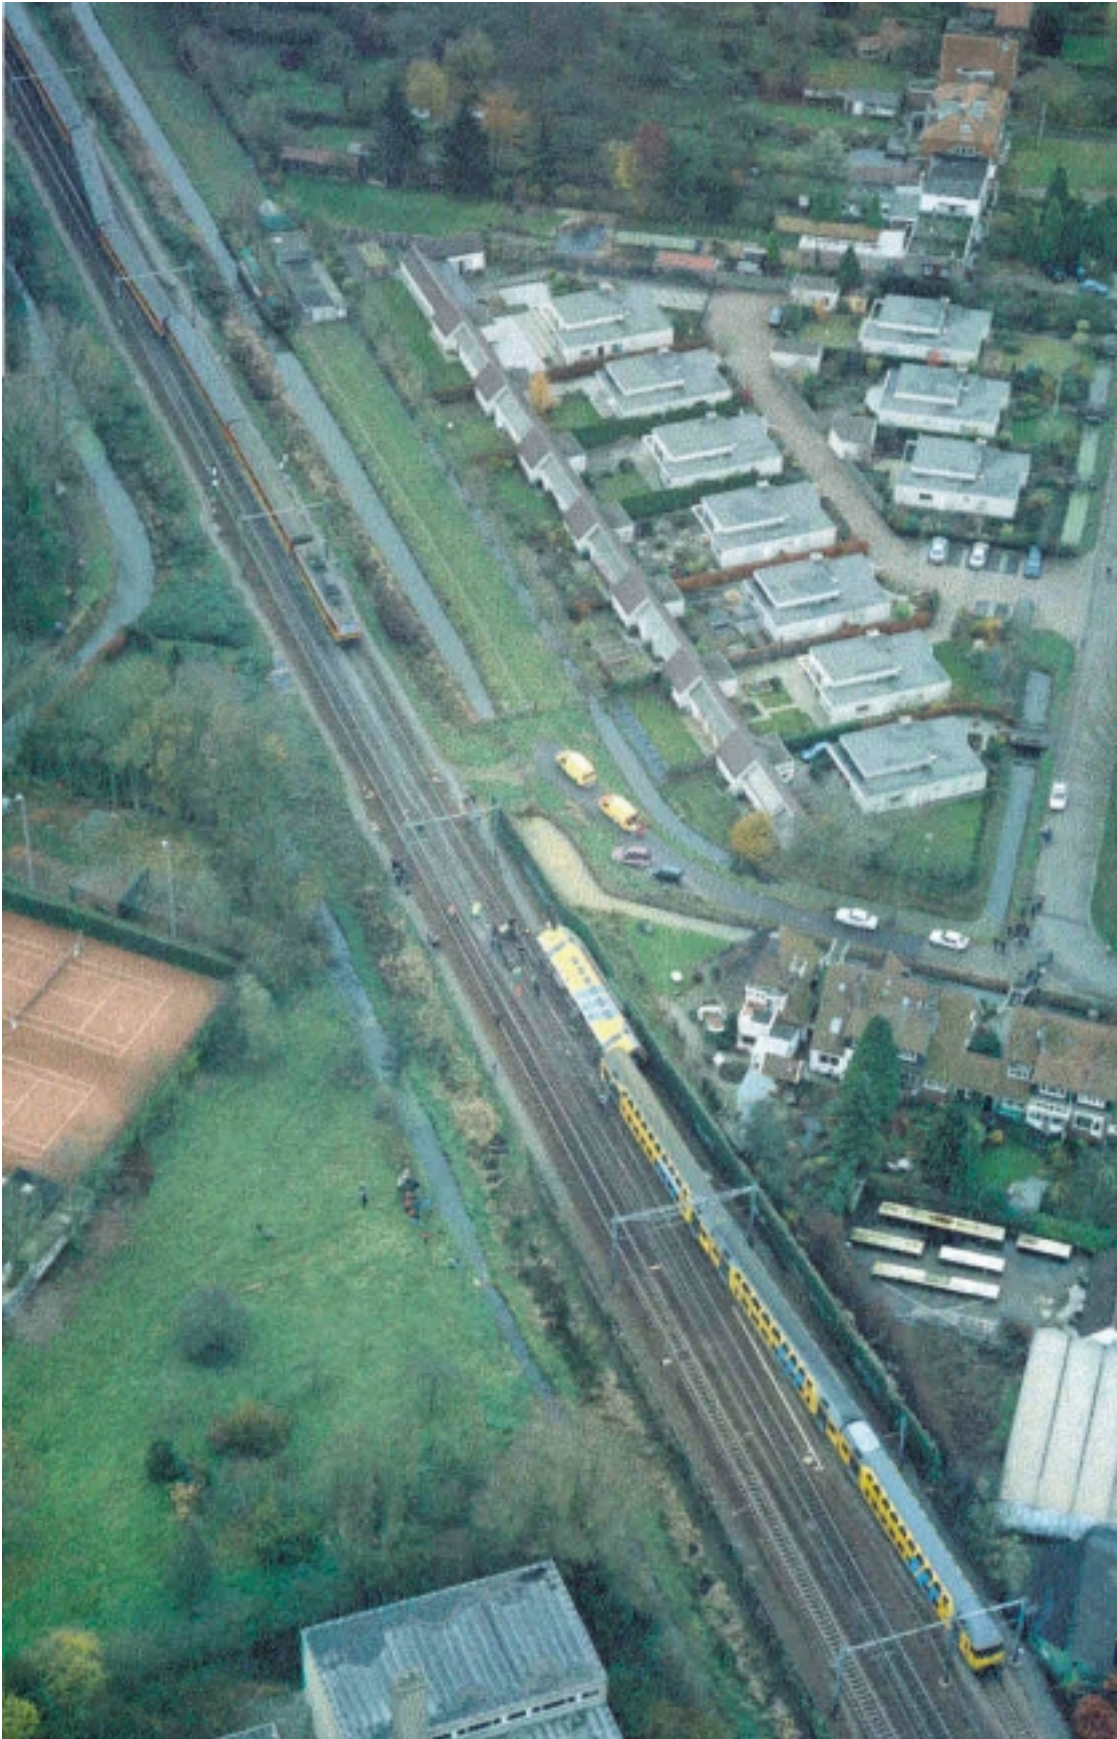
As a consequence of the collision the power car tipped outwards, against a noise abatement screen. A number of carriages of the Benelux train were derailed. They did not tip over, probably because the couplings of these carriages withstand the shock, with the rest of the train. The derailed carriages did enter the envelope of the adjacent track. The driver of the train approaching on this track, from Dordrecht Zuid saw in time that his track was blocked, and halted his train, before the derailed carriages.

Figure 7. Overview of train positions following the collision. In the top left-hand corner, we see how the carriages of the Benelux train are blocking the adjacent track. A potentially very hazardous situation.

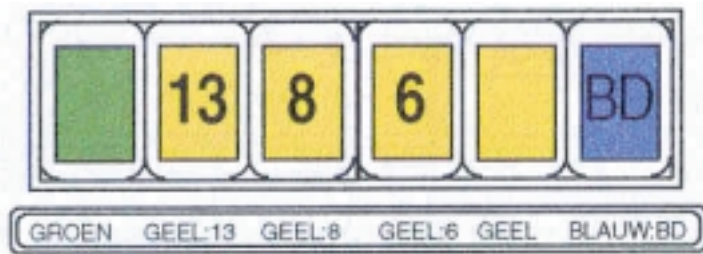
Figure 8. The Automatic Train Influencing table fitted in the train cab.

Although elements of the Automatic Train Influencing system are installed in the track, the core of the system is built into the train. The existing system was developed in the nineteen fifties on the basis of relays. The state of technology at the time limited the number of safety func-

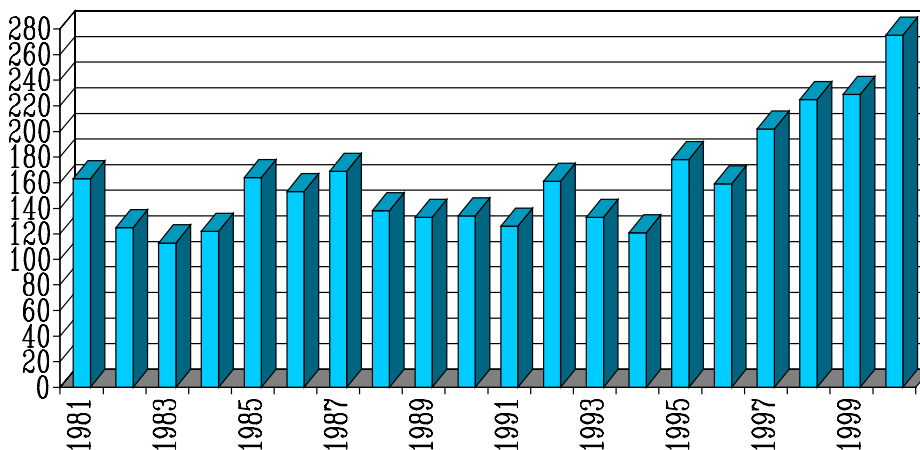
Figure 9. The total number of signals passed at red, in various years. The numbers relate to all signals at danger, and relate to both fixed and light signals. The number of fixed signals at danger equates to approximately 7% of the total.

The table shows a disturbing increase. Every passing of a signal at red is a potentially very hazardous situation. The consequences are not foreseeable. The result could be a collision, leading to an immense number of victims. The result is determined by chance. Effectively a situation not socially acceptable.

Traditionally, the number of times a signal is passed at danger is 150 a year, also in the years before 1989, not shown in the table. From 1995 onwards, a considerable rise has been observed, which for the time being has no clear explanation. In the year just ended, in fact, 280 signals at danger were passed, incorrectly. Since 1990, the number of train kilometres has only risen by 8%. The increase can therefore not be explained by an increase in train frequencies.

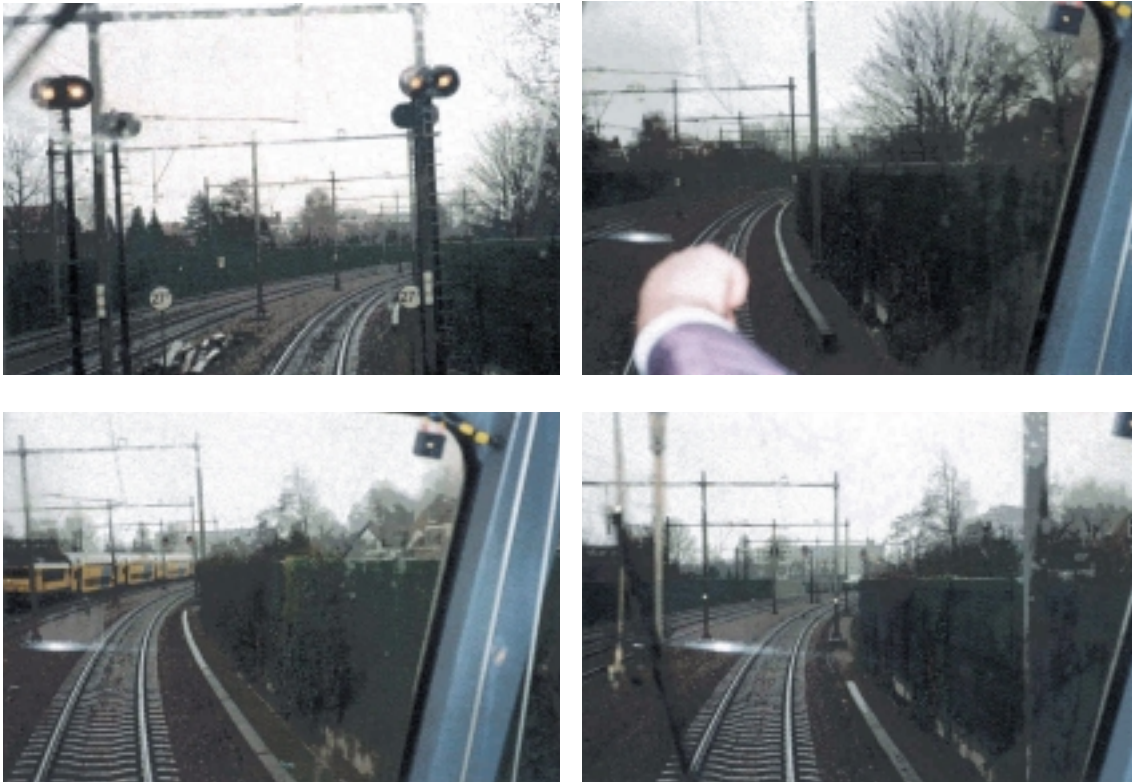
Signals must be observable in good time. In laying the section of track in question in 1994, insufficient attention was paid to the visibility of signal 1132, which was wrongly passed. Visibility is hindered by a noise abatement screen and vegetation growing behind it.

Figure 10. The view of signal 1132 at 200, 178, 140 and 120 metres before the signal, determined two months following the collision. In this period, the trees have few leaves. This is not the case throughout the year. During the passage by the double-decker on 28 November, the central signal for the Benelux train was at green.

In other words, the obvious standard: a visual link between track and signal, was deviated from, to a considerable degree. The Railway Act article 36 also forbids the construction of obstacles in a zone of 20 metres, in the inside curve of railways. If safety is not adversely affected, the Minister is permitted to issue an exemption from this rule. Well back into the last century, the Minister transferred the competence to issue exemptions to the management of Netherlands Railways, and subsequently to the director of Railinfrabeheer. Noise abatement screens are installed by Railinfrabeheer. The exemptions awarded to Railinfrabeheer by itself, are no longer recorded in writing.

*The Council recommends the management of Railinfrabeheer to harmonise the design process for rail infrastructure with the standard sheet on safety assurance systems issued by Railned, and to harmonise the designs with the current statutory rules.*

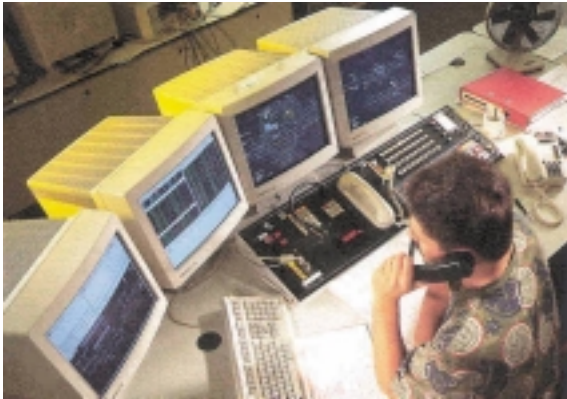
Figure 11. Workstation of a train controller.  
The screens provide a visual overview.

Rail Traffic Control is responsible for operating the signals. It is beyond doubt that within the framework laid down by the management of Rail Traffic Control, the signals may be operated, as was carried out on 28 November. The framework speaks for itself. The control system may not make any mistakes. In other words: signals cannot be operated in such a way that they result in routings which cross one another, and are thus in conflict with one another.

to lower the speed of their train and to travel by sight (stop for any hazard). Immediately thereafter, he could have recalled signal 1130. If he had done this within 15 seconds, it would have been highly likely that the Benelux train would still have been halted in time, either by the driver or by an ATB intervention.

*The Council recommends the management of Railverkeersleiding (Rail Traffic Control) to exercise considerable caution in setting part routings travelled at speeds below 40 kilometres per hour, and thus effectively without ATB monitoring, until the moment of introduction of a new modern ATB system. If part routings are nonetheless set, the*

*train controller should supervise them. A reliable automatic warning signal to the train controller of the passing by a train of a signal at danger would be an essential tool.*
