Report 00-101

train control incidents

hi-rail vehicles and trains occupying the same section of track and a collision

17 December 1999 – 5 September 2000

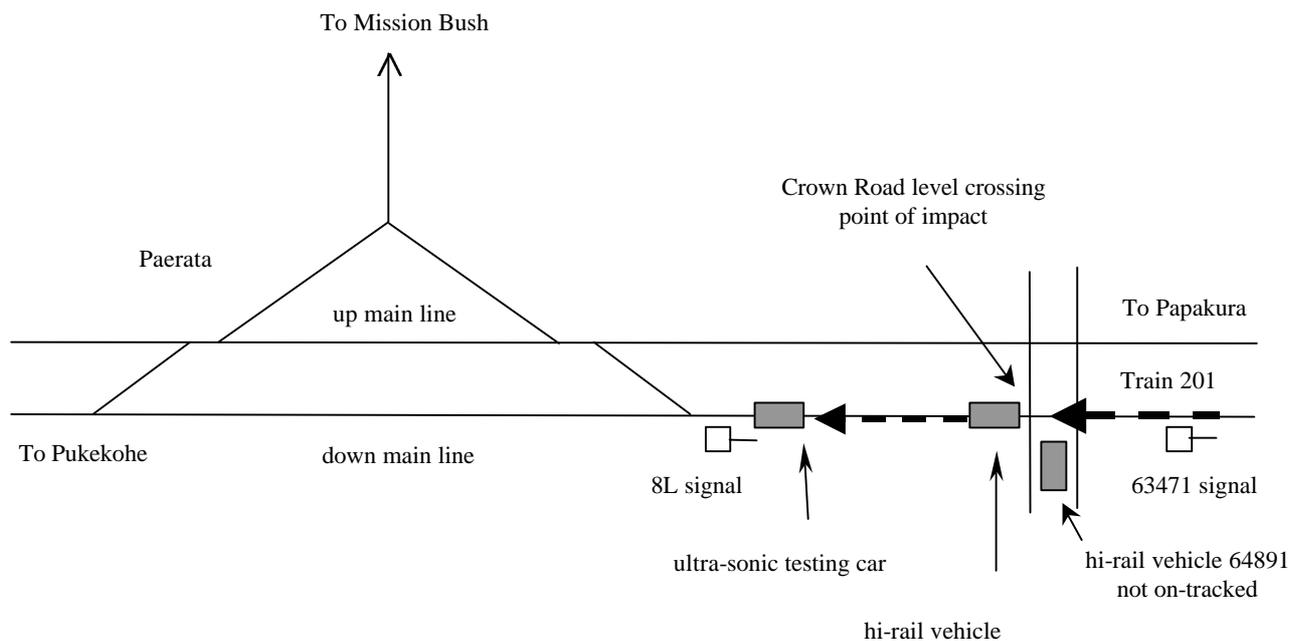
Figure 1
Site plan of Paerata
(not to scale)

1.3.2.3 Paerata was a triangle junction located at 632.65 km between Papakura and Pukekohe where the Mission Bush Branch joined the NIMT (refer Figure 1). The station was under double line automatic signalling control and was usually only manually controlled by the TC to signal trains to and from the Mission Bush Branch. It was in manual mode with all signals at Stop at the time of the collision. Signal 8L at Stop was the reason for the Caution Proceed indication on Signal 63471 as Train 201 approached it.
