## RAILWAY OCCURRENCE REPORT

02-120

electric multiple units, Trains 9351 and 3647, collision,  
Wellington

31 August 2002

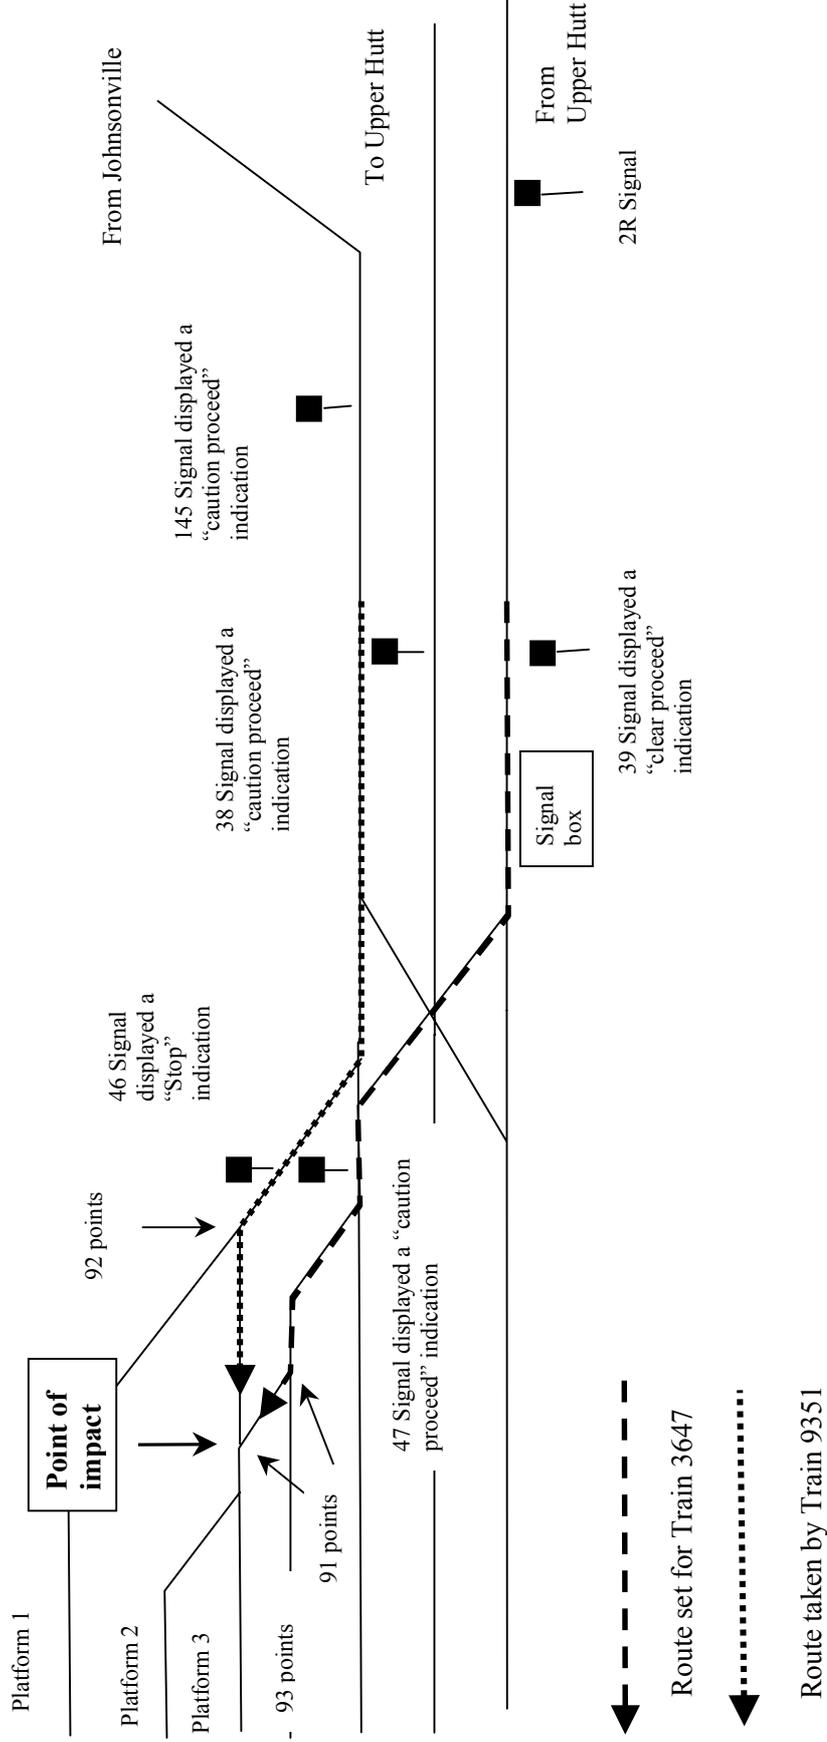
**Figure 1**  
**Wellington track layout showing point of impact (not to scale)**

- 1.1.3 Train 3647 departed from Kaiwharawhara, the last station before Wellington, and as it approached Signal 2R (see Figure 1) the driver saw that the signal displayed a “Stop” indication and he stopped at the signal while a freight train crossed the main line in front of him. At the same time he saw an EMU (Train 9351) proceeding towards Wellington on the Johnsonville Line to his right and above him.

1.4.2 The approaches to platforms 2 and 3 required the use of about 5 m of common territory track between 91 points and 93 points for berthing trains to those platforms (see Figure 1).

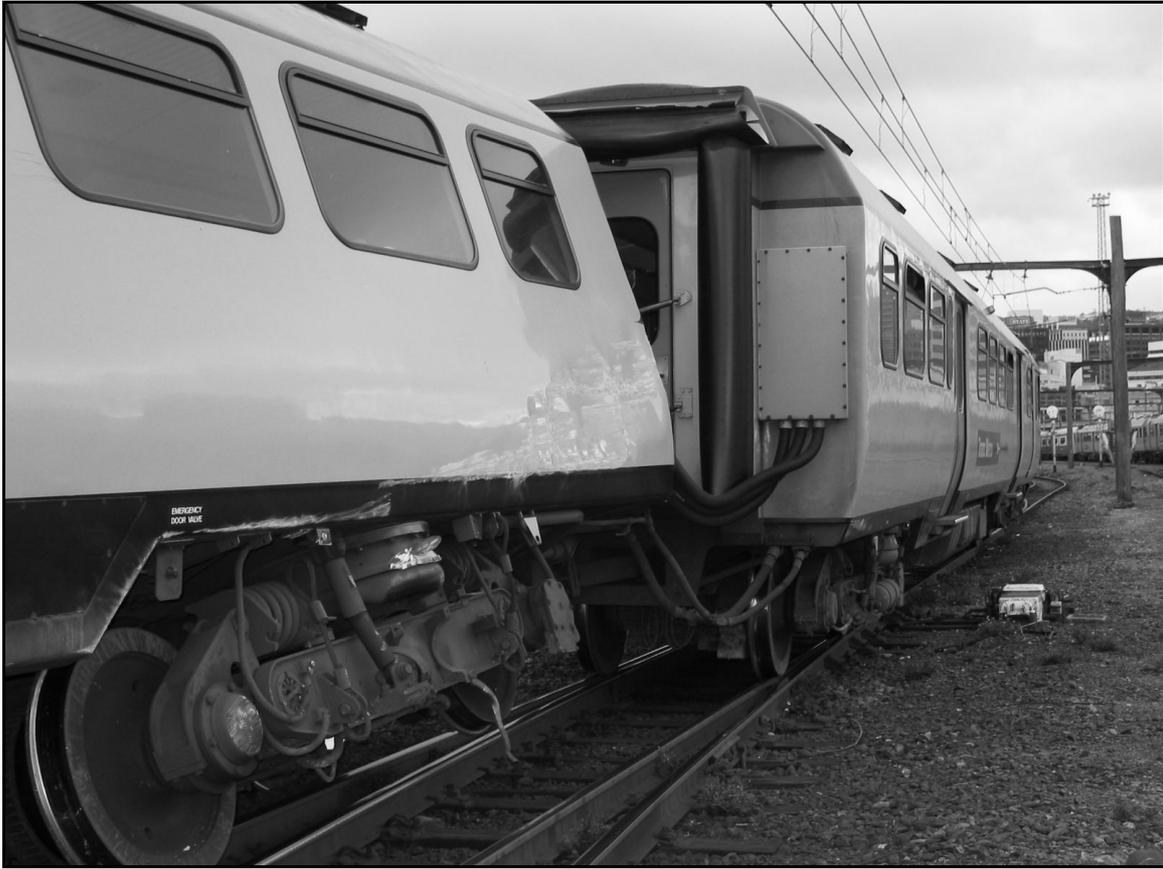
**Figure 2**  
**The rear car of Train 3647 showing the damage sustained**

- 1.1.7 The driver then realised his train had derailed and when it stopped he wound down his cab window and looked back. He saw the other EMU in an unexpected position, so he went to the other side of his train and again looked back to see that the rear car on his train was leaning over at about 30 degrees. He lowered the pantograph from the overhead power supply before climbing out of the train and walking back with the guard to the rear car. He operated the emergency controls located on the outside of the passenger car to open the doors to evacuate the passengers because it was not possible for them to safely get through to the front car because of the lean on the rear car (see Figure 2).

- 1.1.13 Minor damage occurred to the leading end of the rear car of Train 3647 (see Figure 2) and the leading end of the front car of Train 9351 (see Figure 4).

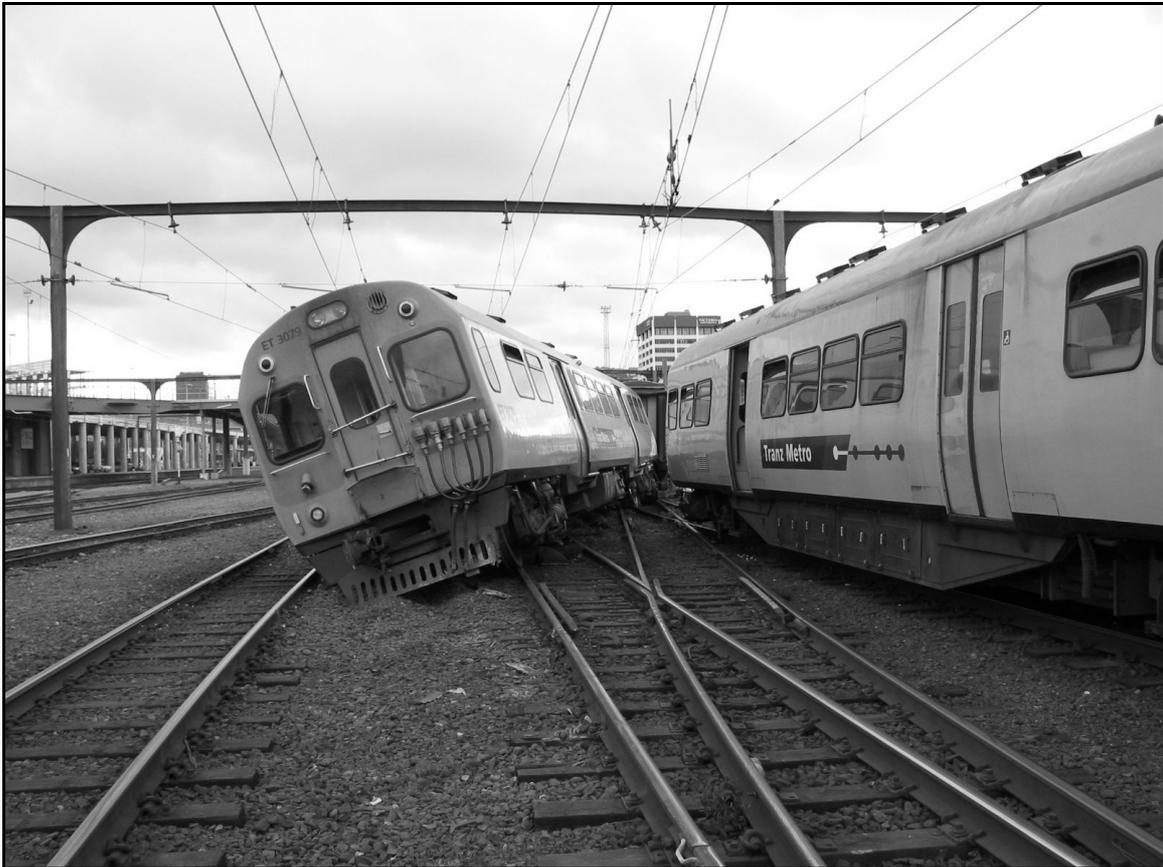
**Figure 3**  
**The rear car of Train 3647 at the point of impact**

- 1.1.11 As his train ran along beside Train 3647, the driver of Train 9351 saw a “caution proceed” indication on a signal he thought was for his train and acted on it. As he did so he glanced briefly at Train 3647 because of their closeness and when he looked back to the front he saw the leading car of Train 3647 crossing in front of him. He immediately made an emergency brake application but he could not stop his train before it collided with the front of the rear car of Train 3647.

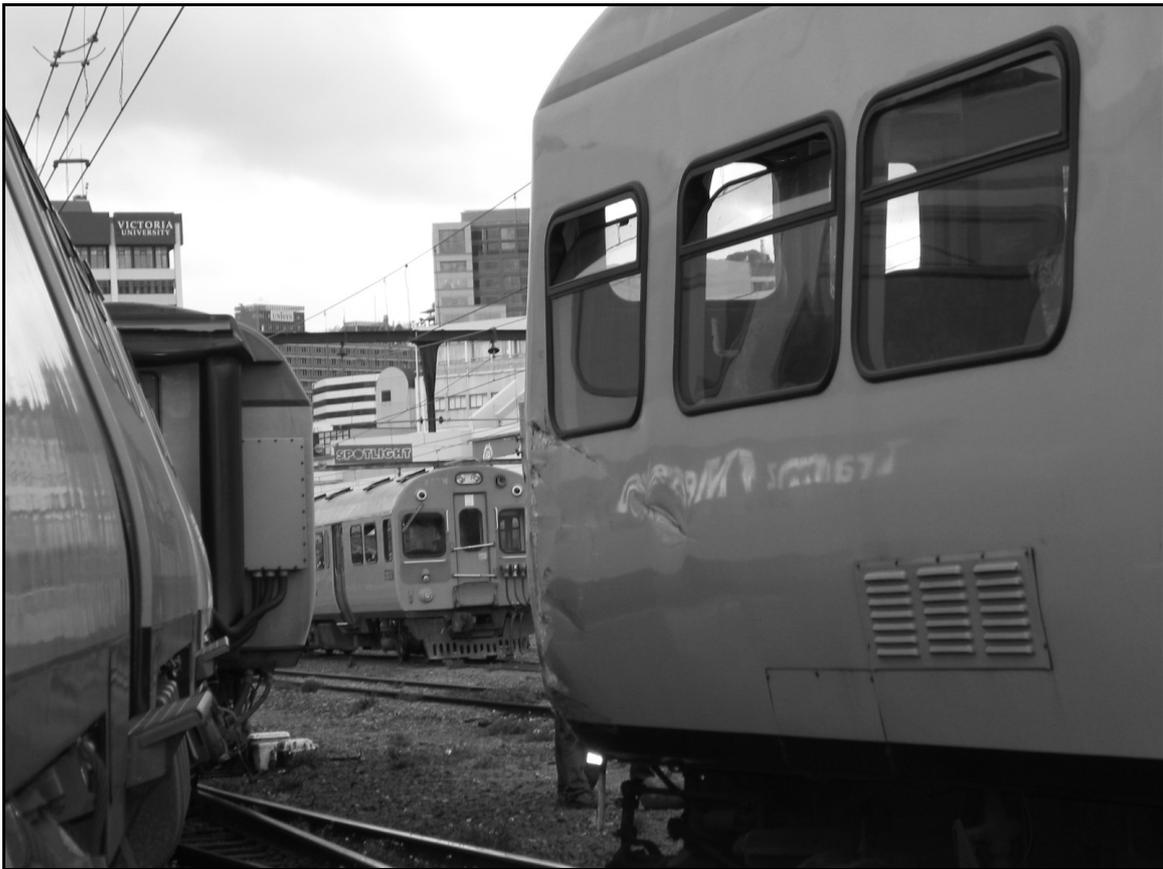
**Figure 4**  
**Damage to leading car of Train 9351**

2.3 Although Train 9351 was travelling slightly faster than the allowable speed shortly before the collision, it is doubtful that this was a contributing factor. The minor damage sustained by both EMUs and the absence of injuries probably reflected the low speeds immediately before and at the point of impact.

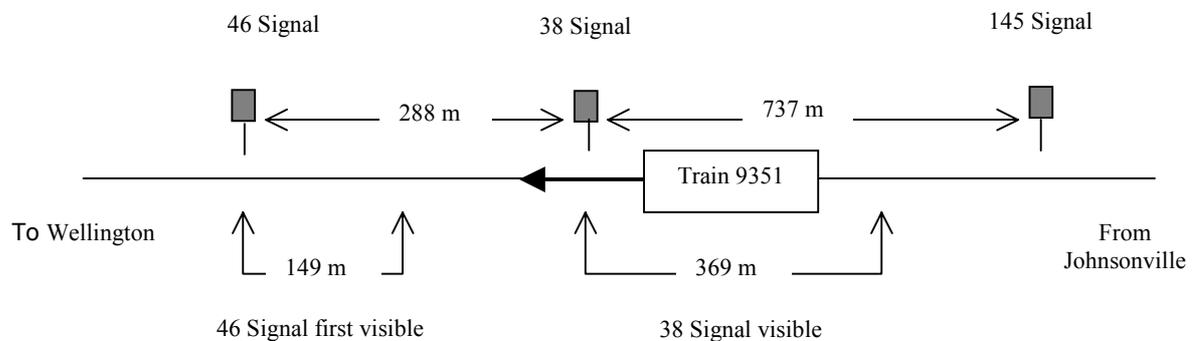
**Figure 5**

- 1.3.1 Train movements into and out of the platforms in Wellington were controlled from the signal box located near the entrance to the platforms. From the signal box the signalman had an unobstructed view of train movements within that vicinity. Signal indications and track occupancy data was recorded on the signal monitor log. The log was downloaded following the collision and supplied for analysis.
- 1.3.2 The 145 Signal was classified as an intermediate signal and was positioned about 1100 m from the northern end of the platforms. It was the first signal encountered by trains approaching Wellington on the Johnsonville Line and indicated to EMU drivers the status of the section ahead and the indications being displayed on the next signal in advance, in this case 38 Signal (see Figure 5).

- 1.3.3 The 38 Signal was the down home signal and was positioned 737 m past 145 Signal. It also indicated to the driver the status of the section ahead and the indications being displayed on the next signal in advance, in this case 46 Signal. 38 Signal was visible for 369 m as trains approached it.
- 1.3.4 The 46 Signal was a directing signal positioned 288 m past 38 Signal. The signal became visible from a distance of about 150 m but the presence of overhead power poles alongside the track meant it was sometimes obscured as trains approached it.
- 1.3.5 A Review of Signalling and Related Operations in Relation to SPAD (Signal Passed at Danger) commissioned by the Director of Land Transport Safety and undertaken by international consultants in November 2002 made the following comments:

2.5 Although 46 Signal was sometimes obscured from the driver of Train 9351 as his train approached it, the preceding signal, 38 Signal, was visible to him from 369 m away. From the indication on 38 Signal he should have expected 46 Signal to be probably at “Stop”. However, having not seen 38 Signal he had no expectation for 46 Signal.

2.6 Following the collision Tranz Rail instigated a review of Wellington suburban signalling to be completed by the end of August 2003. In view of this, no recommendation relating to signalling has been made.
