RAILWAY OCCURRENCE REPORT

02-129

train control incidents, trains authorised to enter sections of track already occupied by hi-rail vehicles and work groups, various locations

29 August 2002 –
4 December 2002

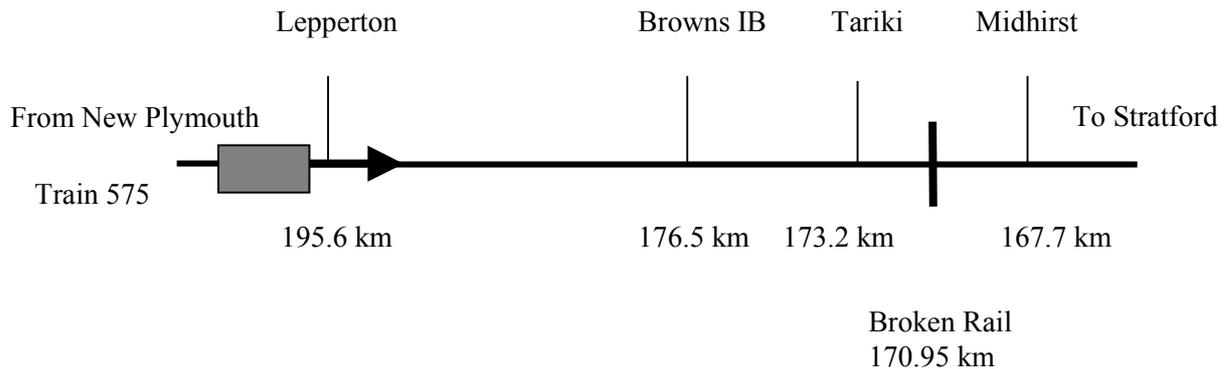
Figure 1
Location of the broken rail
 (not to scale)

2.1.3 At about 1120, the track inspector found a broken rail at 170.95 km. He continued his inspection until he reached the track gang at 175 km about 10 minutes later where he advised the ganger of his findings.

- 2.1.4 At about 1155 the ganger contacted TC1 and cancelled his work time between Tariki and Browns and requested track occupancy instead between Midhirst and Tariki to replace the broken rail. TC1 authorised the track occupancy, and advised that the next train into the section was Train 575, a New Plymouth to Whareroa express freight service departing at about 1215. He said this train would be held at Lepperton until the ganger confirmed the broken rail was replaced.

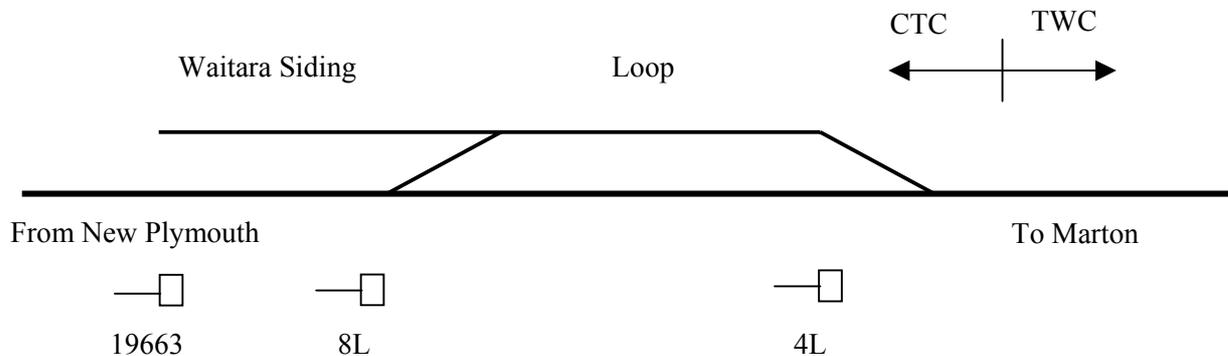
Figure 2
Layout of signals passed by Train 575 at Lepperton
 (not to scale)

- 2.1.5 At 1218 TC1 issued the locomotive engineer of Train 575 a track warrant to proceed from Lepperton to Stratford and the train departed from New Plymouth about 2 minutes later. As he approached Lepperton, the locomotive engineer observed the intermediate signal (19663) displaying a yellow caution indication and stopped his train at Signal 8L, his next signal in advance, which was displaying a red aspect (see Figure 2).

- 2.1.6 At 1231, TC1 cleared 8L Signal to proceed and also cleared 4L Signal, which allowed Train 575 to enter the occupied Lepperton-Stratford track section.
- 2.1.7 At about 1245 a change of shift hand-over between TC1 and a second train controller (TC2) took place, after which TC1 left the train control office.
- 2.1.8 At about 1251 the ganger off-tracked his HRV at 171.025 km and called TC2 to advise that the broken rail had been replaced and the track was now safe for trains.
- 2.1.9 Train 575 went through the worksite about 2 minutes after track clearance was given.

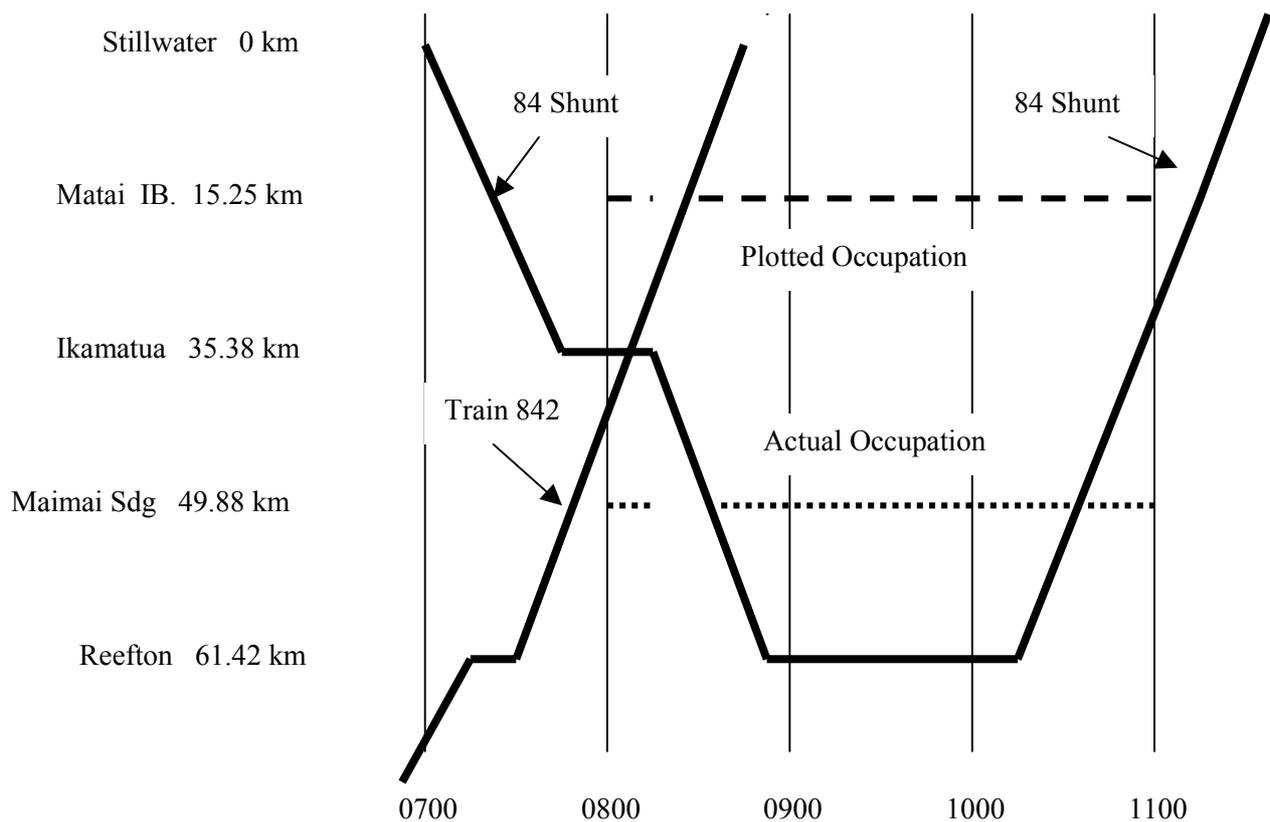
Figure 3
Information plotted on the train control diagram
(not to scale)

- 4.1.1 On Thursday 29 August 2002, at about 0800 a track maintenance contractor called train control and requested track occupancy at Maimai Siding, between Tawhai and Ikamatua on the Stillwater-Westport Line (SWL), to carry out maintenance welding on the mainline turnout. The train controller referred to the train movements plotted on his diagram and because of planned train movements authorised a 15-minute track occupation to enable the contractor to carry out preparation work only. He instructed the contractor to be off and clear of the track by 0815 for the passage of the next service, Train 842.
- 4.1.2 The train controller incorrectly plotted the contractor's track occupation at Matai rather than at Maimai on his train control diagram.

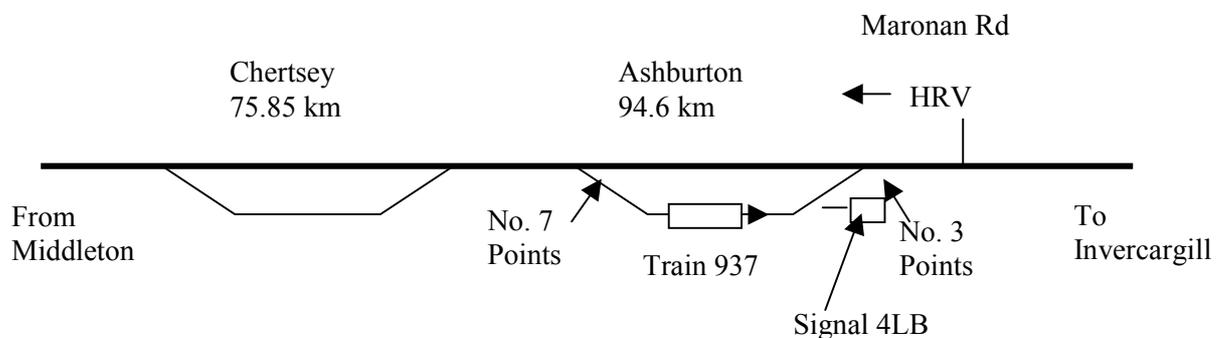
Figure 4
Chertsey-Ashburton track section
(not to scale)

- 6.1.4 TC2 then instructed TC1 that once Train 937 berthed in the yard at Ashburton, he was to apply the signal blocking command and then advance the track inspector from Maronan Road level crossing through to the mainline at Ashburton. TC1 was also instructed to ensure the track inspector called when he was clear of the south end mainline points at Ashburton. TC2 then left the train control desk temporarily to arrange a relief locomotive engineer for a late running train in the area.
