## RAILWAY OCCURRENCE REPORT

03-103

hi-rail vehicle and express freight Train 142, track occupancy  
irregularity, Amokura

10 February 2003

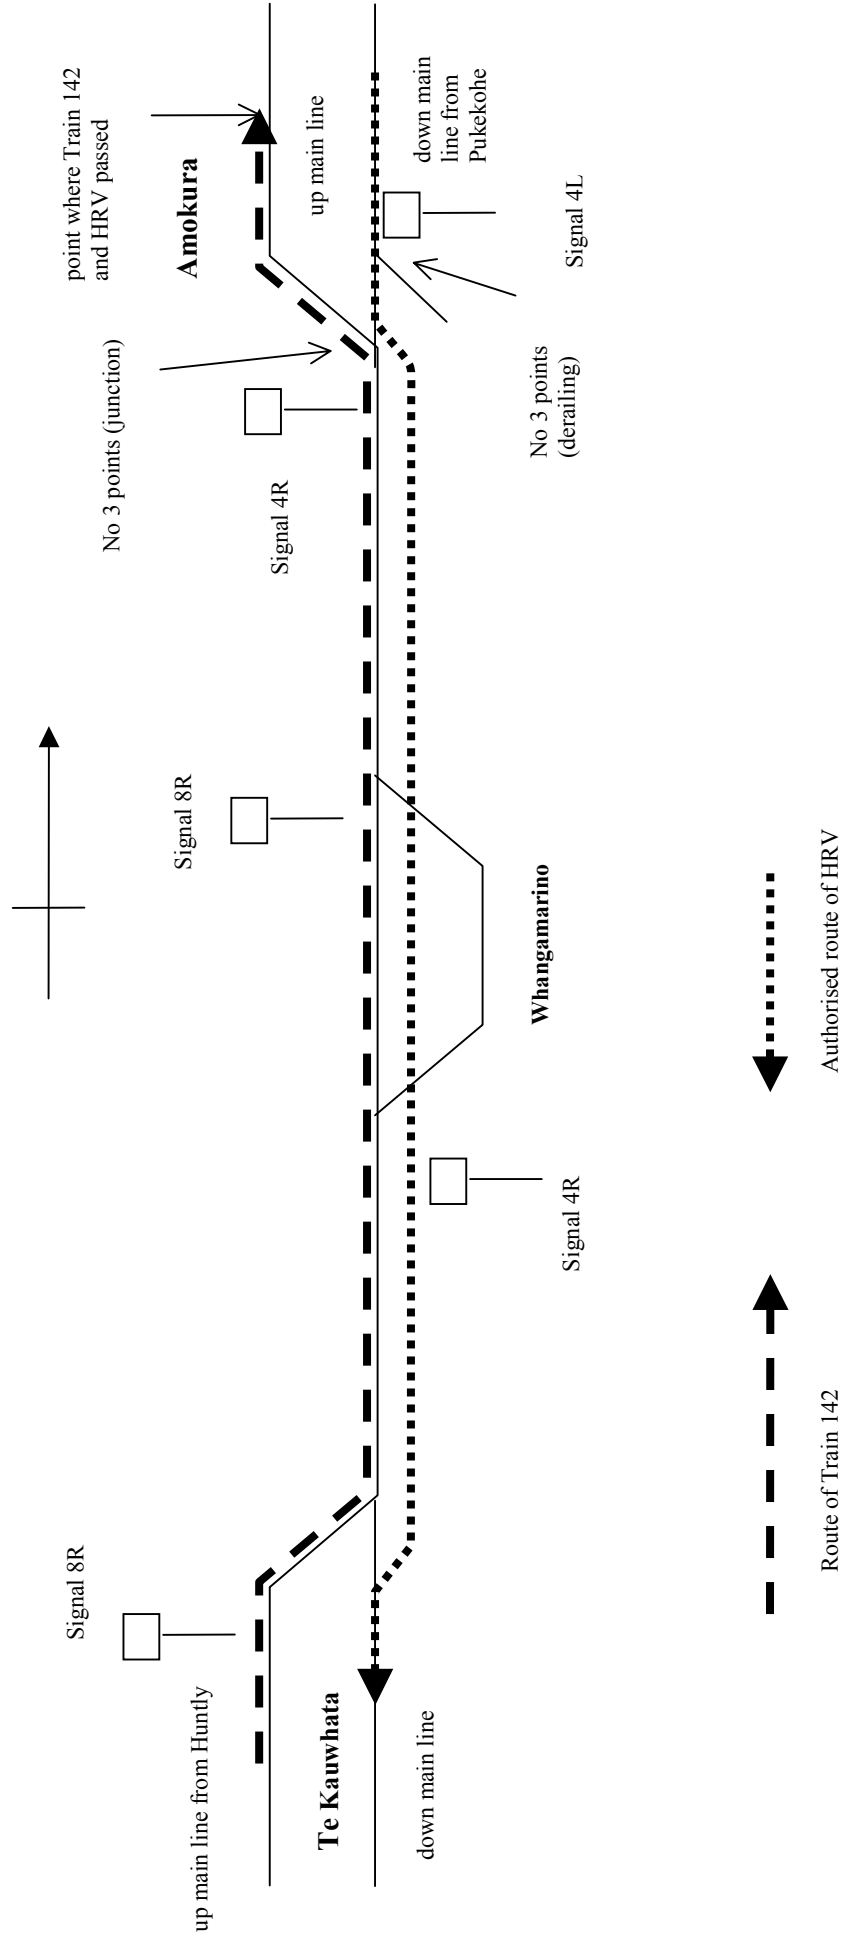
**Figure 1**  
**Track and signalling layout Amokura to Te Kauwhata (not to scale)**

- 1.2.1 The North Island Main Trunk (NIMT) from Pukekohe to Amokura was double line and controlled by double line signalling.
- 1.2.2 The track from Amokura to Te Kauwhata was single line with a crossing loop at Whangamarino, about halfway between Amokura and Te Kauwhata (see Figure 1). The signalling through this section was remotely controlled from the train control centre in Wellington by computerised centralised traffic control (CTC). From a visual display unit (VDU) on the desk, the train controller could see points and signal indications and monitor the progress of trains as they passed through the section.

- 1.2.3 HRVs were insulated so did not activate either track circuits or signal indications and were not visible on the VDU. However, northbound trains approaching Te Kauwhata on the up main line became visible on the VDU about one km south of Te Kauwhata and there was a similar approach distance for southbound trains approaching Amokura on the down main line. Apart from this, the double line was not generally monitored on the VDU.

- 1.2.4 No 3 points at Amokura consisted of 2 sets of points, which worked in conjunction with each other. One set was at the junction of the single and double lines and controlled entry to and exit from the single line section. The second set was a derailing set positioned about 100 metres north of the junction on the down main line as a protection against unauthorised traffic entering the single line section. If a southbound rail service vehicle passed through Amokura while these points were set in reverse it was diverted from the down main line and would derail before it reached the junction with the single line section.
