RAILWAY OCCURRENCE REPORT

04-119 Diesel multiple unit passenger Train 3358, signal passed at Stop and wrong line running irregularity, Tamaki 28 July 2004

TRANSPORT ACCIDENT INVESTIGATION
COMMISSION
NEW ZEALAND

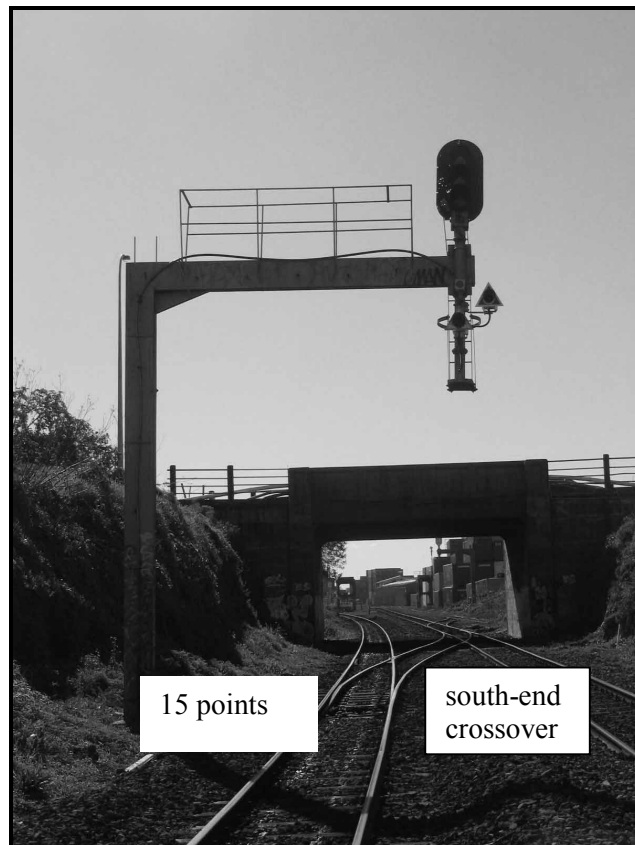
Figure 2
Signal 16AC, Up Home Signal at Tamaki

- 1.1.4 Another LEMU (LEMU2), who was repositioning from his Westfield Depot to take up the running of a Britomart to Waitakere (via Newmarket) DMU passenger service, travelled in the driving compartment with LEMU1.
- 1.1.5 At about 1253, LEMU1 stopped his train short of Signal 16AC, the Up Home Signal at Tamaki, and queried the signalman⁴ as to why the signal was displaying a red aspect. The signalman explained that passenger service Train 3367 and shunting services L71 and L61 would pass him on the Down main and that his train would then be signalled over to the Down main as soon as the movements were clear of 15 points at Tamaki (see Figure 2).

- 1.6.10 While waiting for the trains to clear, LEMU1 and LEMU2 continued their discussion on the proposed roster changes. At about 1320, LEMU1 saw 15 points move to the reverse position and Signal 16AC change to a low speed aspect. He said he considered that that was his authority to travel on to Britomart.

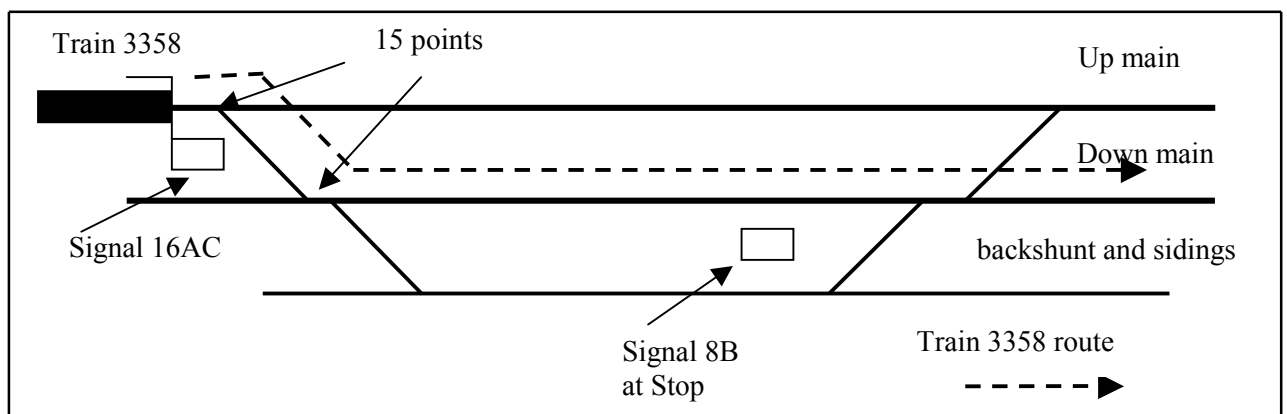
Figure 3
Route set for Train 3358 to depart Tamaki Station (not to scale)

- 1.2.1 The North Island Main Trunk from Papakura to Auckland was double line⁵ and was controlled by Double Line Automatic Signalling (DLAS).
- 1.2.2 The movement of trains between Tamaki and Britomart Station was controlled from the train control centre in Wellington.
- 1.2.3 Tamaki was an interlocked station with a "switch out" facility. The station was usually operated in the "switched out" mode, meaning that all signals and points levers were in the "normal" position. On the day of the incident Tamaki was "switched in" to allow wrong line running (WLR). In this case, WLR allowed Up trains to run on the Down main line under controlled conditions. When Tamaki operated as a "switched in" station its signals were controlled by the signalman at Britomart.
- 1.2.4 Figure 3 shows the route set by the signalman for Train 3358 to depart Tamaki.

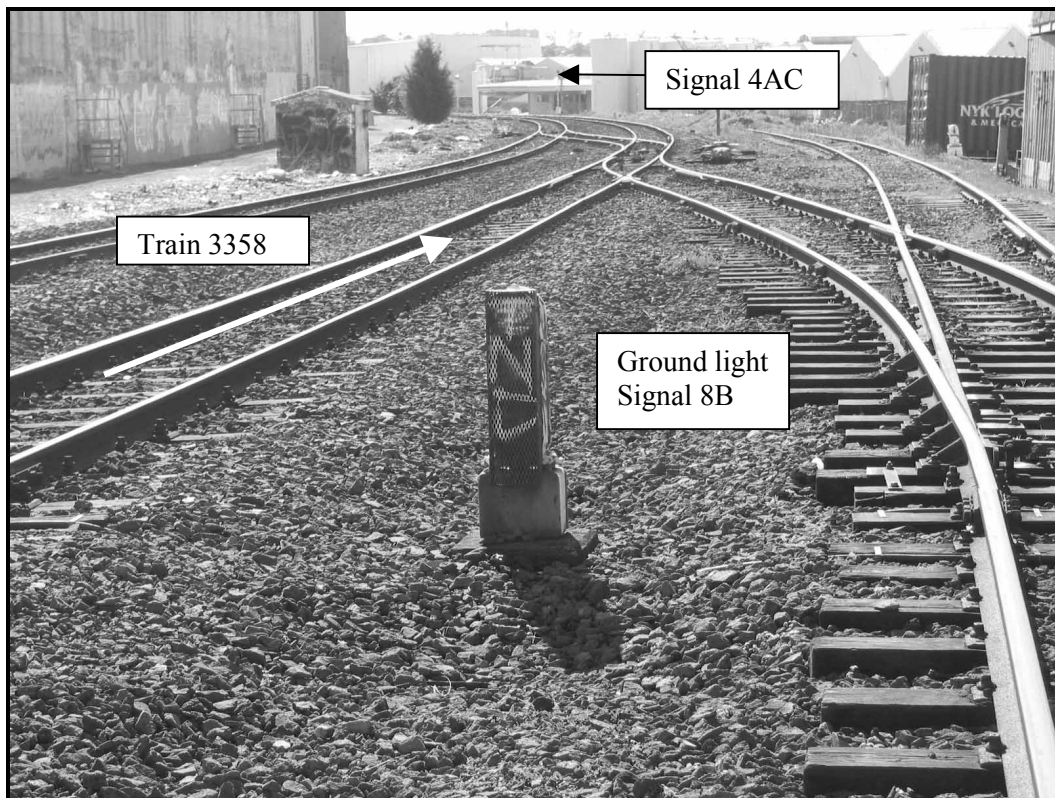
Figure 4
Signal 8B, Shunt and Up starting from Down main, Tamaki

- 1.6.11 LEMU1 said he did not have authority from the signalman to pass Signal 8B Tamaki at Stop, nor did he hold a Mis 60 authority to proceed from Signal 4AC Tamaki to Signal 111 Auckland as required by the information bulletin (see Figure 4).

- 2.6 Signal 8B was a ground light which nearly always displayed a Stop indication. It would display a Proceed indication only when a shunt service was lifting or placing wagons in the siding and the shunt service had authority to cross from the Down main to the Up main. DMUs would be required to pass the signal only when the Up main from Tamaki was unavailable and WRL was operating.

- 2.16 The starting point for the WRL operation was defined as non-facing Signal 4AC. In practice, the entrance to the WLR section was Signal 8B some 265 m before reaching Signal 4AC. A LEMU was required to have both authority from the signalman to pass Signal 8B and a valid Mis 60 authority issued by the train controller to enter the WRL section. A safety recommendation has been made to the Chief Executive of ONTRACK to address this issue.

incorporate into existing procedures a requirement that the limits of wrong line running be defined by controlled facing signals. At locations where facing signals are not provided, these limits should be defined by appropriate permanent notice boards. (046/05)
