RAILWAY OCCURRENCE REPORT

05-124 express freight Trains 834 and 841, collision, Cora Lynn 20 October 2005

**TRANSPORT ACCIDENT INVESTIGATION COMMISSION
NEW ZEALAND**

Report 05-124
express freight Trains 834 and 841
collision
Cora Lynn
20 October 2005

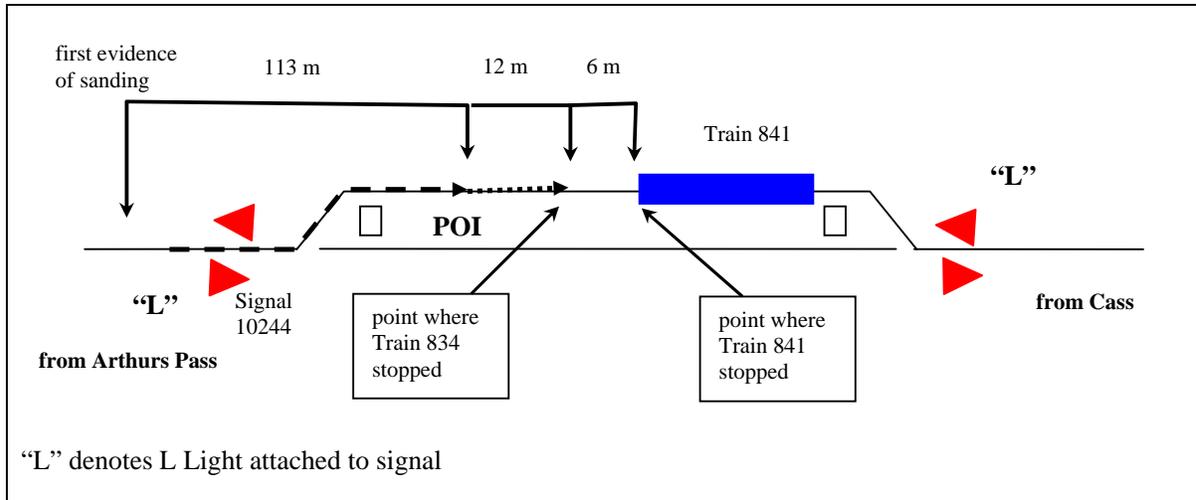
Figure 4
Positions of Trains 841 and 834 after impact (not to scale)

- 1.2.14 The maximum authorised line speed for express freight trains between Arthurs Pass and Cora Lynn was 80 kilometres per hour (km/h).
- 1.2.15 Following a 14 km descending grade from Arthurs Pass, the majority of which was 1 in 85, the eastbound approach to Cora Lynn was a level section for about 250 m after rising a gentle gradient of 1 in 210 for about 750 m.
- 1.2.16 Cora Lynn consisted of a main line and a 572 m long crossing loop, connected to the main line at each end by hand-operated points.
- 1.2.17 The first evidence of sand application⁵ was about 38 m before Arrival Signal 10244 at Cora Lynn. Sand had continued to be from there to the point of impact (POI), a further 75 m beyond the signal.
- 1.2.18 The impact of the collision pushed Train 841 back 18 m while Train 834 continued about 12 m past the POI before stopping (see Figure 4).

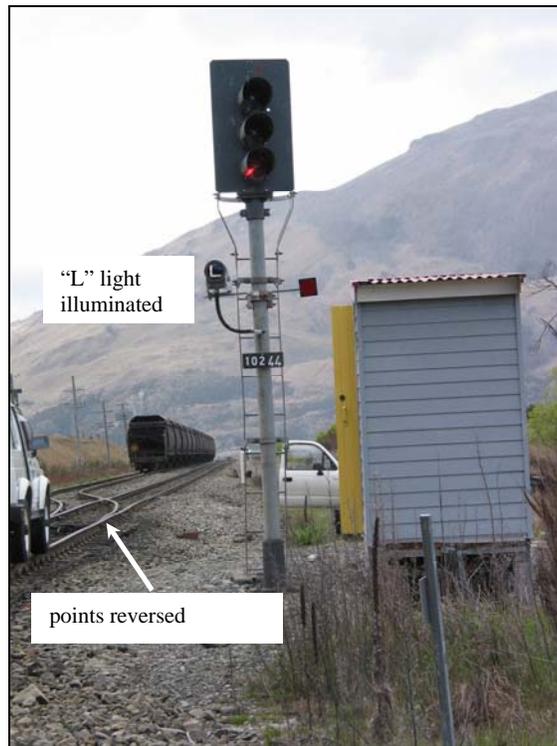
Figure 6
Arrival Signal 10244 at Cora Lynn with the “L” light illuminated

- 1.3.8 Arrival signals were fitted with a short-range light, which showed an illuminated white letter “L” when the points were set for the loop (see Figure 6), with the points for any diverging lines off the loop in the normal position. With the points set for the loop, the arrival signal controlling the entrance of a train into the station was at “Stop”. The illuminated “L” light confirmed that the route was set for the loop, but not that the loop was unobstructed. If the “L” light was illuminated, locomotive engineers on trains entering the loop were not required to stop at the arrival signal but were required to satisfy themselves that the route was clear before proceeding.

- 1.5.14 He said the “L” light on the arrival signal was illuminated when he approached but it was dusk and he had not had a good view of the signal until he was very close. He said he had not been distracted, was not fatigued and his hours on duty were not excessive. Even though his duties had been altered on his arrival at work, he would still have been able to book off at his rostered shift completion time of 2300.

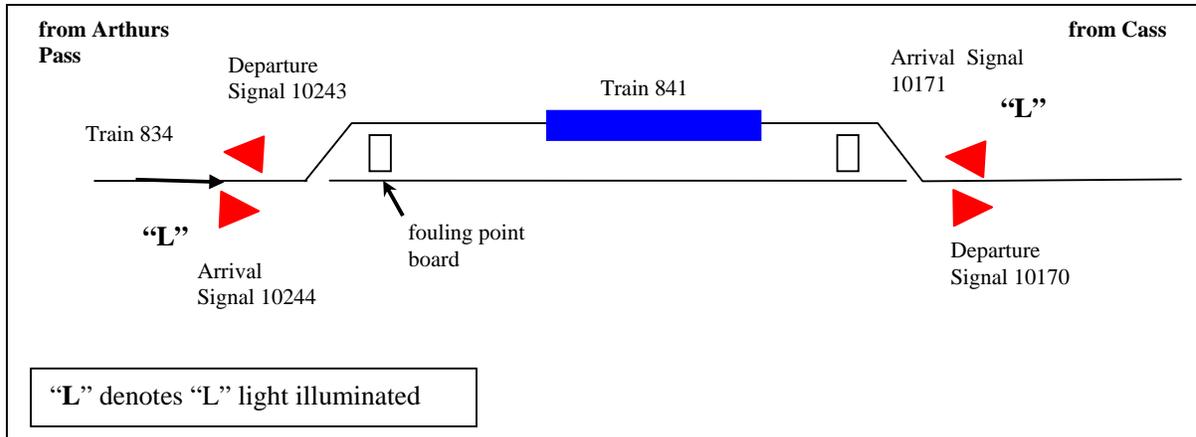
Figure 7
Points settings and signal indications after Train 841 berthed
 (not to scale)

- 1.3.14 About 2 hours before the collision, 2 other trains had crossed at Cora Lynn. After the crossing, the east end points had been left set for the main line and the west end points set for the loop. When Train 841 arrived, the locomotive engineer had stopped his train at Signal 10170, reversed the east end points, and berthed his train on the loop, in accordance with his operating instruction (see Figure 7).

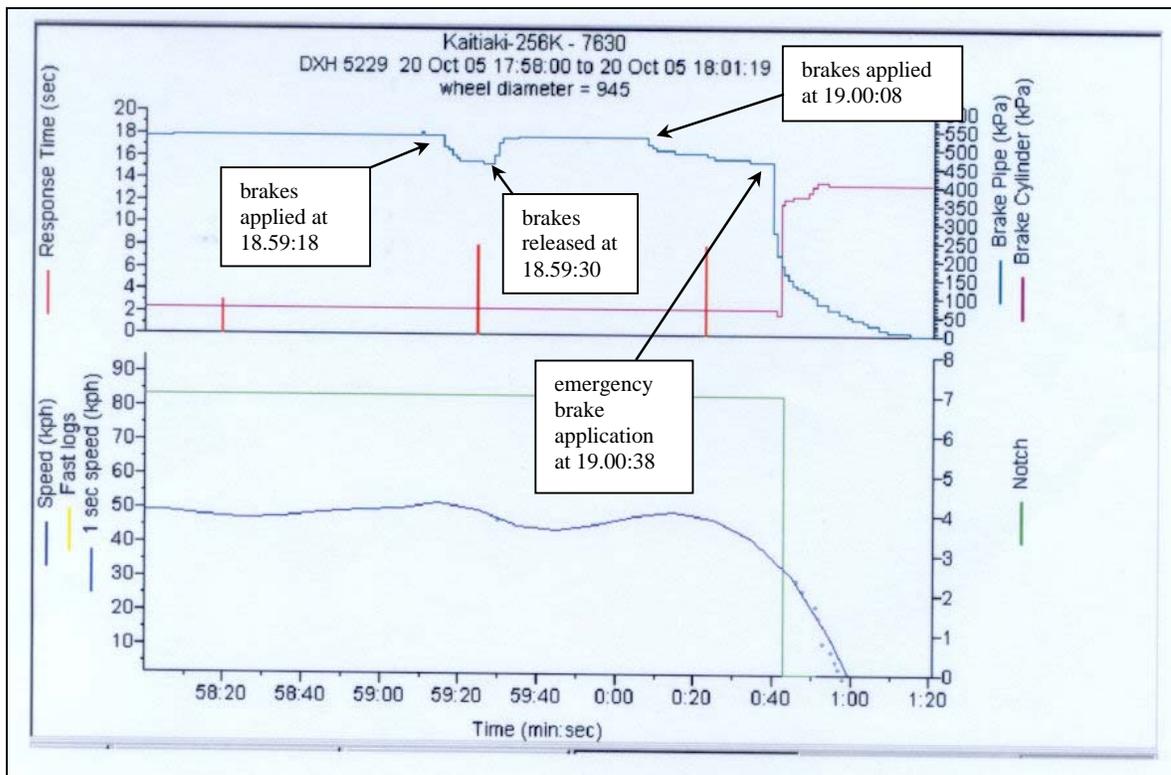
Figure 9
Locomotive event recorder data from DXH5229
 (courtesy Toll Rail)

- at 19.00:08 the train speed had increased to about 49 km/h and an incrementally increasing air brake application was made, which reduced the train speed to about 35 km/h at 19.00:38 when an emergency air brake application was made (see Figure 9)

- at 19.00:51 the speed reduced from 22 km/h to 15 km/h at 19.00:52
- at 19.01:00 the speed ceased to register.
