RAILWAY OCCURRENCE REPORT

Report 05-127, mainline shunting service Train M52, track occupation irregularity, Te Rapa, 27 October 2005

**TRANSPORT ACCIDENT INVESTIGATION COMMISSION
NEW ZEALAND**

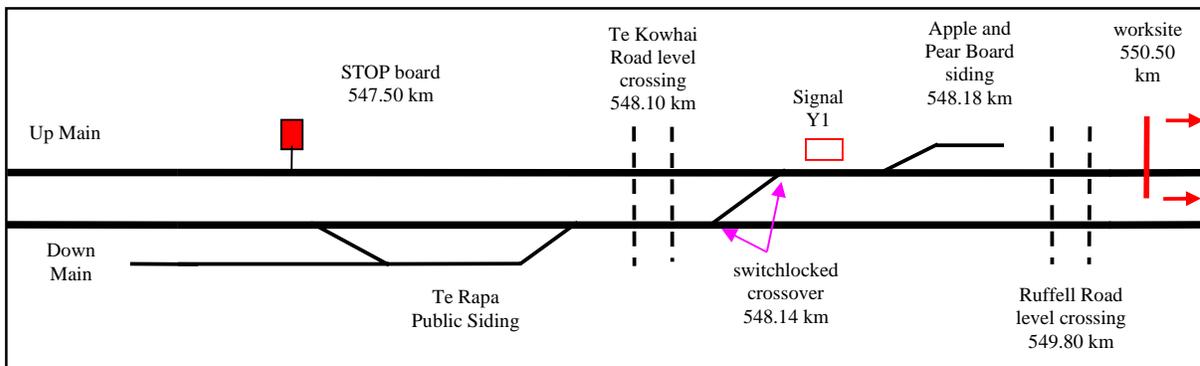
Figure 1
Locality plan (not to scale)

- 1.1.2 At about 1400, Train M52 stopped short of the STOP board erected at 547.5 kilometres (km) on the Up Main line of the North Island Main Trunk (NIMT). The locomotive engineer radioed the protector of the track maintenance worksite (site protector) who authorised him to pass the STOP board but proceed no further north than the Apple and Pear Board Siding at 548.18 km (see Figure 1) before crossing to the Down Main line via the switchlocked crossover. The authority was acknowledged and repeated by the locomotive engineer to the site protector.

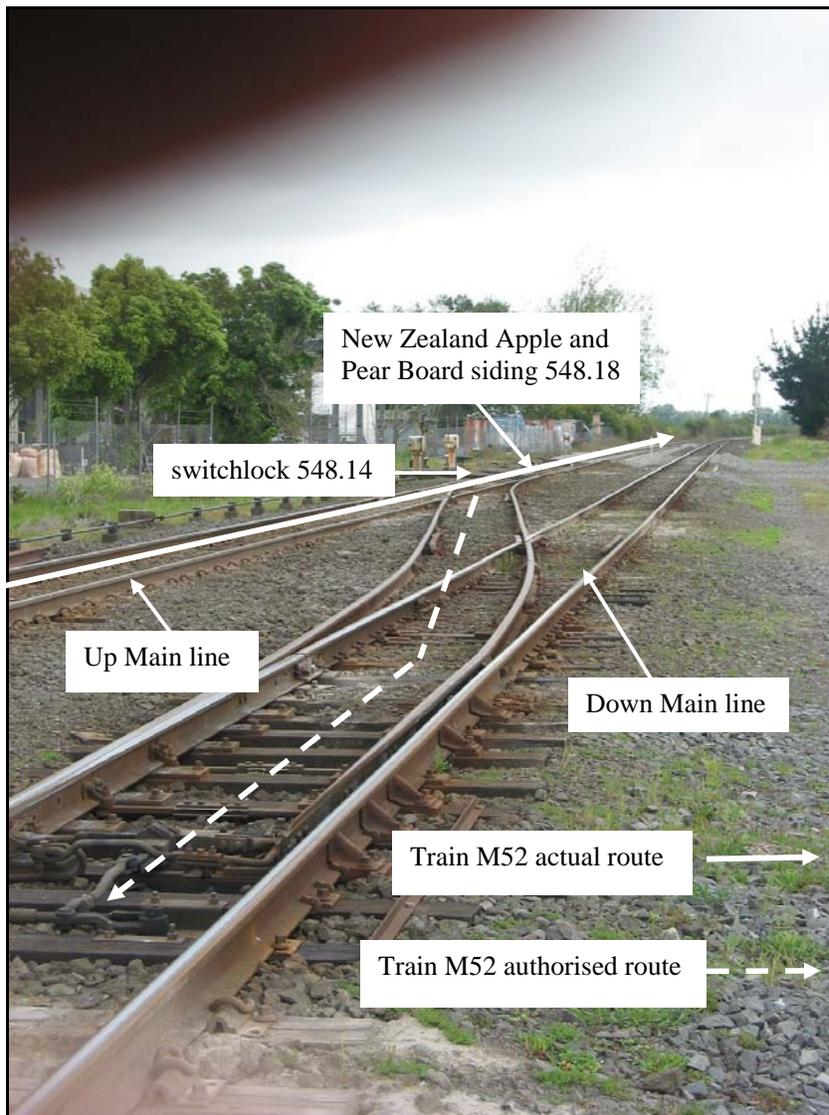
Figure 2
Switchlock-controlled crossover

1.2.2 A switchlock-controlled crossover at 548.14 km on the Up Main line allowed Up trains to reverse onto the Down Main line from which they could then access Te Rapa Public Siding (see Figure 2).

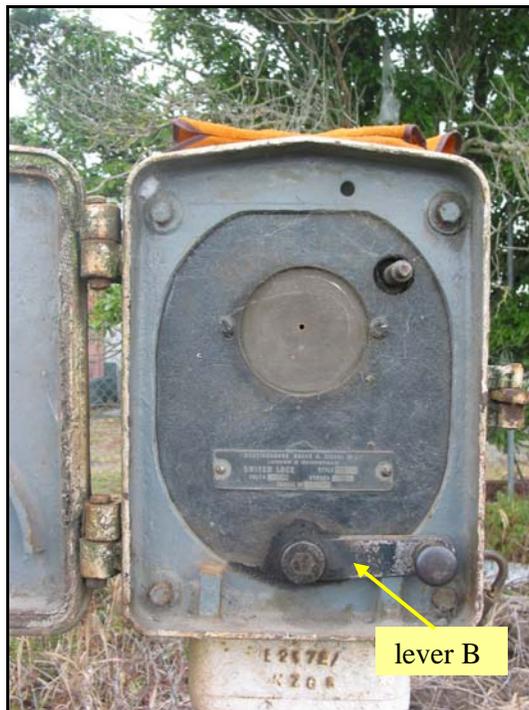
Figure 3
Switchlock control mechanism at 548.14 km NIMT

- 1.3.5 Switchlocks controlled the main line points at both Te Rapa Public Siding and New Zealand Apple and Pear Board Siding. The operation of switchlocked sidings in DLAS territory was governed by ONTRACK’s³ Rule 5, which stated in part:
