Report 11-101: Wrong line running irregularity,
leading to a potential head-on collision, Papakura - Wiri, 14 January 2011

Final Report

Rail inquiry 11-101
Wrong line running irregularity,
leading to a potential head-on collision,
Papakura-Wiri,
14 January 2011

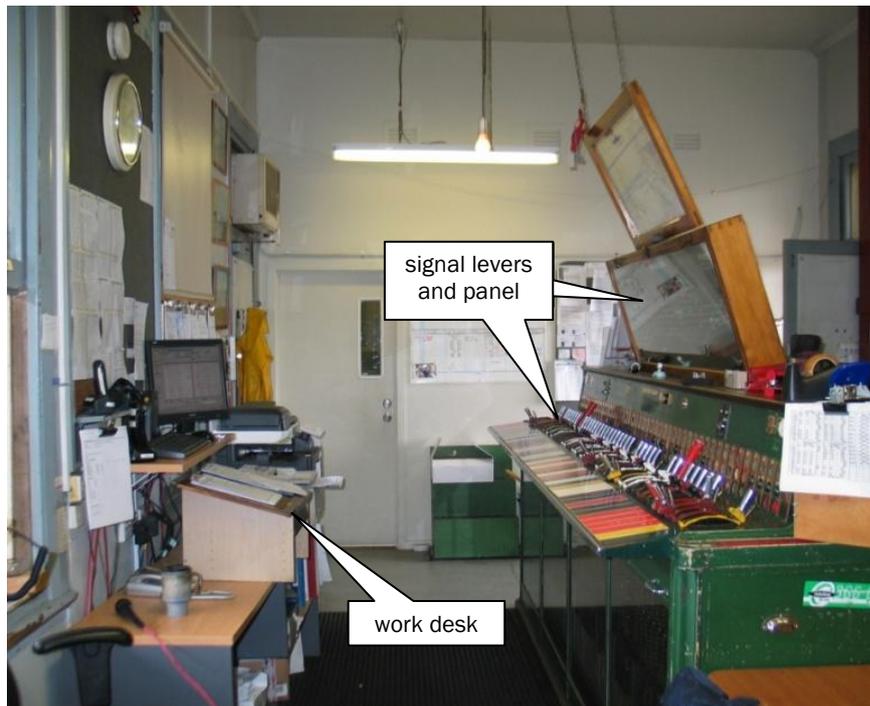
Figure 1
Inside the Papakura signal box

- 3.1.5. Papakura station was located on an island platform arrangement with main lines on either side of the platform. The signal box was located within the station building and was equipped with a Westinghouse power-operated signal panel. The panel had been commissioned in November 1939 and was one of the largest of this type remaining in use (see Figure 1).

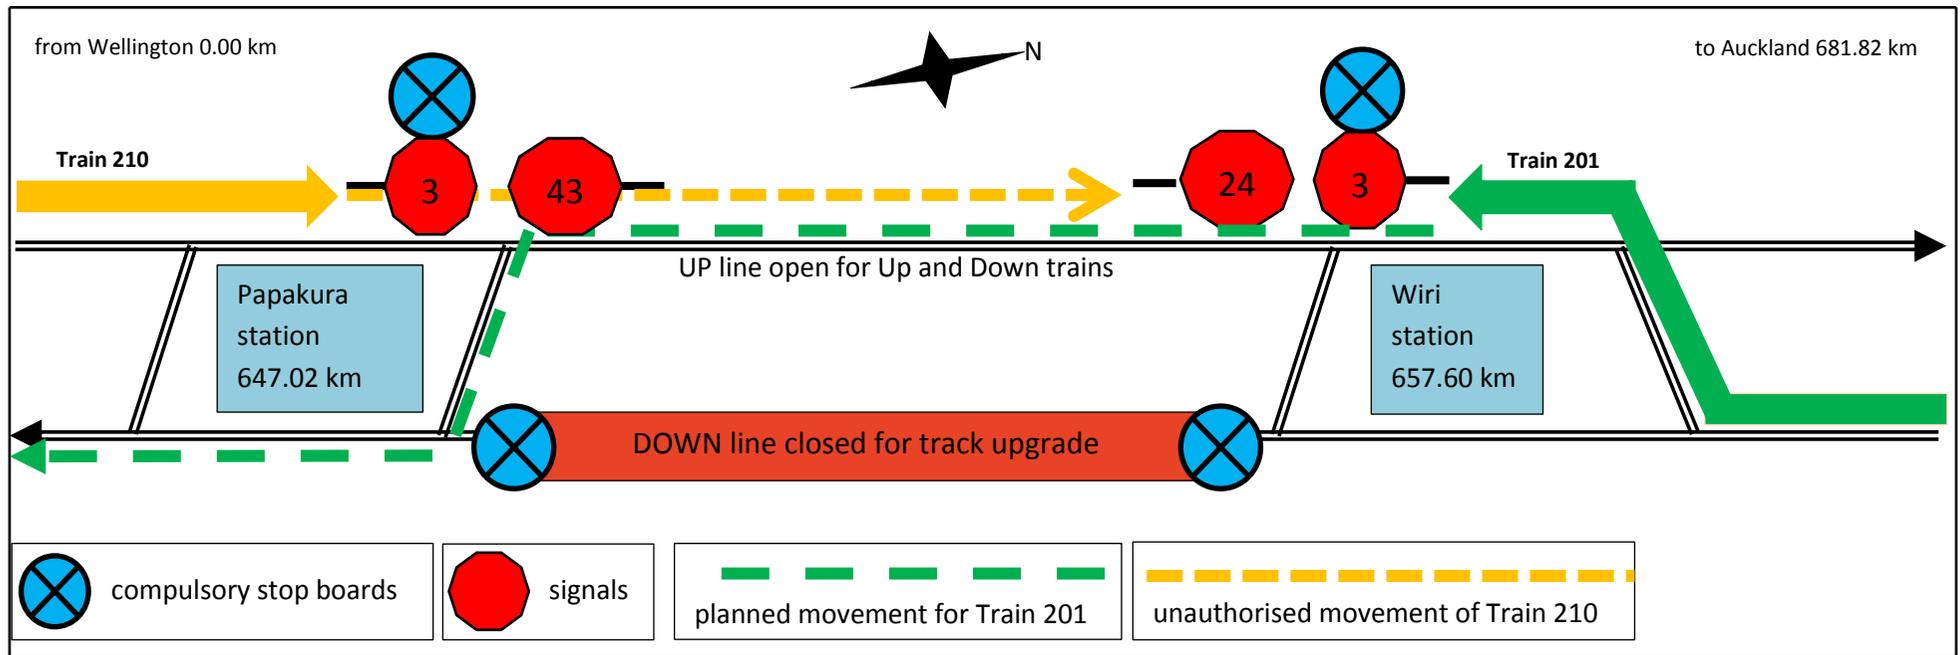
Figure 2
Track layout, protection details and train running arrangements
between Wiri and Papakura (not to scale)

- 3.1.15. At 0630 on Friday 14 January 2011, a KiwiRail train controller, based in Wellington, told the Veolia signaller at the Papakura signal box that freight Train 210 should arrive at about 0745. The train controller instructed the signaller to hold the train at Papakura to allow southbound passenger Train 201 to pass. The signaller wrote the instruction on a sheet of notepaper and placed it on a clipboard located on top of a work desk (refer Figure 1).
- 3.1.16. The train controller at the time intended to give passenger Train 201 priority to proceed along the wrong line from Wiri to Papakura ahead of freight Train 210 (see Figure 2).

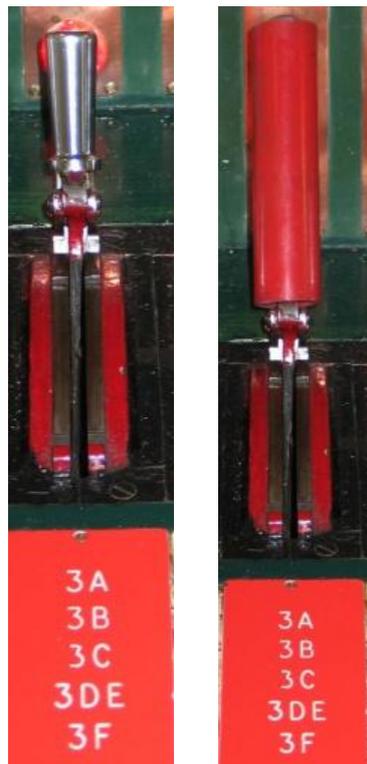
Figure 3
Signal 3 lever un-collared (left) and collared (right)

- 3.1.18. The train controller issued the Mis.60 to the signaller at Wiri 58 minutes later at 0748, authorising the wrong line movement of Train 201, then to the signaller at Papakura at 0755. KiwiRail's double-line automatic signalling rule 1 (c) required the train controller to ensure that the signaller had collared the Signal 3 lever, but this was not done. The signaller at Papakura placed the Mis.60 on a clipboard at the work desk, but beneath other documents, and placed a red collar over the Signal 3 lever as required, even though she had not been instructed to do so by the train controller (see Figure 3).

- 3.1.19. The collar provided a visual reminder to the signaller to not operate the lever without first getting the train controller's permission. Track safety rule 907 in KiwiRail's rail operating rules for compulsory stop board protection, and sections one and 10 in KiwiRail's rail operating procedures for wrong line running arrangements, both contained instructions for the use of collars.

- 4.1.7. The Signal 3 lever should have been collared permanently while the worksite was active. During the upgrade work this should have been 24 hours each day. Two KiwiRail train controllers on the day of the incident had failed to ensure that this had been done. Further, the collar should only have been removed with the person-in-charge’s permission. This defence was necessary to protect the staff and machinery at the worksite. The signaller, however, did not apply the red collar for this reason but instead applied it to remind her that a Mis.60 had been issued. The train controller should have reminded the signaller to collar the signal lever to protect the Mis.60 operation but did not do that either.

- 4.1.10. Veolia and KiwiRail have since introduced a double lockout system at Papakura to prevent this type of occurrence in the future. The Commission, therefore, is satisfied that it does not need to issue a recommendation to address this safety issue.

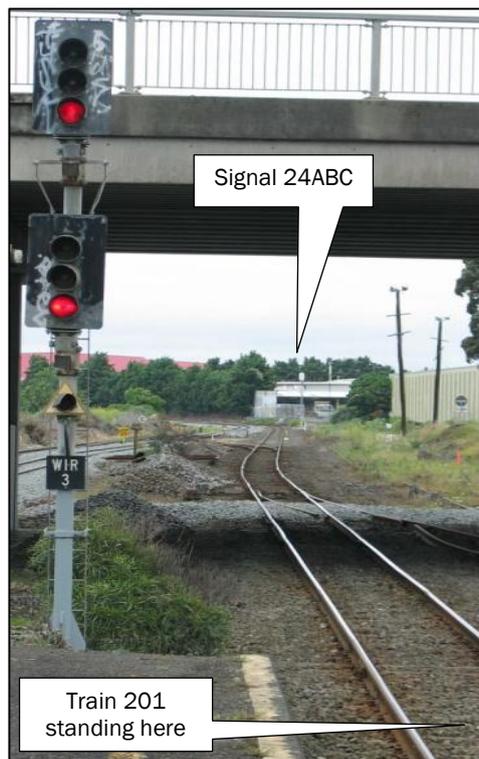
Figure 4
Looking south from Wiri

- 3.1.28. At about 0820, Train 210 arrived and stopped at Signal 24ABC (at red) on the Up line at Wiri, 365 metres from Signal 3ABC where Train 201 was standing (see Figure 4).
