Inquiry RO-2012-105: Unsafe recovery from wrong-route
at Wiri Junction, 31 August 2012

Final Report

Rail inquiry RO-2012-105
Unsafe recovery from wrong-route at Wiri
Junction, 31 August 2012

Transport Accident Investigation Commission

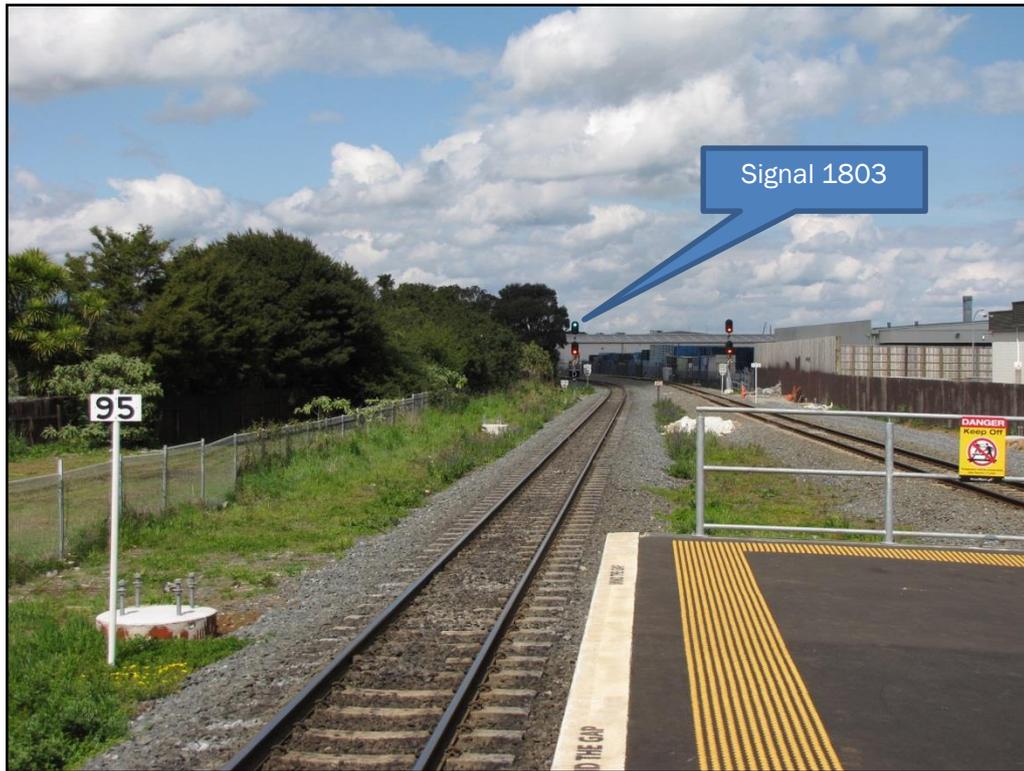
Figure 2
Signal 1803 as it was seen from Puhinui Station at the time of the incident

- 3.1.2. After the train passed through Middlemore Station (see Figure 1), three of the next four automatic signals along this straight displayed a 'flashing yellow over red' to indicate to the driver that there was a train ahead travelling in the same direction, but far enough ahead so that he could proceed at 'normal speed'². The fourth and last automatic signal before Puhinui Station was a steady 'yellow over red', indicating that the next signal, past Puhinui Station (signal 1803) would be at 'stop' (displaying 'red over red'). The train stopped at Puhinui Station to exchange passengers. Signal 1803 indicated the direction in which the train would be routed through Wiri Junction and the speed at which it was permitted to travel. It was about 170 metres ahead and visible to the driver when his train was berthed at the Puhinui Station platform (see Figure 2).

- 3.1.6. The train driver saw signal 1803 change to ‘flashing yellow over red’ (caution, proceed at normal speed), and departed Puhinui Station (see Figure 4). Normal speed meant anything up to 90 kilometres per hour (km/h). The driver had not recognised from his route knowledge that the signal should have been the opposite – displaying red on the top and either green or yellow on the bottom, to indicate that his train was routed across to the Manukau Branch Line and that he should only proceed at medium speed⁴. The driver knew that the speed limit for crossing to the Manukau Branch Line was 40 km/h, which was the speed to which he accelerated his train.

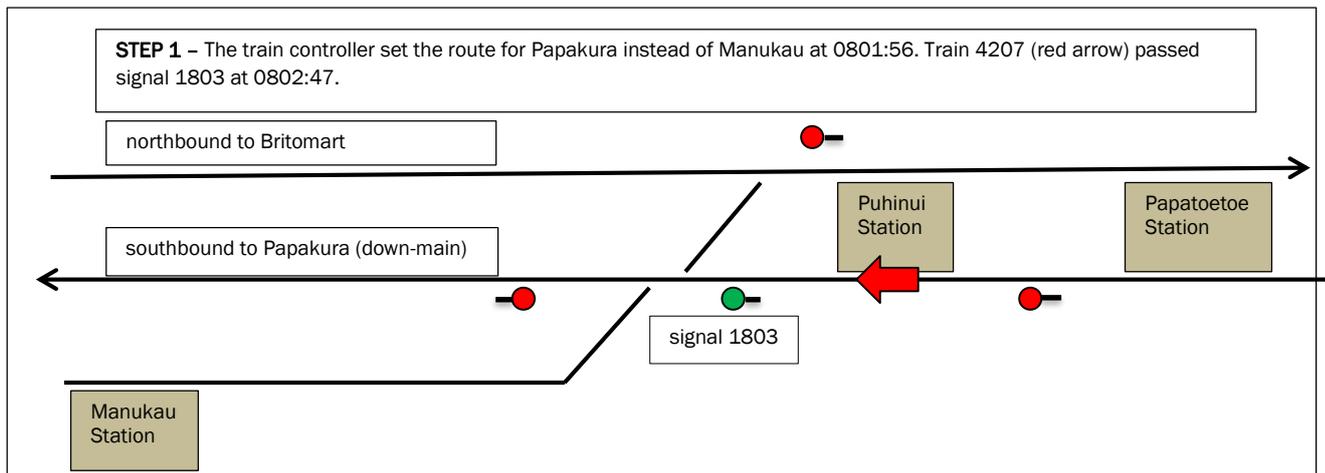
Figure 3
Step 1 of sequence

- 3.1.5. When the train controller looked back at the Wiri Junction screen, he saw that the train departing Manukau had cleared the area, so he set a route for the train at Puhinui Station, through Wiri Junction towards Papakura (see Figure 3). He then returned to look at the Papakura control zone screen. However, the train should have been routed to take the left branch to Manukau.

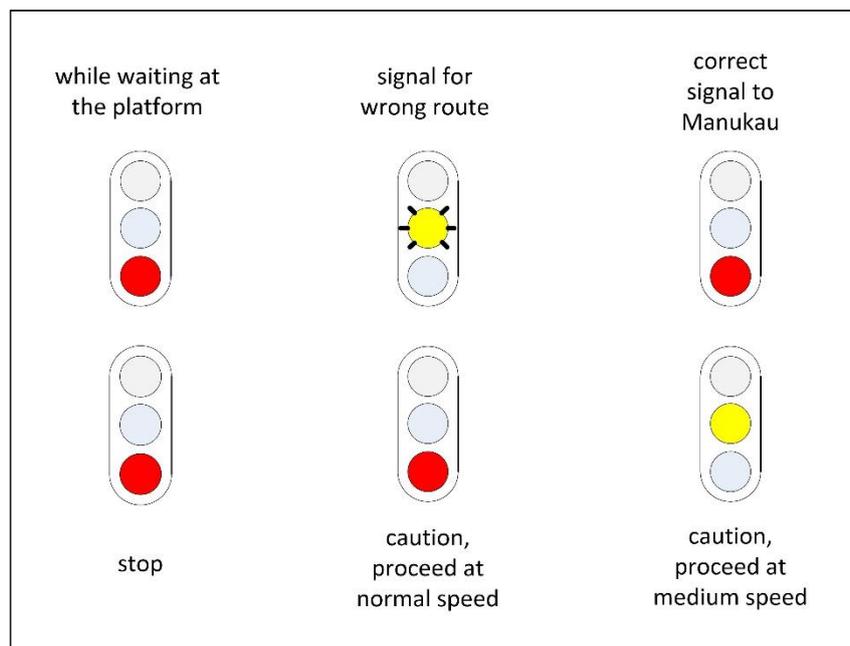
Figure 4
Signal 1803 as it was and as it should have been (right hand set)

- 1.7. The Commission also found that the driver assumed the route ahead had been correctly set for his train then selectively read the 'proceed' aspect of signal 1803, but he did not recognise that it was also displaying the wrong route for his train.

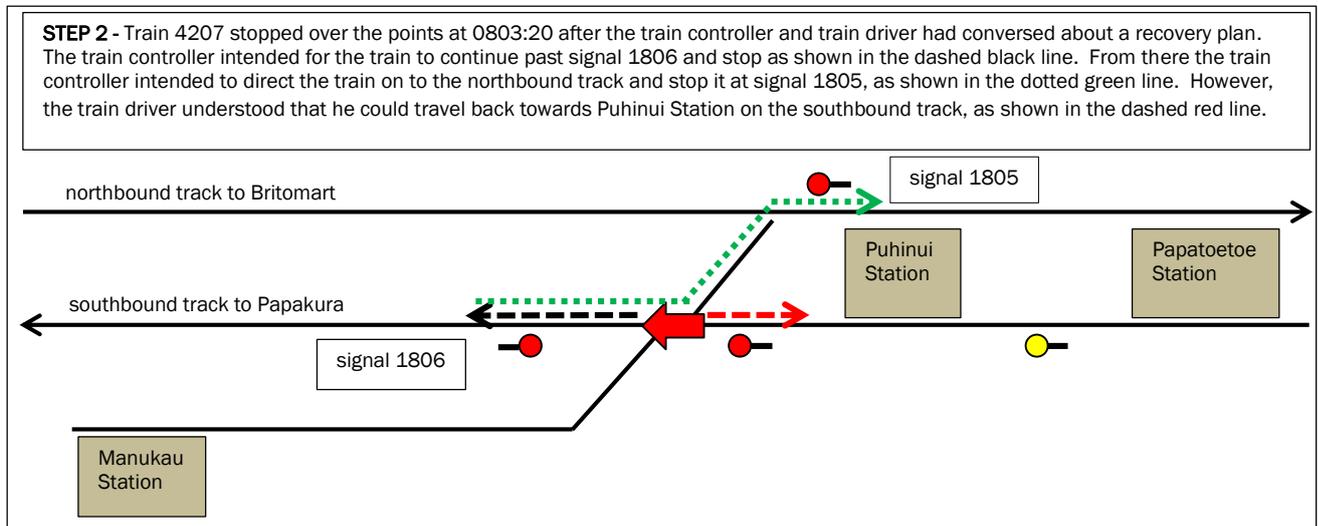
Figure 5
Step 2 of sequence

- 3.1.9. The train controller replied, “Sorry about that. Better take that, 1803 back and send you in the right direction.” The driver slowed the train to 30 km/h and asked the train controller to repeat his message. The train controller responded with, “Yeah, 4207, a bit late now. [Exact words could not be determined] inside 1806 signal on the down and change ends, over” (see Figure 5).

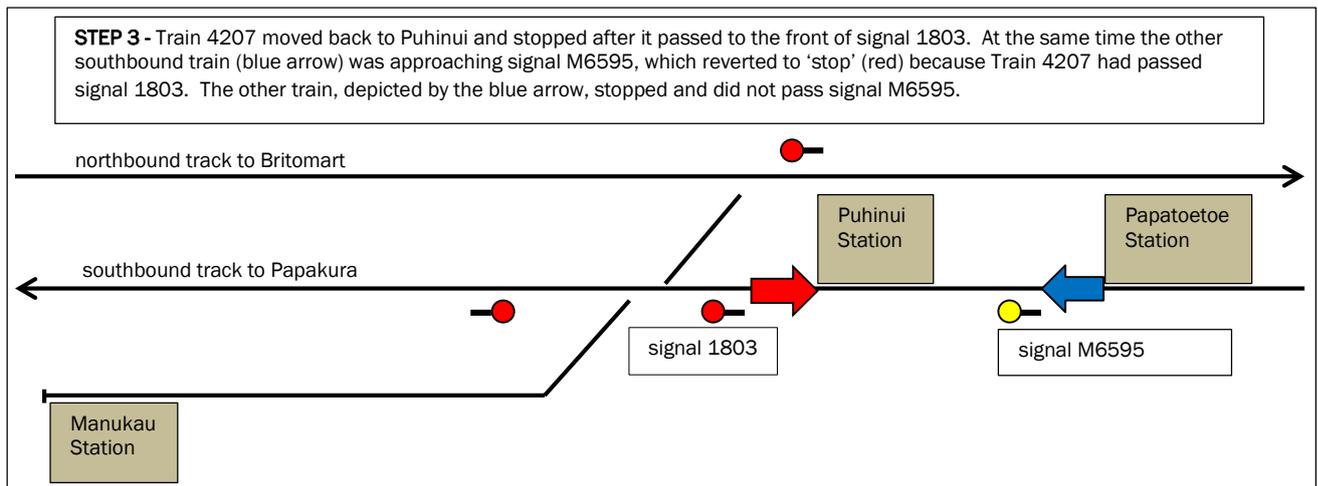
Figure 6
Step 3 of sequence

- 3.1.11. The driver then stopped the train. It came to rest near the points for the Manukau Branch Line. Meanwhile another train that had been following Train 4207 was approaching Puhinui Station from Papatoetoe Station (see Figure 6).

- 3.1.12. The driver changed ends to the rear driving cab and, without any further communication with the train controller, proceeded at 40 km/h back along the down-main⁶ towards Puhinui Station. This put the train on a collision course with the other train. The other train was about one kilometre away around a curve and out of the driver’s line of sight.

- 3.1.13. The train controller saw on his screen that the trains were heading towards each other and urgently called for the reversing train to stop.
- 3.1.14. The driver responded while stopping his train clear of signal 1803. He then called the train controller to say he was ready for the next movement towards Manukau. At this point he looked up into the distance and saw the headlights of the opposing train directly ahead (see Figure 6).

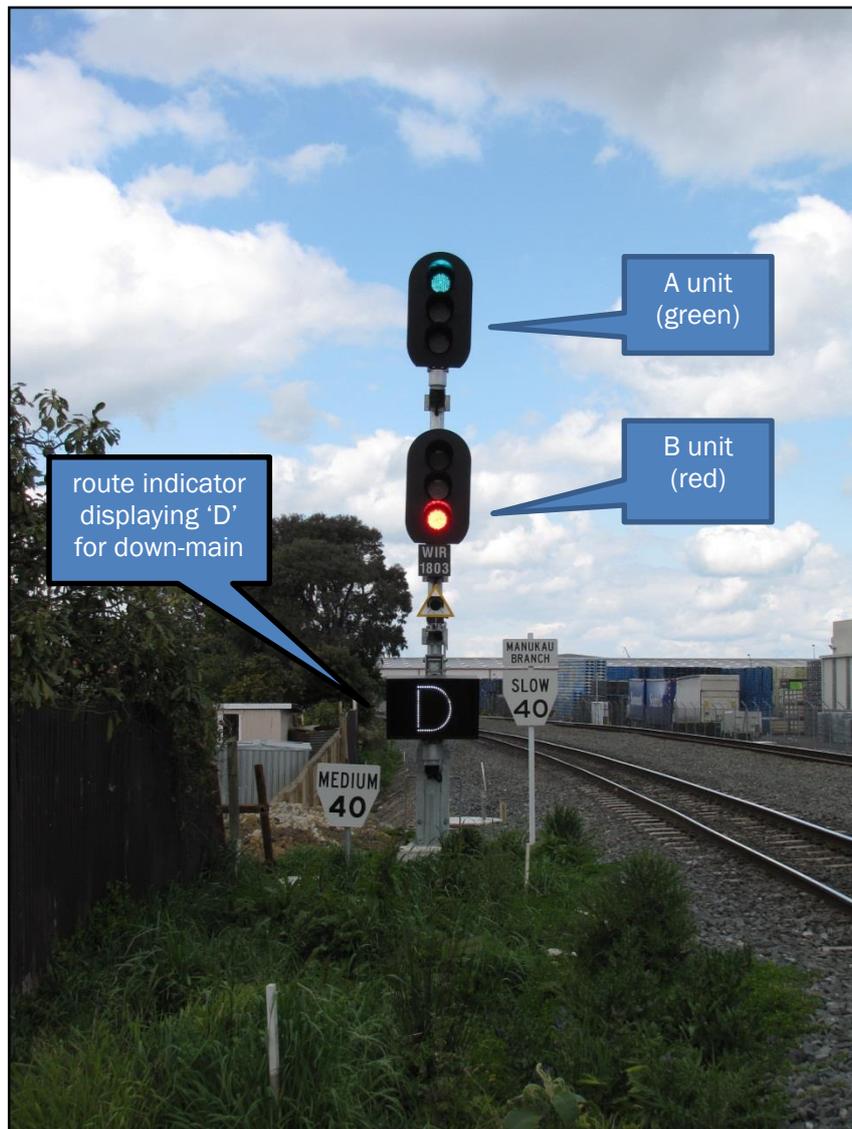
Figure 7
Signal 1803 displaying 'proceed at normal speed' (green over red)

3.4.3. Figure 7 shows signal 1803 telling drivers that their trains are routed straight ahead towards Papakura, 'proceed at normal speed'. When the B unit is red, the colour of the top A unit has the following meanings for the straight-through route:
