Final report RO-2016-102: Train 140 passed Signal 10R at 'Stop'  
Mission Bush Branch line, Paerata, 25 October 2016

Rail inquiry RO-2016-102  
Train 140 passed Signal 10R at 'Stop'  
Mission Bush Branch line, Paerata  
25 October 2016

Approved for publication: August 2017

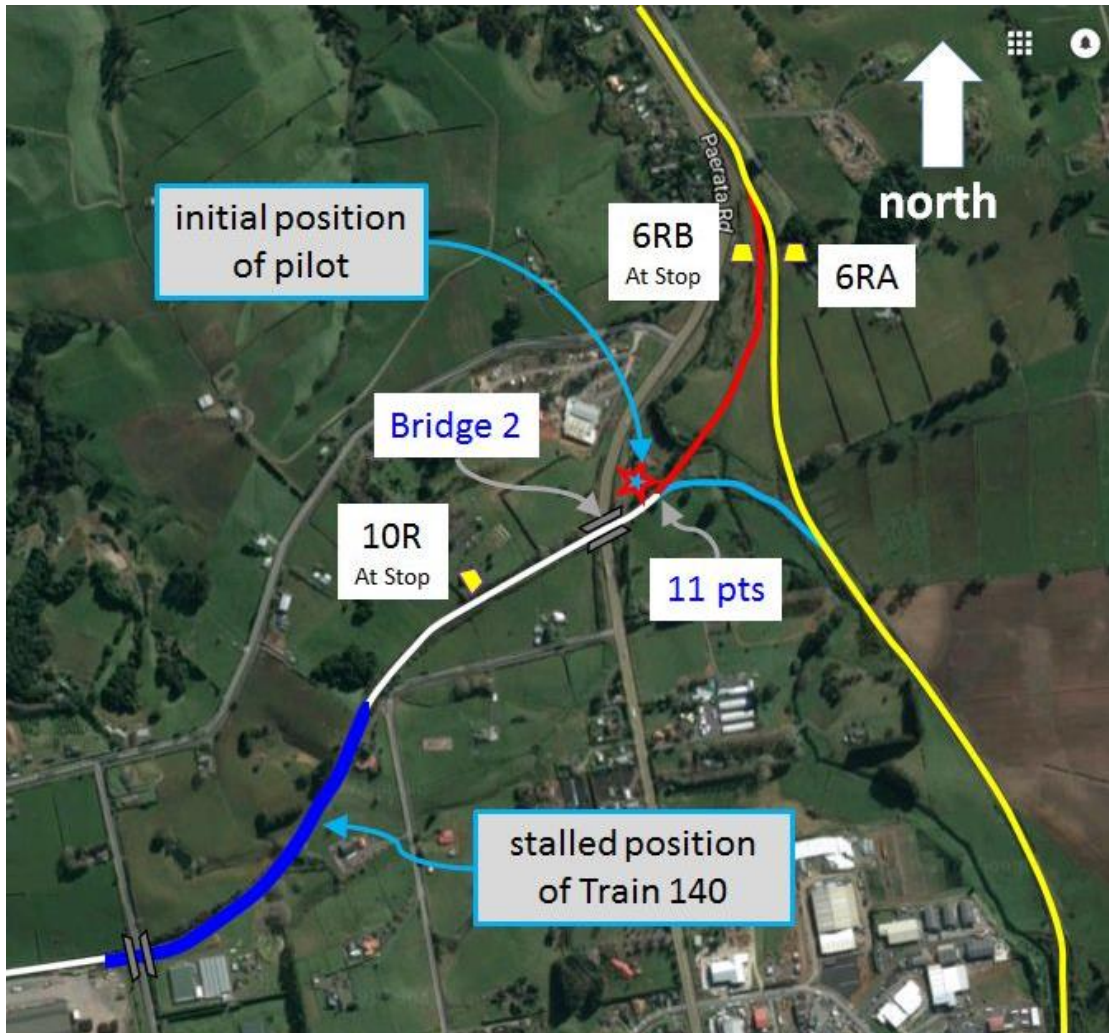
Figure 2  
Location where the train stalled (not to scale)

Main, the train could attain a higher speed and thus more momentum to climb the gradient. The pilot was required to act as the 'eyes' for the driver, because the driver was in the locomotive at the head of the train and unable to see the track and signals behind the train as it reversed.

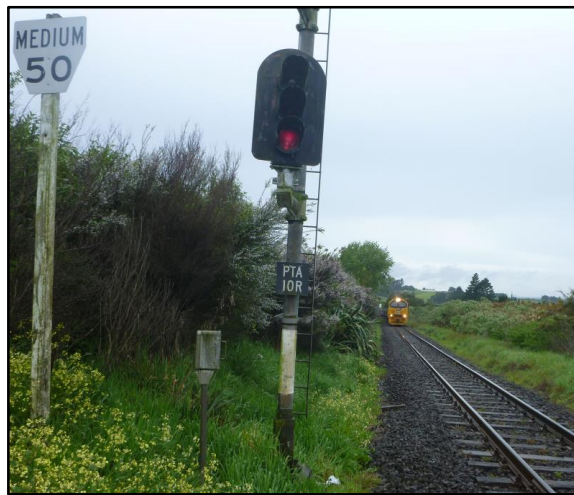
Figure 3  
Signal 10R at 'Stop'

- 3.1.10. The train driver released the automatic brake and the setback movement started at 0927:10. The train gradually picked up speed and at 0929:33 it was travelling at 16 km/h when the rear wagon passed Signal 10R, which was displaying a red aspect ('Stop') (see Figure 3).

- 3.1.11. Signal 10R was displaying red because an empty northbound passenger train was approaching Paerata on the NIMT. The coal train was required to stop at Signal 10R. However, because of the curve in the track the driver was not able to see the signal from his driving position at the head of the train. The pilot was also not able to see from where he was positioned beside 11 points that Signal 10R was displaying a 'Stop' indication (see Figure 4).

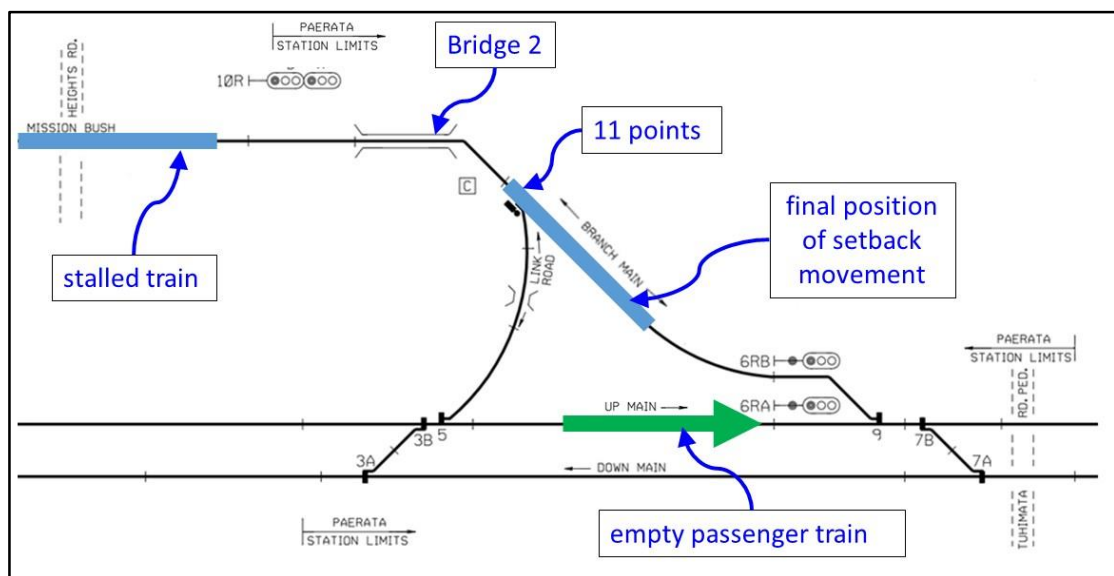
**Figure 5**  
Location where the setback movement stopped (not to scale)

3.1.12. Once the reversing train came into his view, the pilot relocated to the eastern end of the Branch Main, where he saw that the next signal, Signal 6RB, was displaying a red aspect. He immediately radioed the driver shouting, 'STOP, STOP, STOP'. The train stopped at 0931:19, with the front of the locomotive some 80 m past Signal 10R and the rear-most wagon about 420 m short of Signal 6RB.

3.1.14. The northbound empty passenger train was travelling on the adjacent NIMT line and was passing Signal 6RA at the exact time that the setback train stopped (see Figure 5).

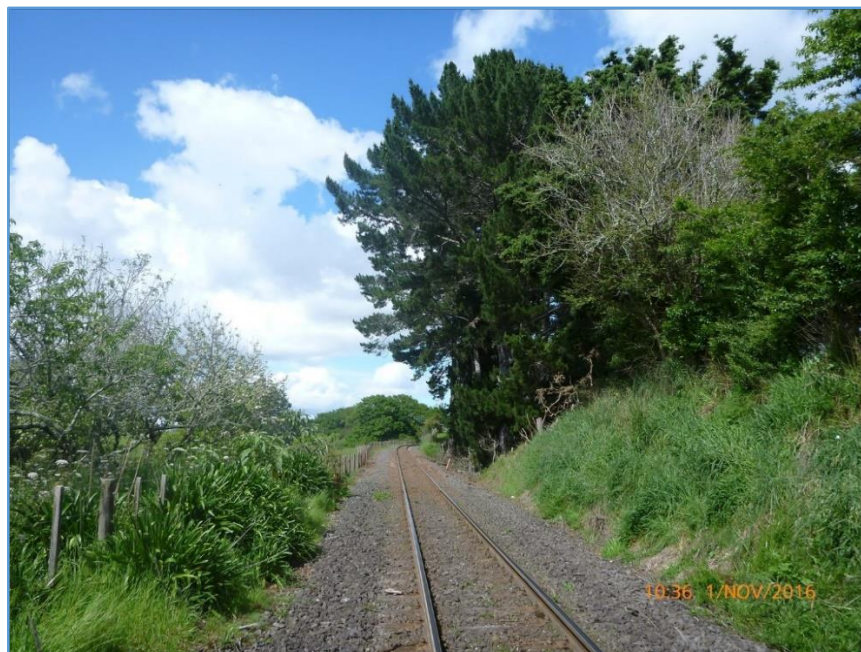
**Figure 6**  
**Overhanging vegetation near the 1 km mark**

- 4.2.1. Trains can stall for a number of reasons: train overloading; locomotive performance; driver skills; and low-adhesion track conditions. Low-adhesion track conditions are likely to occur when there is a combination of wet, windy weather and leaf drop onto the railhead (see Figure 6). These conditions were present on the morning of this occurrence.
