Final report RO-2017-101: Signal Passed at Danger 'A' at compulsory stop boards protected
worksite, Pongakawa, Bay of Plenty, 7 February 2017

Rail inquiry RO-2017-101
Signal Passed at Danger 'A' at
compulsory stop boards protected worksite
Pongakawa, Bay of Plenty
7 February 2017

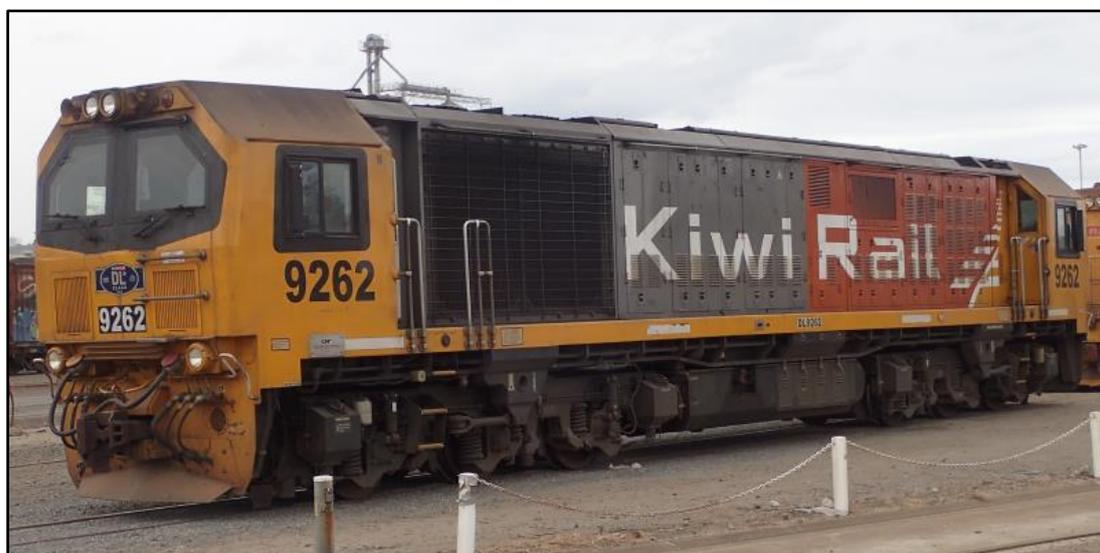
Figure 1
Diesel electric locomotive DL9262

Damage none

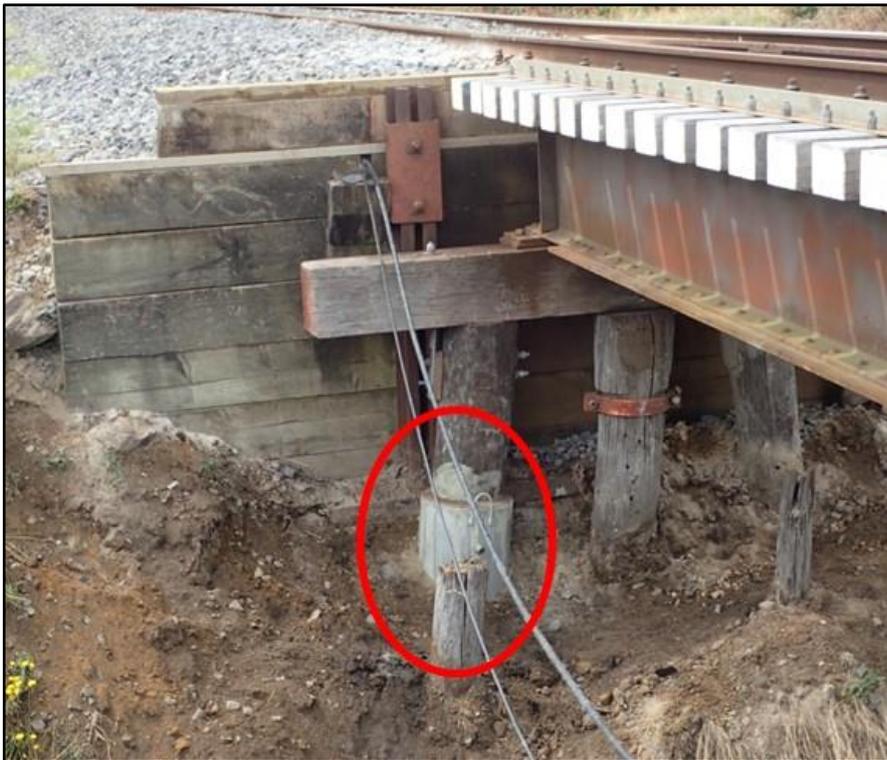
Figure 2
The repaired section of bridge support

- 3.1.1. Tuesday 7 February 2017, the day of the incident, was the first of three planned days of repair work on Bridge 107, which involved replacing a section of wooden support pile under the bridge.
- 3.1.2. The work involved dismantling a wooden support from the bridge and replacing the lower section with a metal sleeve filled with concrete (see Figure 2). With the lower section of the support removed, the bridge would have been deemed unusable until the replacement pile was in place. There would have been a risk of damage to the repair had a train traversed over the bridge before the concrete used in the repair had set, a window of between 45 minutes and one hour.

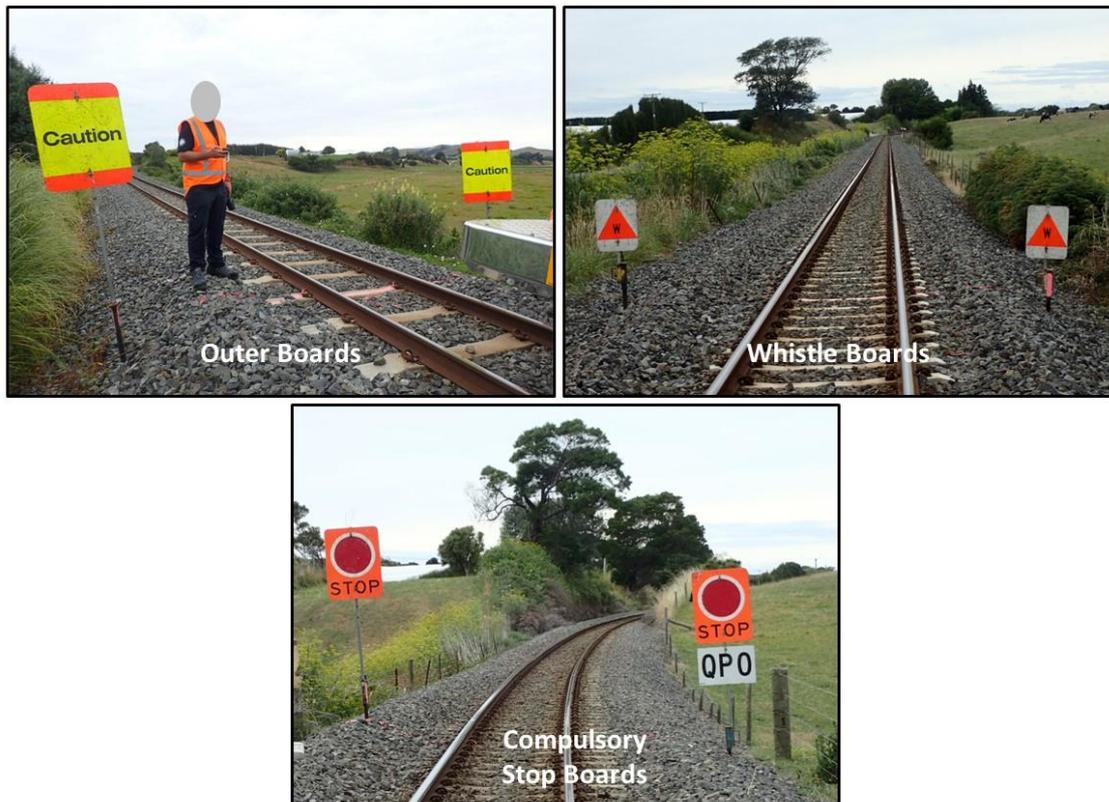
Figure 4
The warning boards and compulsory stop boards for the worksite

- 3.2.1. A three-person work group had been assigned to the Bridge 107 worksite. They had placed the caution boards, the whistle boards and the compulsory stop boards either side of their worksite. The compulsory stop boards were placed 500 metres (m) out from the worksite (see Figure 4). They then called Train Control⁶ at 0830 to confirm the worksite had been established.

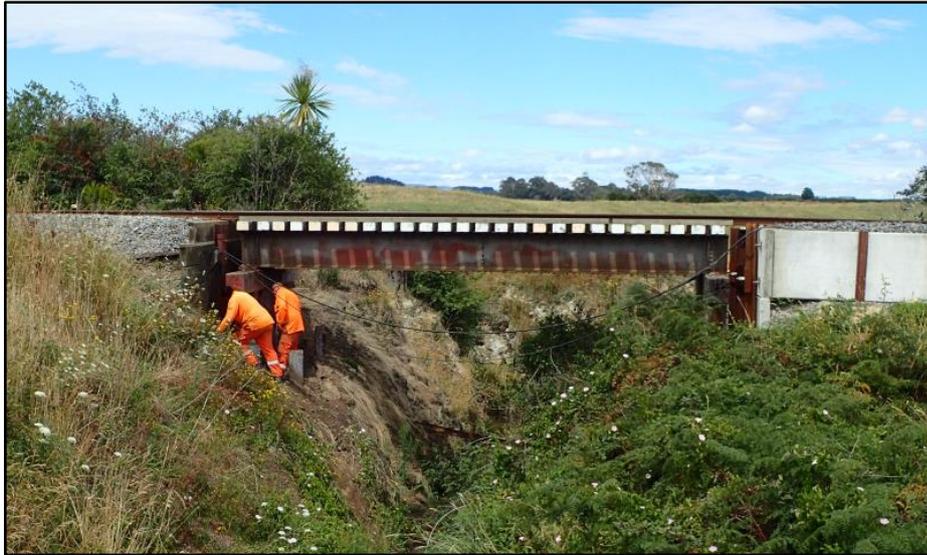
Figure 6
Location of bridge work group members when the train crossed Bridge 107

3.2.13. The train had passed the compulsory stop boards by 1.6 kilometres; it passed through the worksite and nearly reached the far side of the protected area when it stopped. Passing compulsory stop boards without permission is classed as a Signal Passed at Danger 'A'¹⁰.

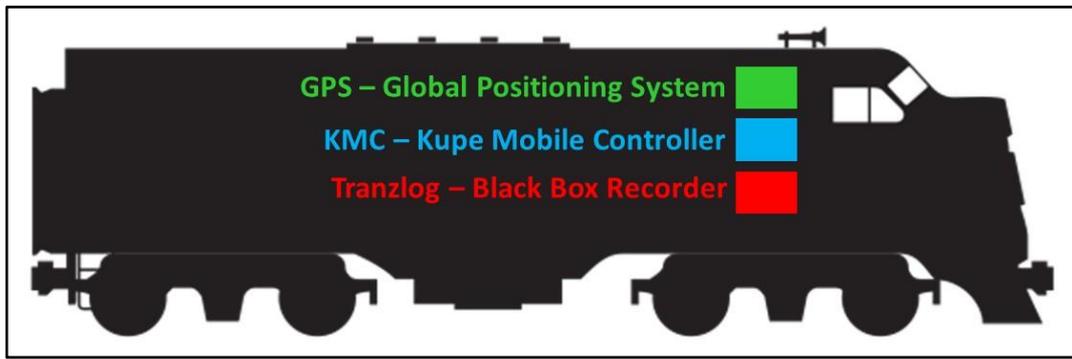
Figure 11
eProtect system component parts on board locomotives

- i. a GPS unit, which receives the real-time GPS position of the locomotive
- ii. a KMC module, which was initially installed to monitor train locations and send train GPS positions back to Train Control. The KMC module was modified to receive and store locations of worksites around New Zealand via the mobile network, and monitor the position of the locomotive in relation to the locations of the worksites
- iii. a Tranzlog event recorder, which monitors and records the details of the locomotive's control settings. The Tranzlog can automatically apply the brakes if it receives a signal from the KMC module to do so.

- 4.5.3. The examination of the KMC module identified a hardware fault, which was traced to a failed integrated circuit chip. The integrated circuit chip was used by the KMC module to switch its memory power source from the external 12-volt supply to an internal battery backup whenever the locomotive was powered down.

- 4.5.4. It was not possible to determine why the chip failed. The design and manufacturing specifications did not indicate a lifecycle for this type of integrated circuit chip. However, irrespective of why the chip and subsequently the KMC module failed, the issue is that the module had reported the error to the eProtect activity log database, but the monitoring process had not picked up the error message.

- 4.5.5. Without the ability to write the location of the worksite at Bridge 107 to its memory, the KMC module was not aware of its existence. Thus the data for the location of the compulsory stop boards was missing, and that is why the eProtect system failed to apply the train brakes when the train did not stop at the boards.

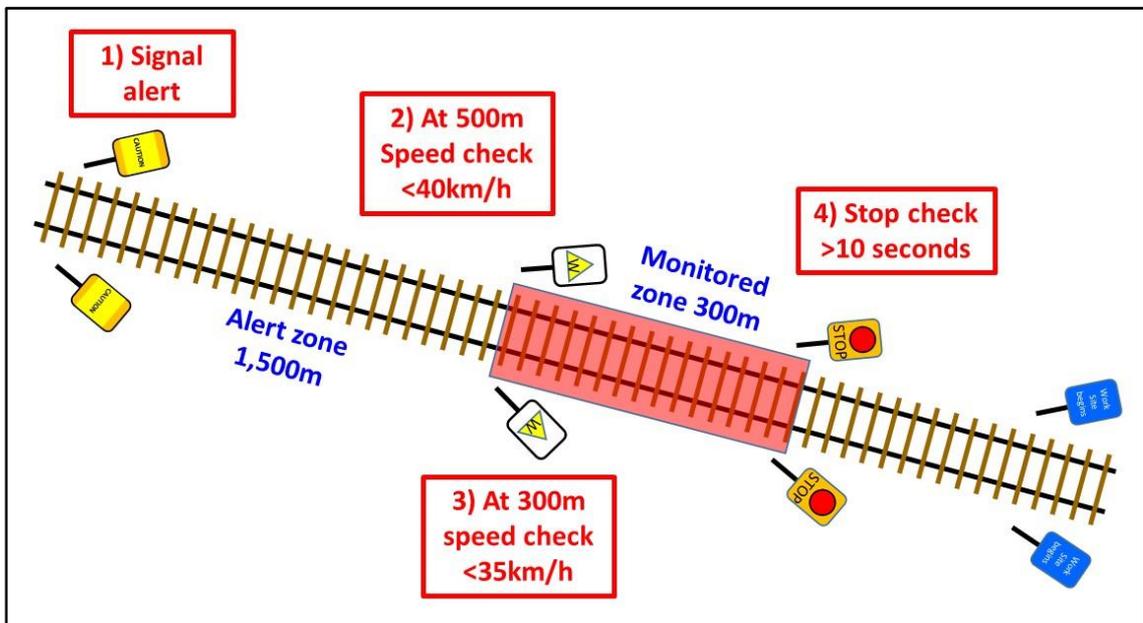
Figure 12
Stages of eProtect system checks

3.4.5. When a locomotive arrives at the outer caution boards of a worksite, the eProtect system is configured to sound a signal alert alarm¹² to notify the driver. At 500 m and 300 m from the compulsory stop boards the system checks that the speed of the locomotive is below 40 km/h and 35 km/h respectively. If not, the system activates the locomotive brakes automatically. At the compulsory stop boards, eProtect checks that the locomotive remains stationary for at least 10 seconds. If not, it applies the locomotive brakes automatically (see Figure 12).

- 3.4.6. An eProtect system brake activation will not necessarily prevent a locomotive passing compulsory stop boards. It is intended to minimise the distance that a locomotive can move past the boards and prevent it entering an area where work is being undertaken.
- 3.4.7. The eProtect system utilises both GPS and mobile phone signals, which can be affected by local terrain and tunnels. KiwiRail considers that the eProtect system was designed and implemented as a supplementary overlay system, thereby providing another safety defence to the primary defence achieved by Rule 905. The primary protection for workers at a worksite is the train driver observing and stopping at the compulsory stop boards.

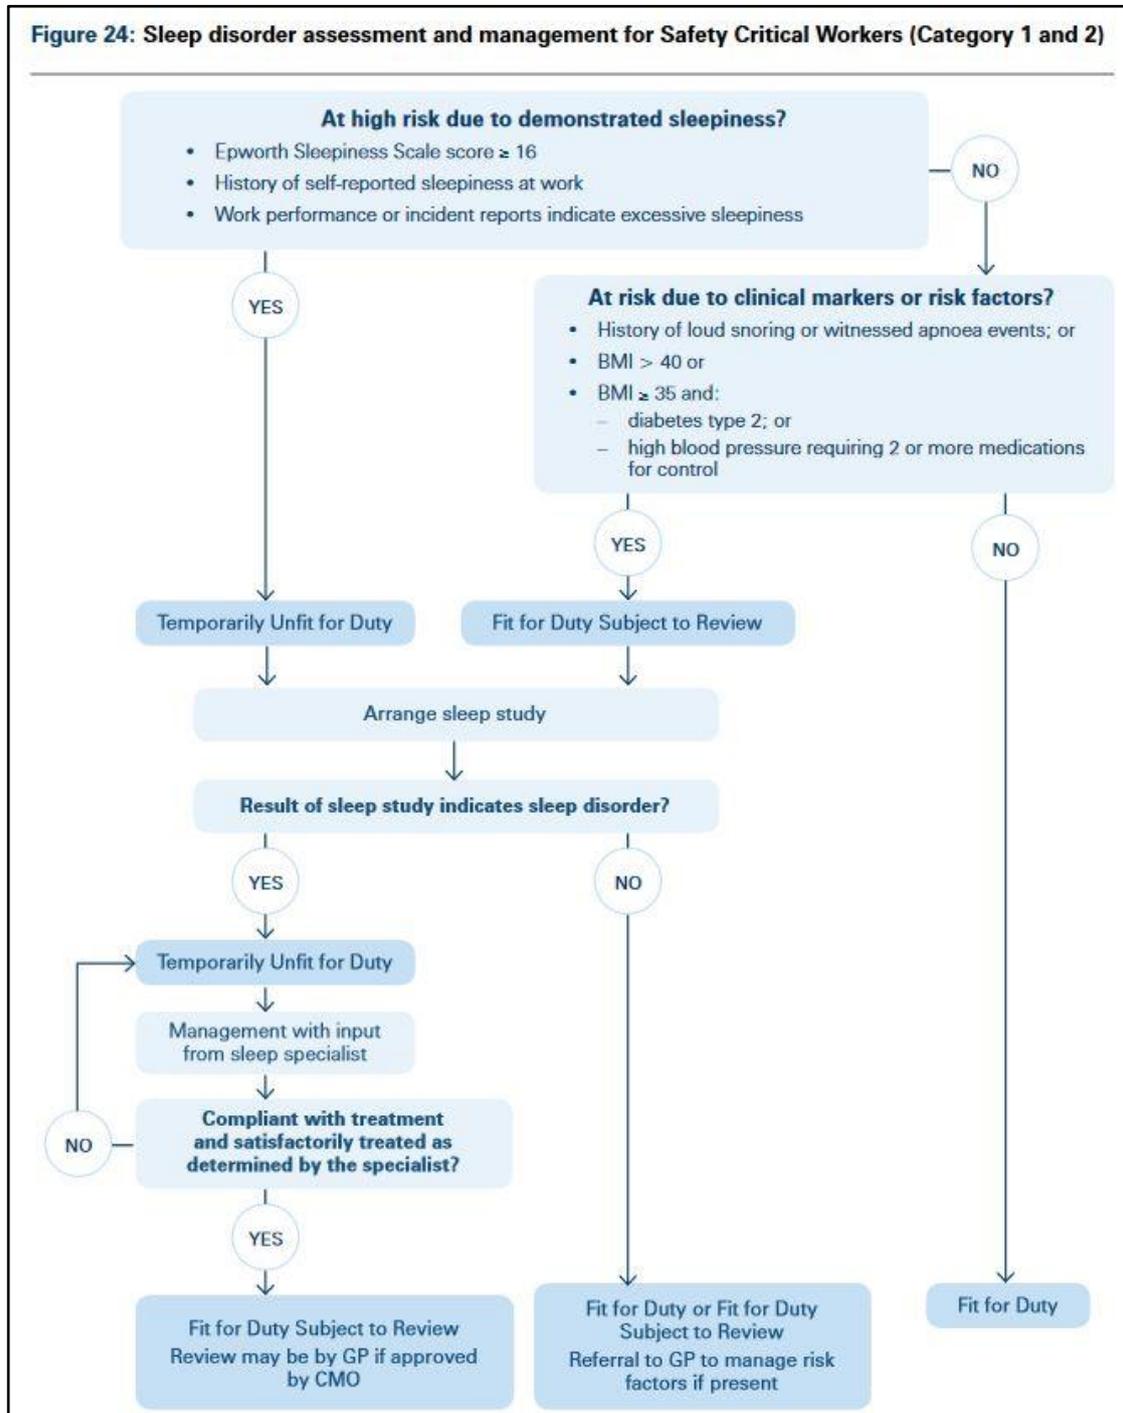
Figure 13
Australian National Transport Commission standard for sleep disorder assessment of rail safety critical workers

BMI and blood pressure; therefore they did not exceed the threshold for referral for a follow-up sleep study. As part of the continuous improvement cycle of the standard there are already discussion documents out for consultation with regards to potential changes to tighten the standard. Many of these proposed changes would likely have indicated that this driver required a follow-up sleep study.

On 23 August 2018 the Commission recommended that the Chief Executive of KiwiRail improve the health assessment system to ensure that the periodic medical check system captures data directly from the subject. (O18/18)
