**Report 07-110, collision, express freight Train MP2 and Work Train 22, Ohinewai,  
19 June 2007**

On Tuesday 19 June 2007 at about 1105, express freight Train MP2 was travelling between Huntly and Te Kauwhata when it struck a gantry crane from Work Train 22. Work Train 22 was stationary and was working on the adjacent Down Main line with its cranes fouling the Up Main line. The gantry swung around and struck one of the crane operators, knocking him from the wagon and under the passing train. The operator was fatally injured.

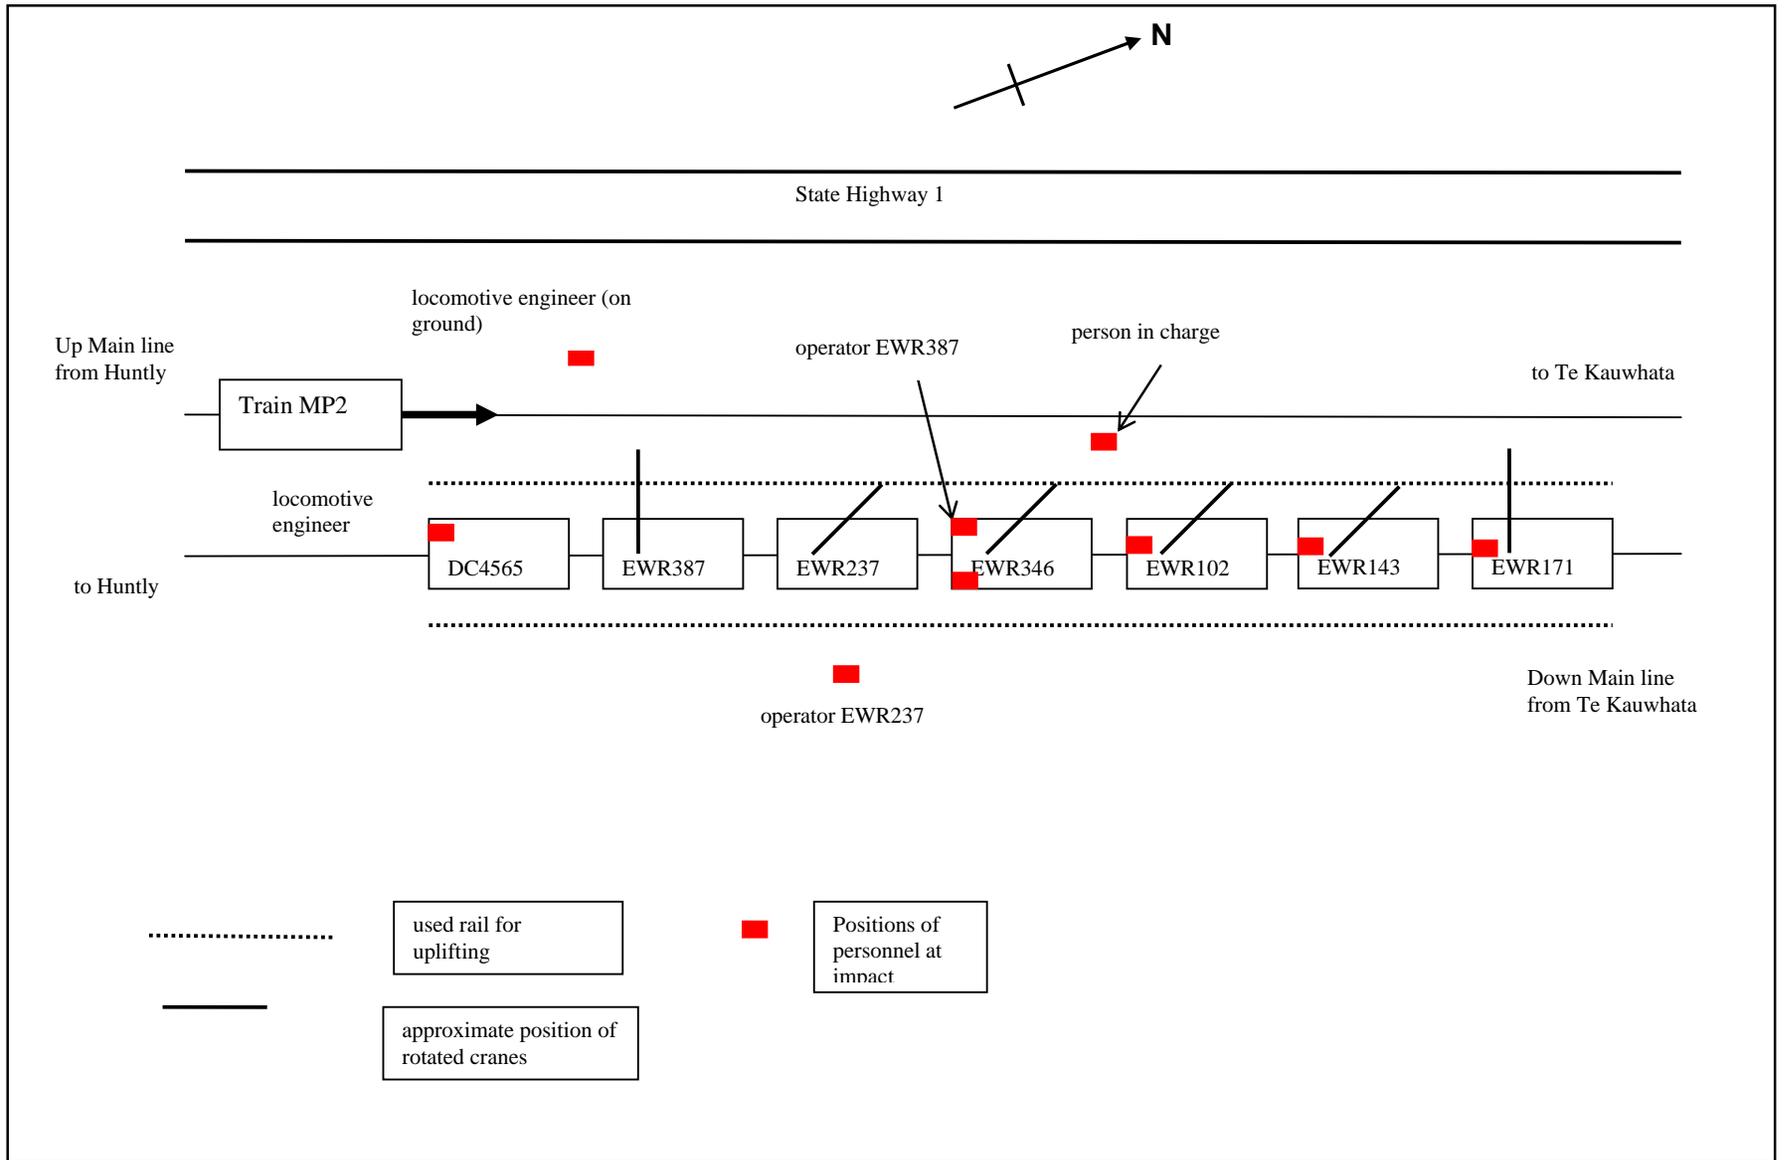
Figure 1

- 1.1.19 Operator EWR171, who was working on the last wagon of the rake, had his back to the person-in-charge, the other crane operators and the approaching train. Because of this and the hearing protection he was wearing, the person-in-charge could not attract his attention. The person-in-charge could see by the actions of Operator EWR143, who was the closest to Operator EWR171, that he was also trying to attract the attention of Operator EWR171 but without success. The train was only metres away from the person-in-charge when he dived across to the opposite side of the rake and out of the way.

WT22 status as MP2 approached and passed (not to scale)

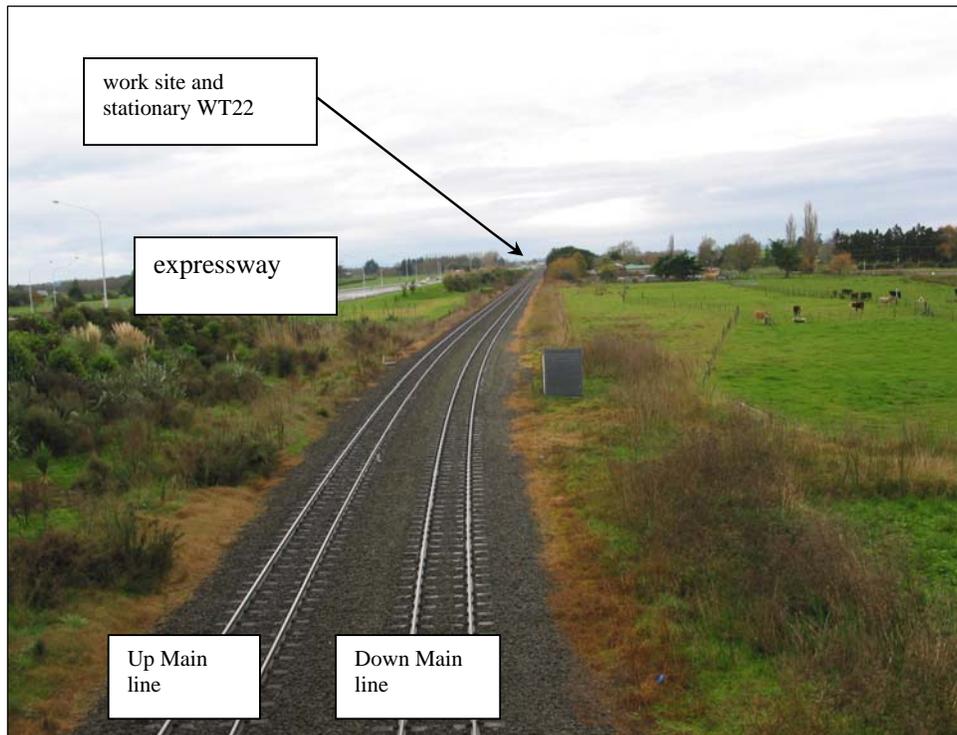
- 1.2.5 The northbound approach to the work site was a 1040 m radius curve beneath overhead Bridge 278 (see Figure 3) at 581.90 km. Bridge 278 was 1100 m before the collision site.

**Figure 2**  
North from Bridge 278 towards the work site

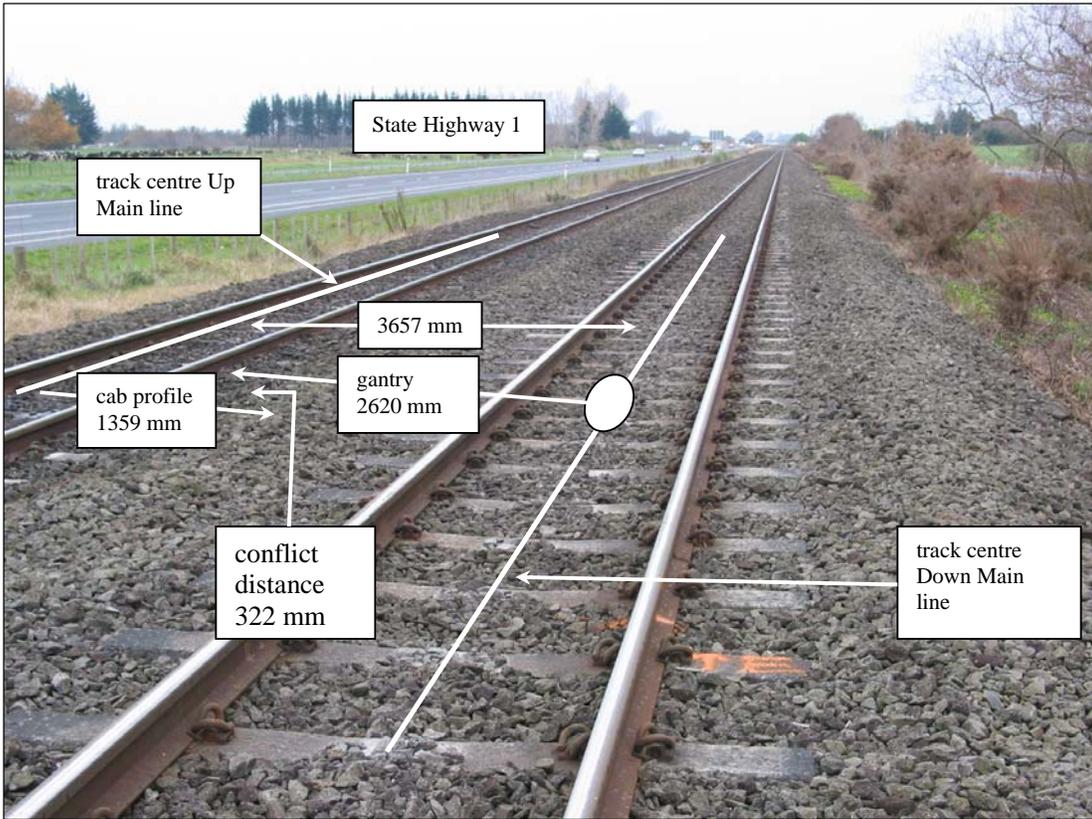
- 1.2.6 The measurement between the track centre lines of the main lines at the accident site was 3657 millimetres (mm). The outer profile of the DX locomotive cab extended to 1359 mm from the track centre line and the gantry arm, when rotated towards the Up Main line, measured 2620 mm from the track centre line. Figure 4 shows the locomotive cab profile and crane gantry clearances.

**Figure 3**  
**Track, gantry and locomotive clearances at the collision site**  
 (not to scale)

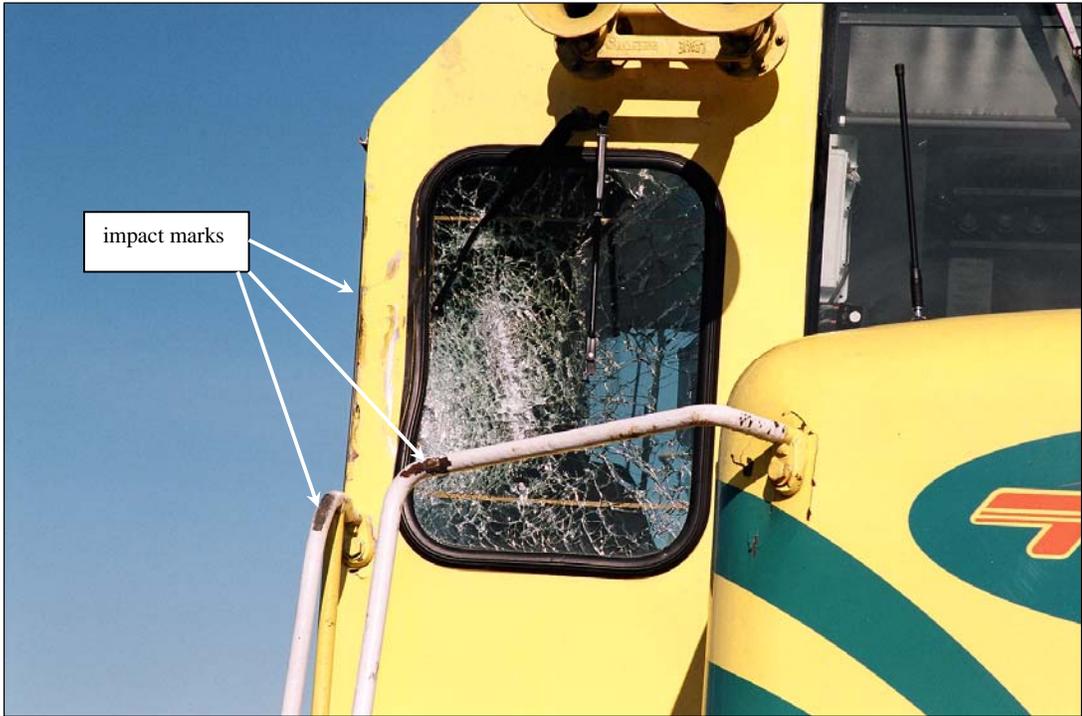
**Figure 4**  
**Locomotive cab forward window of MP2 after impact**  
 (photo courtesy New Zealand Police)

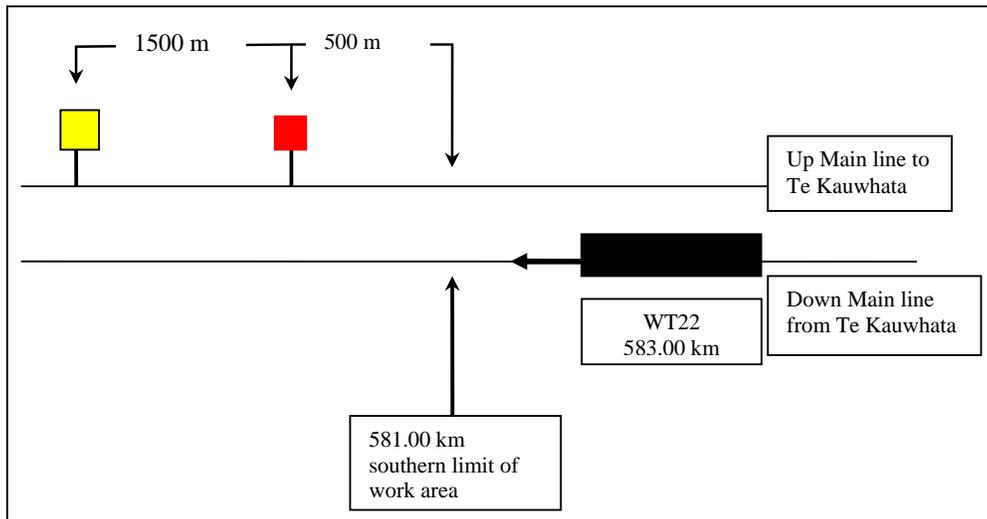
**Figure 7**  
**Work area if Rule 905 protection had been in place on the Up Main line**  
 (not to scale)

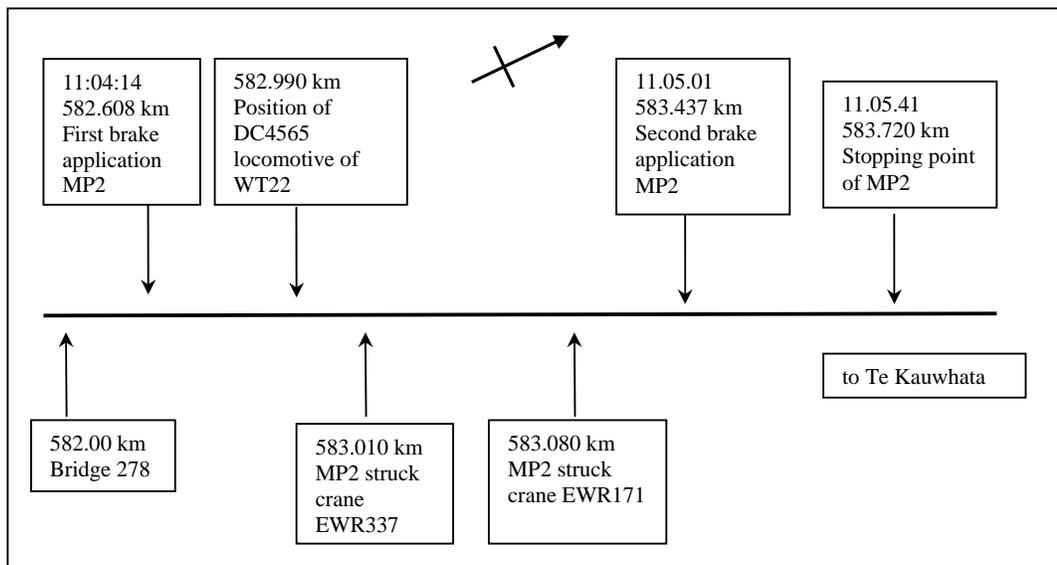
- 11:03:29: the front headlights and ditch lights were illuminated as MP2 approached Ohinewai
- 11:04:07: the locomotive horn was sounded for 4 seconds
- 11:04:12: the throttle was moved from notch 5 to notch 3; train speed was 79 km/h
- 11:04:14: a full service automatic brake application was made. Train speed was 80 km/h
- 11:04:32: the automatic brake application was released; train speed was 68 km/h and the throttle was in notch 3
- 11:04:46: the throttle was returned to notch 1; train speed had reduced to 47 km/h
- 11:04:54: the throttle was returned to idle; train speed had reduced to 43 km/h
- 11:05:01: a 90 kilopascals reduction with the automatic brake was initiated; train speed had further reduced to 41 km/h
- 11:05:41: MP2 stopped.

**Figure 8**  
**Locomotive event recorder data incorporated into site diagram**  
(not to scale)
