**Report 07-113, express freight Train 239, wagons left in section at 514.9km,  
between Te Awamutu and Te Kawa, 22 September 2007**

## **Report 07-113**

### **express freight Train 239**

### **wagons left in section at 514.9km between Te Awamutu and Te Kawa**

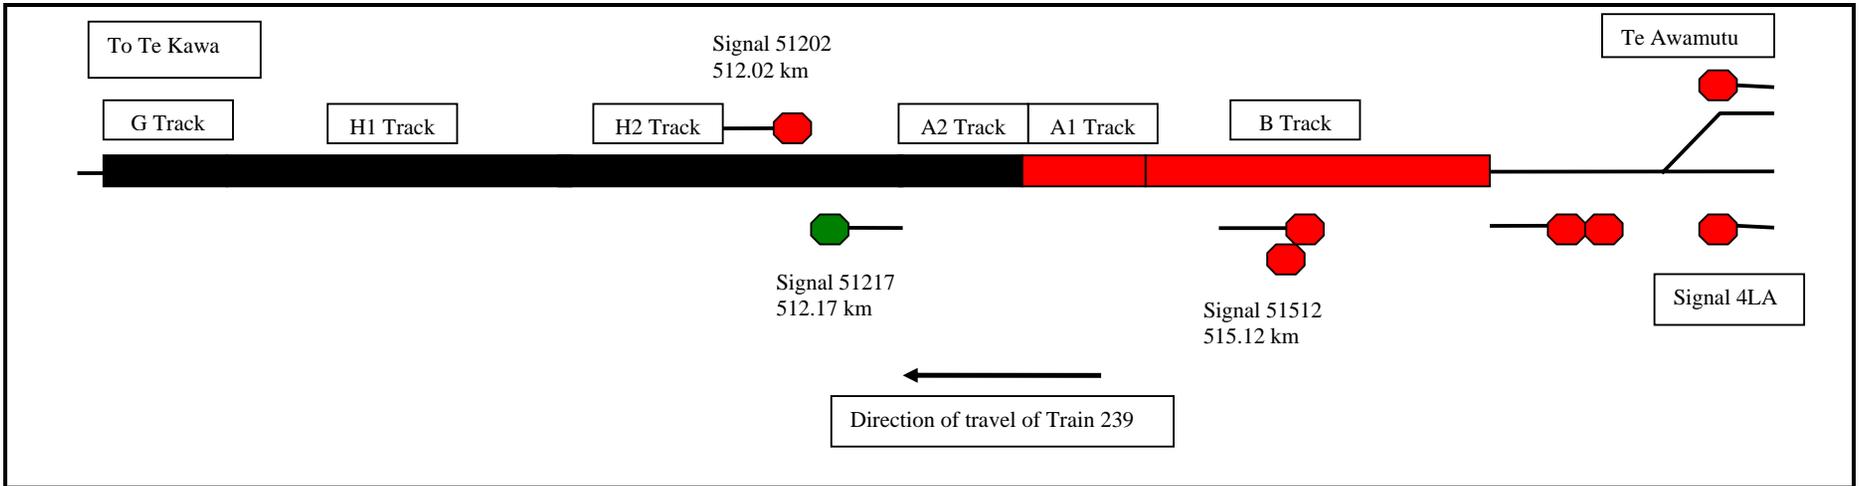
**Figure 4**  
**Track indications as Train 239 occupied A1 Track**

- 2.29 The centralised traffic control signalling system was operating as designed. Both B and A1 Tracks were illuminated because they were still occupied by the rear 10 wagons which straddled the track joint. The safety defence in centralised traffic control signalling to prevent another train entering an already occupied or potentially unsafe block section was that in this instance the Departure signals at either end of the block section could not be cleared to “proceed”. The manual overriding of the “Stop” indication on the Departure signal at Te Awamutu by the issue of a Mis 59 to allow Train 243 to enter the block section effectively removed the safety defence to prevent potential conflicts, and it was of concern that the safety defence of a correctly operating signalling system could be so easily bypassed.

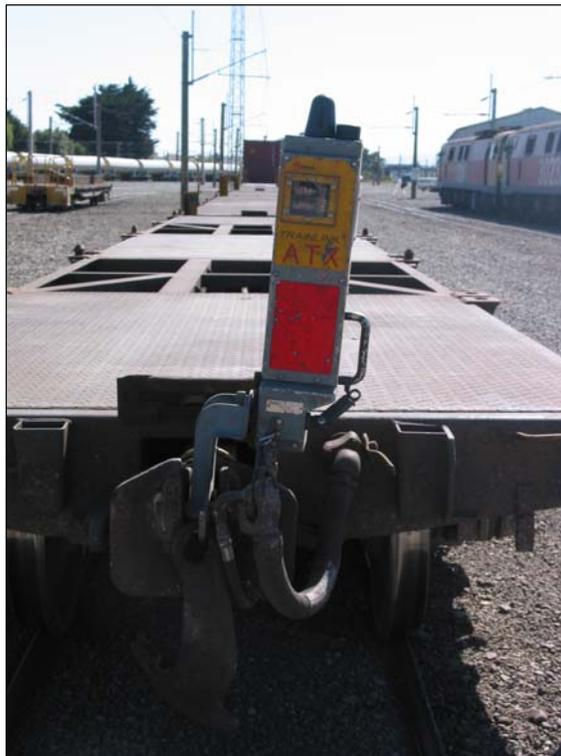
**Figure 10**  
**Trainlink ATX train end monitor attached to the wagon coupling**

- 1.5.3 The Trainlink ATX train end monitor with bracket attached extended 950 millimetres above the drawbar.
- 1.5.4 Rail Operating Rules and Procedures (Signals) Rule 69 “Signals Displayed by Trains” provided that train end monitors were an approved end of train marker. The tail light of the train end monitor operated while the train end monitor was in the upright position, except during daylight conditions when a photo-electric cell turned the marker off. There was also a reflector fitted to the train end monitor.

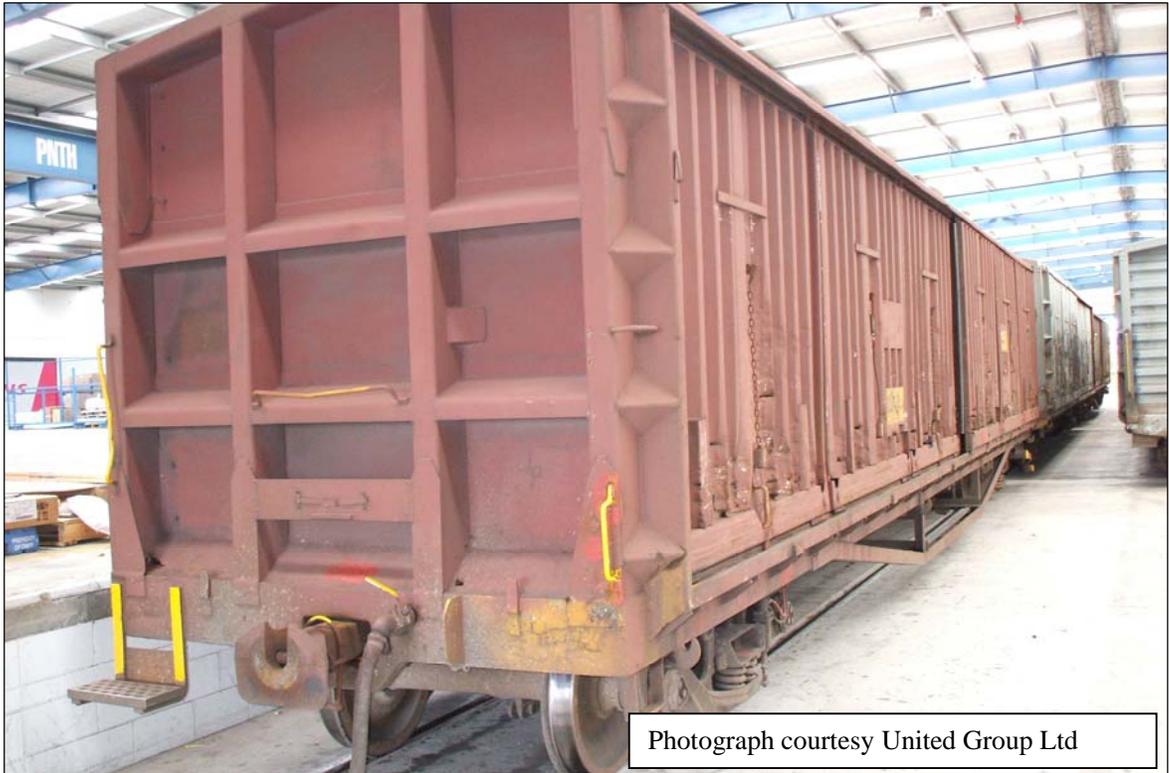
**Figure 12**  
**a ZL class wagon**

1.10.1 The wagon on the rear of Train 239 when it departed Te Rapa was ZL462. These wagons were used for carrying general freight traffic.

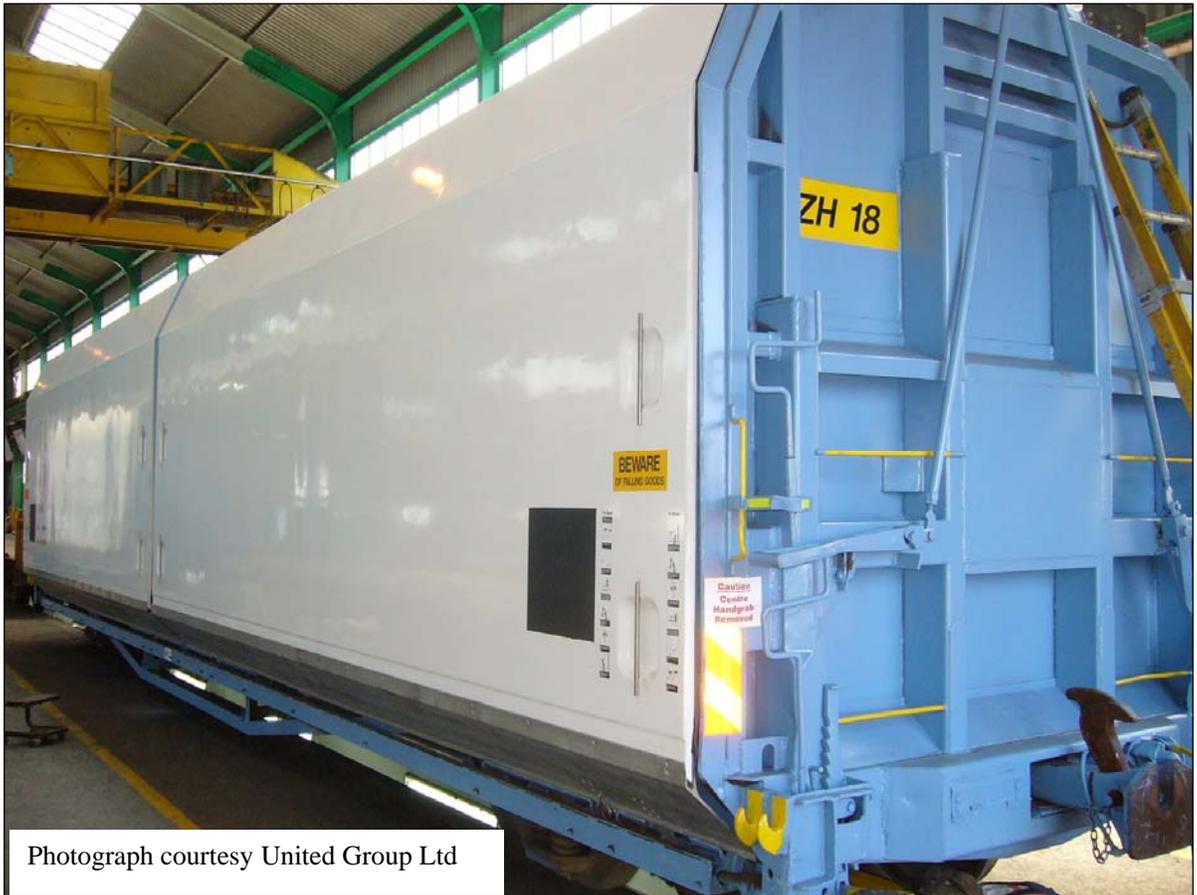
**Figure 13**  
**a ZH class wagon**

1.10.2 The wagon on the rear of Train 239 to which the replacement TEM was attached at Otorohanga was ZH53. These wagons were used for conveying palletised bulk product such as milk powder and urea, as well as palletised general freight.
