RAILWAY ACCIDENT

Report on the Derailment that
occurred on 27th December 1973
at Lower Darwen

IN THE
LONDON MIDLAND REGION
BRITISH RAILWAYS

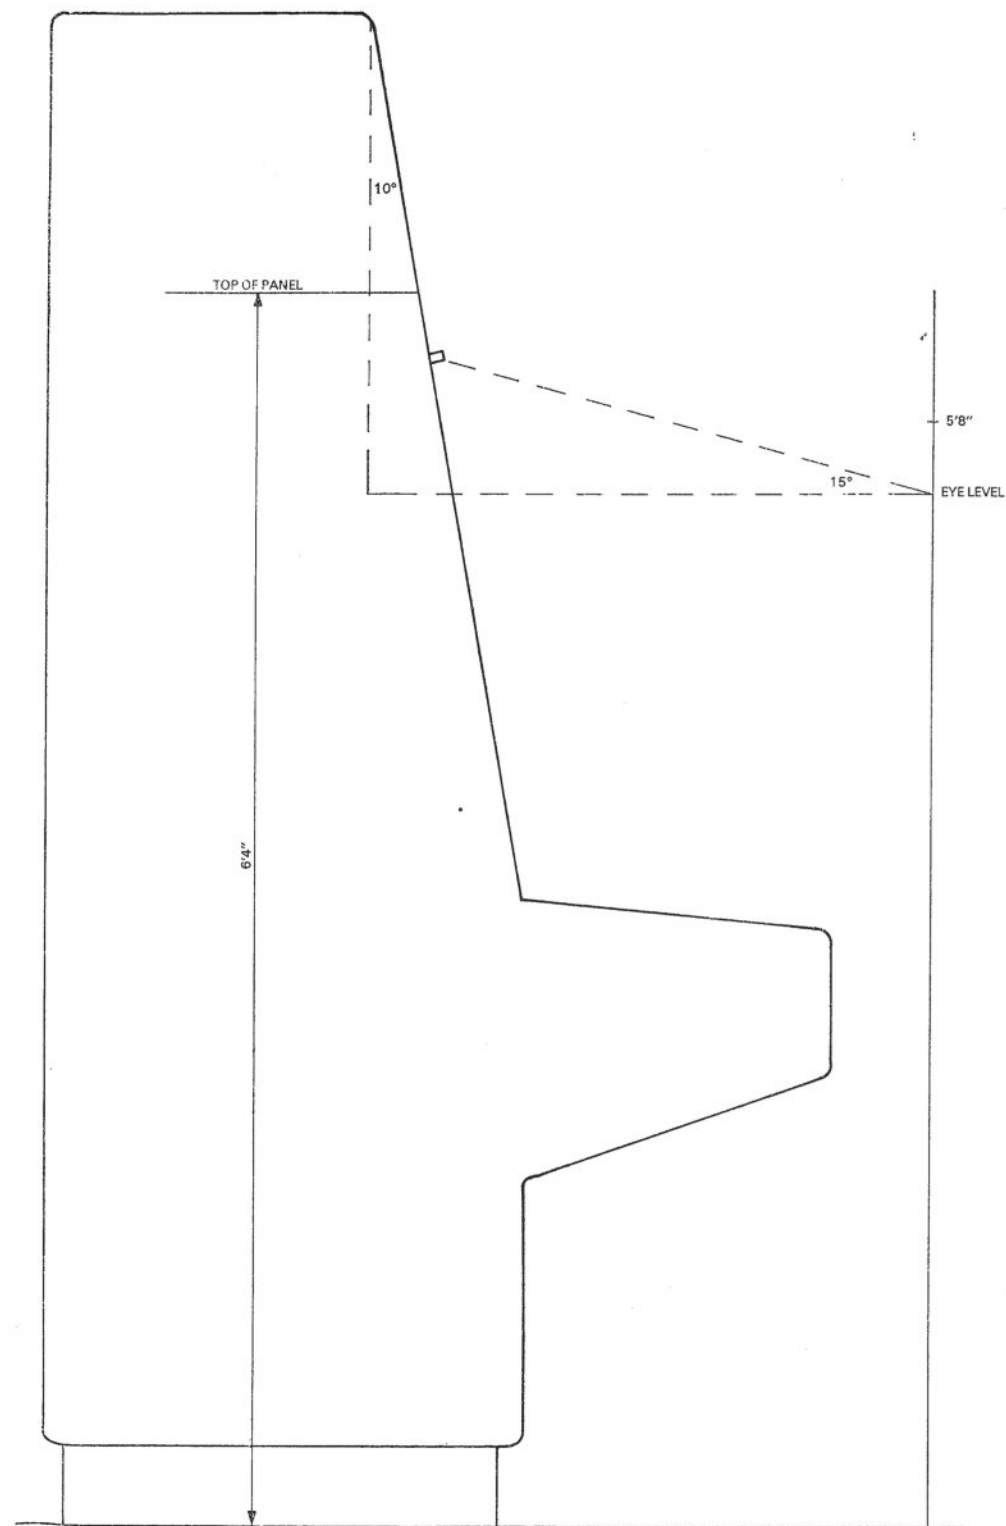
Fig 3

5. The panel (Fig. 3) is composed of 80 mm × 40 mm mosaic units placed at an angle of 10 degrees to the vertical, its top edge being 1930 mm (6 ft 4 in) above the floor. Beneath it there is a writing surface at an angle of 5 degrees to the horizontal some 480 mm wide and 950 mm (3 ft) above the floor. The panel faces the railway and the signal box windows. Desks are provided for the Area Controller, train regulators and other staff who, when seated at their desks, are about 13 feet from the face of the panel. Figure 5 shows a part of section B which includes Darwen Station and signal PN 461 approaching Bolton Branch Junction. It shows the indicator placed just below the single line to the left of the goods loop which indicates the direction for which trains are signalled on the single line and the point switches situated in the third row of mosaic units from the top of the panel some 6 feet above the floor, including those which can be used to operate the automatic catch points in case of failure. In the mosaic unit above each of the latter there is a sealed release push-pull key.

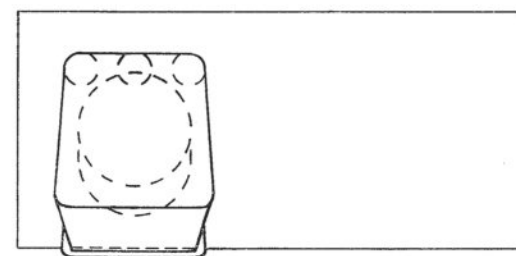
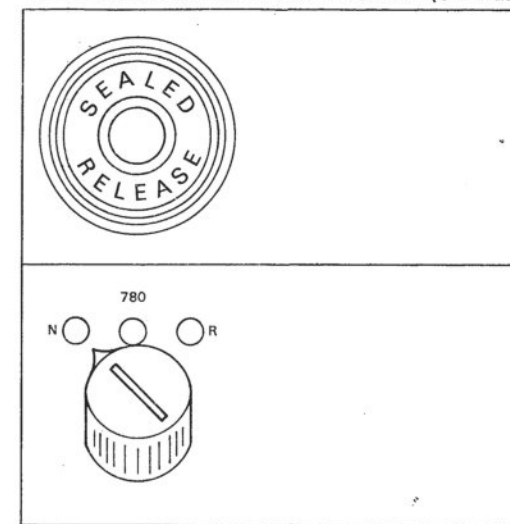
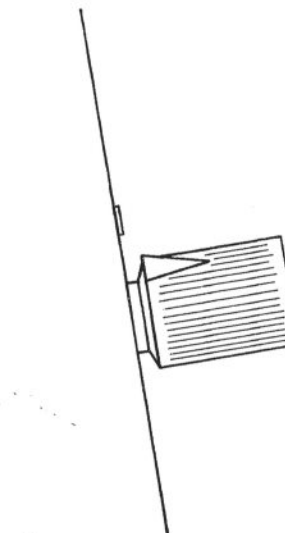
Fig 4

6. As shown in Figure 4, the point switches have a central position for automatic route setting and normal and reverse positions for setting points individually. The push-pull key above each catch point switch requires to be in the pushed-in (F) position for the point switch to be operative, and in the fully pulled out (T) position for the points to be automatically operated by the route setting procedure as described in paragraph 3. When the switch is in the T position a key-hole collar can be dropped over it to hold it out and a paper seal through which the button protrudes is then glued to the collar to seal it. Movement of the collar to release the button will break the paper seal on which the words "Sealed Release" are printed. The signaller on section B has eleven such releases along the top of his panel, and there are four more elsewhere on the Preston signal box panel. In addition to these fifteen sets, there are five sets of catch points within shunting areas also with sealed releases, which close automatically on signal clearance and track circuit occupation all on double lines of railway signalled for one direction working only.

23. Foulkes is a Class E signalman with 27 years' experience. He joined the new Preston Signal Box at its commissioning in November 1972 after a two-week's course of instruction. He told me that he had never previously worked in a power signal box, nor had he ever worked a Tokenless Block section. He described the working of the single Darwen line as track-circuit block operated from Preston signalbox and he thought there was little difference between working the bi-directional lines through Preston station, and the Darwen line. He had never been involved with automatic catch points prior to coming to Preston, and he did not remember seeing any in the Derby box where he had been trained. He thought that they had been mentioned on the course, but not in any great detail. He was able to describe to me their method of working, but he agreed that it had only become clear to him since the accident. He told me that during the afternoon he had trouble with 788 catch points near Entwistle Station but he had overcome it by operating the point switch. The signal technician had not been called and he had made no entry in his register. He agreed that he should have recorded the breaking of the sealed release on 781 catch points but that he had not done so. He had not discussed pilot working with Mr Hammill because he had hoped that the signal technician would have been able to put the trouble right quite quickly, as he had on other occasions. Signalman Foulkes is 5 feet 8 inches tall and he told me that he has to stand back on his toes to see the point indication lights above the switches at the top of the panel, particularly when reminder appliances are placed over neighbouring switches. (See Fig. 4.)

58. A signalman operating a power signal box must rely entirely on panel indicating lights for his knowledge. With reminder appliances placed over point operating switches at the top of the panel, the signalman cannot easily see the point indicating lights, and I recommend that those at the top of panels should be placed below their switches and not above them as at present. Points should be numbered consecutively along a line so that their switches, which should remain positioned in numerical order, shall more logically apply to the points they operate.

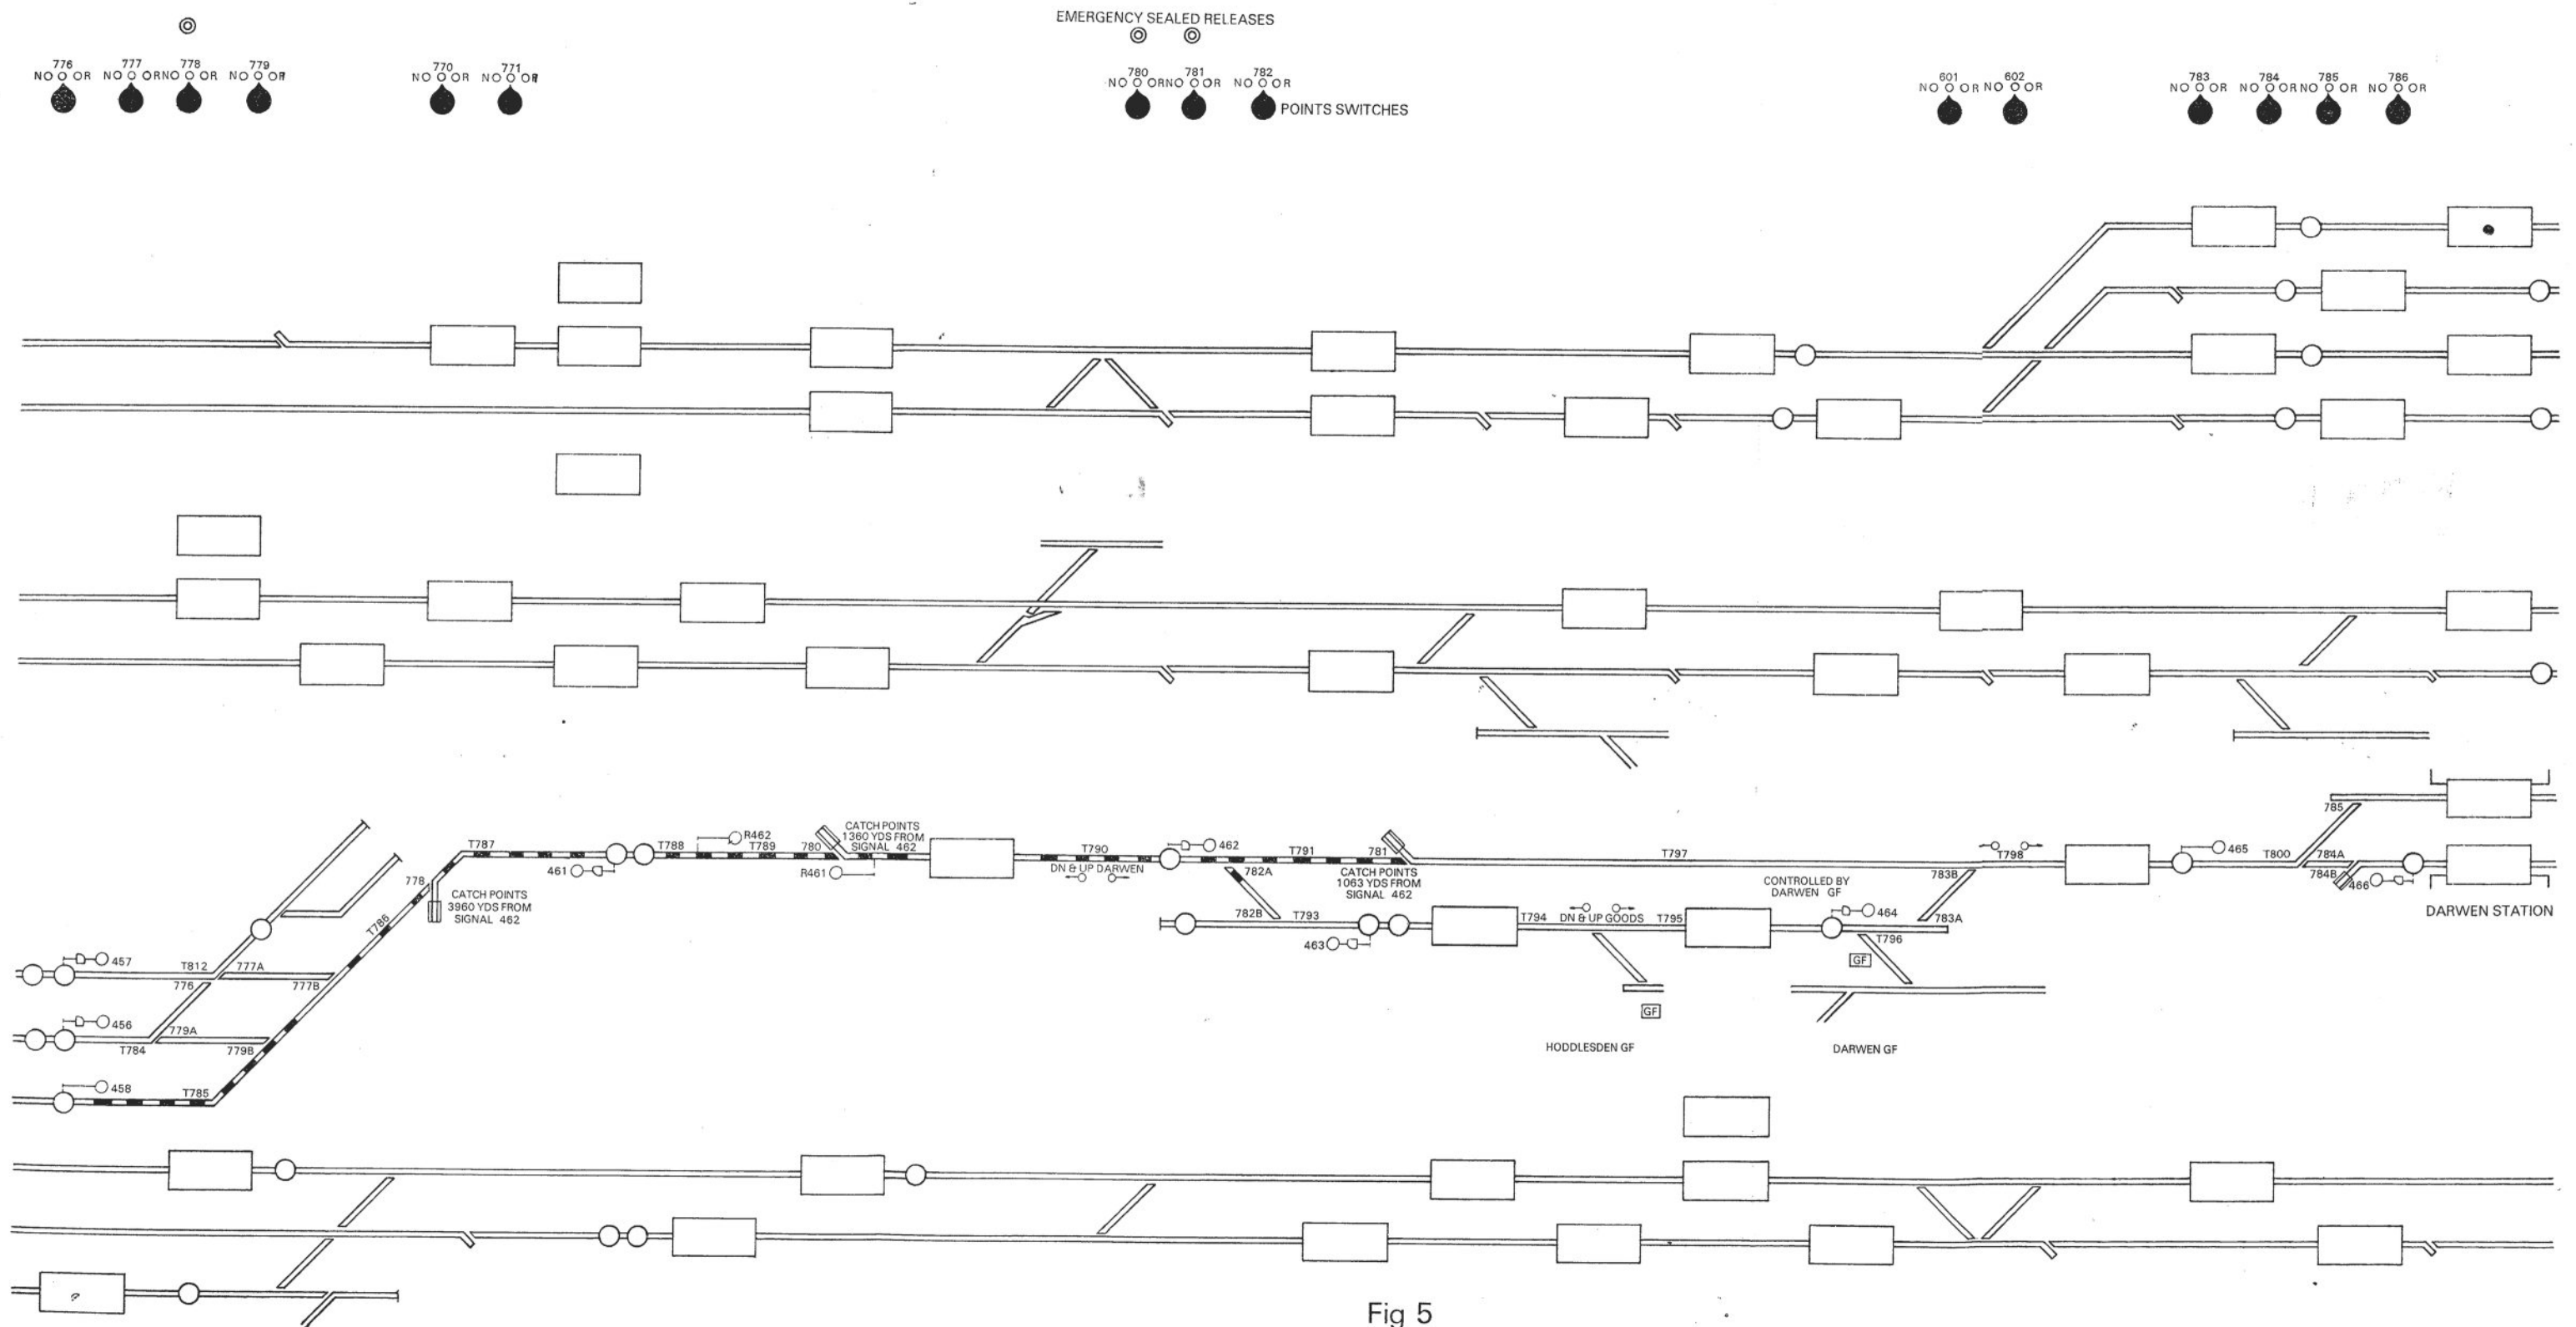
Fig 5

7. Individual or groups of track circuits are separately indicated on the panel using different colours and those on the Darwen line are coloured alternately green and brown. The minimum number of route setting lights in a track circuit is two although most have at least three. The track circuits on the Darwen line are shown in Fig. 5 and are indicated as follows:

TC 785	8 lights	green background
TC 786	3 lights	brown background
TC 787	5 lights	green background
TC 788	2 lights	brown background
TC 789	4 lights	green background
TC 790	6 lights	brown background
TC 791	8 lights	green background (one being on the goods loop exit)

Two of the lights of TC 789 are only lit when catch points 780 are set reverse.
