# RAILWAY ACCIDENT

## **Report on the Accident that occurred on 4th May 1971 at Tooting Broadway**

ON THE  
NORTHERN LINE  
LONDON TRANSPORT RAILWAYS

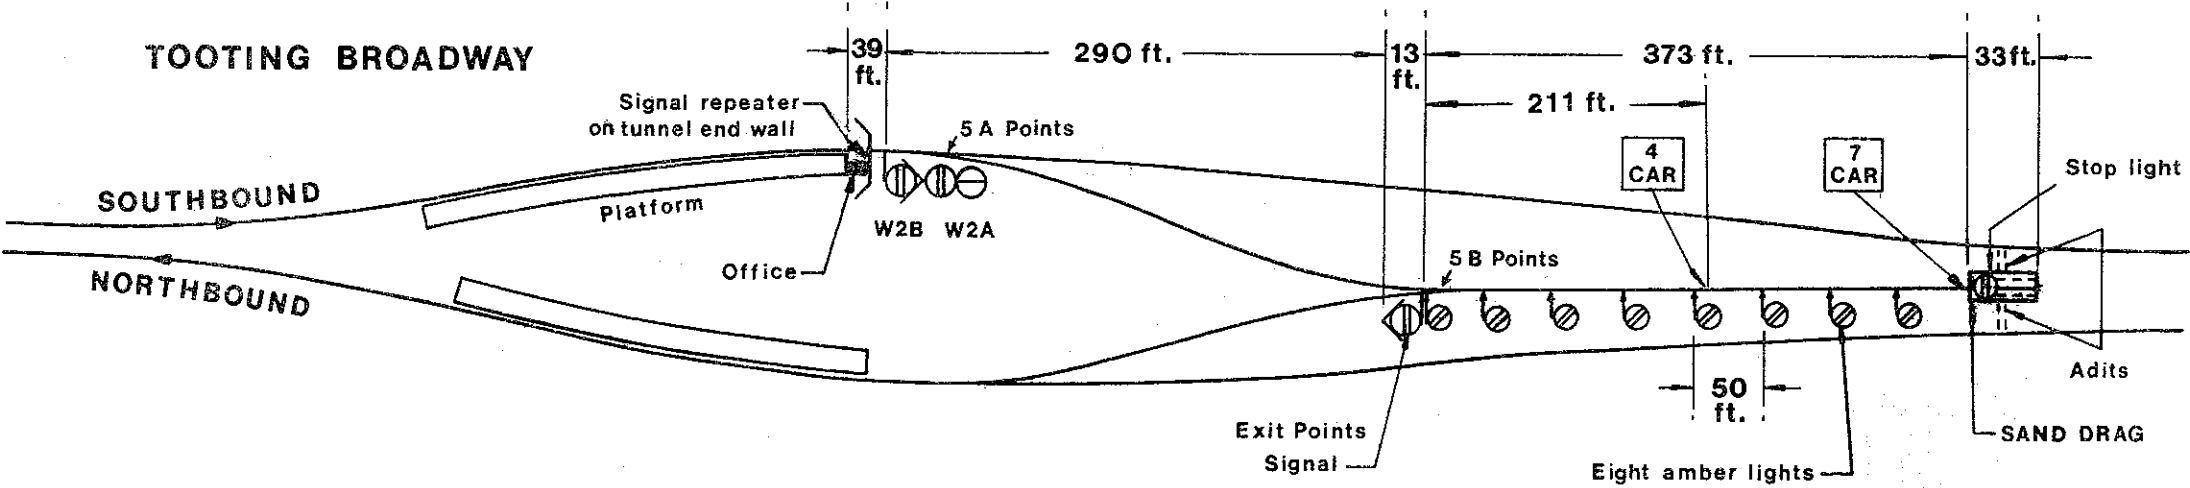
Fig 1.

1. Figure 1 opposite shows the scene of the accident. The entrance to the siding starts some 40 feet beyond the end of the southbound platform of Tooting Broadway Station. The entrance line to the siding curves right and then left at radii of 5 chains to the exit facing points some 330 feet from the platform end. The siding is almost straight and level thereafter to the start of a sand drag some 380 feet clear of the trailing points. The sand drag is 33 feet long and terminates in the concrete end wall of the tunnel. Mansized cross-adits connect the siding to the running line tunnels on either side halfway along the sand drag. The end wall of the siding tunnel is of concrete.

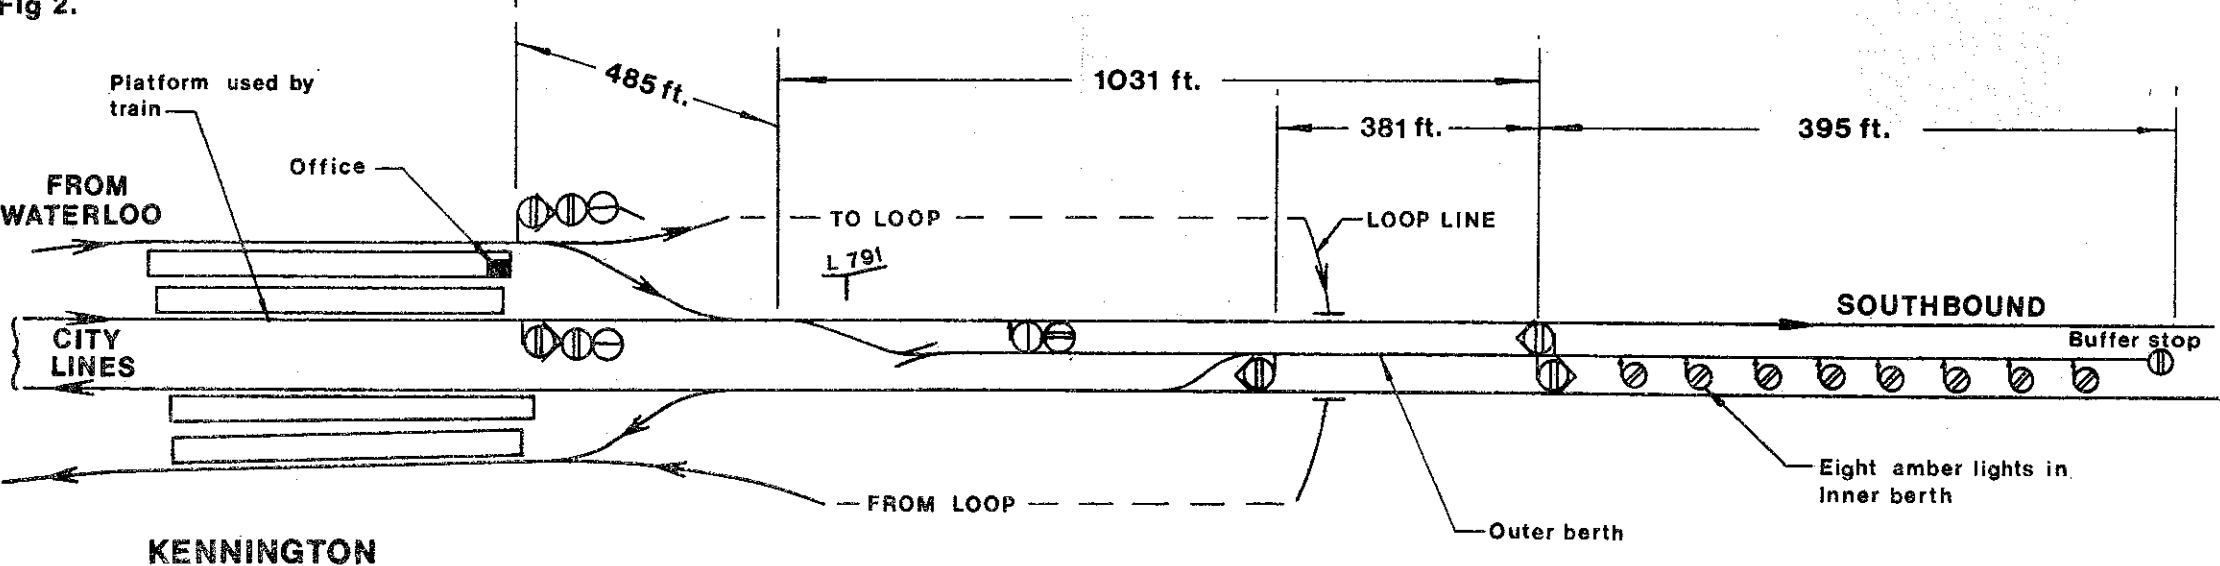
Fig 2.

4. There are only two other reversing sidings in tunnels on the Northern line. One is at Archway on the High Barnet section where the tunnel length is 468 feet (compared with 373 feet at Tooting Broadway) and the other is at Kennington, 8 stations north of Tooting Broadway, where the Charing Cross and City branches connect. The reversing siding tunnel there is 1,428 feet in length, and there is a subsidiary signal and trip cock at its mid-point to enable two trains to be stabled in the siding together, as is shown in figure 2.

SHOWING ENTRANCES TO, & LENGTHS OF, DOUBLE SIDING
