RAILWAY ACCIDENT

Report on the Collision that occurred on 27th November 1973 near Whitehaven

IN THE
LONDON MIDLAND REGION
BRITISH RAILWAYS

COLLISION AT WHITEHAVEN (BRANSTY) - L.M. REGION ON 27th NOVEMBER 1973.

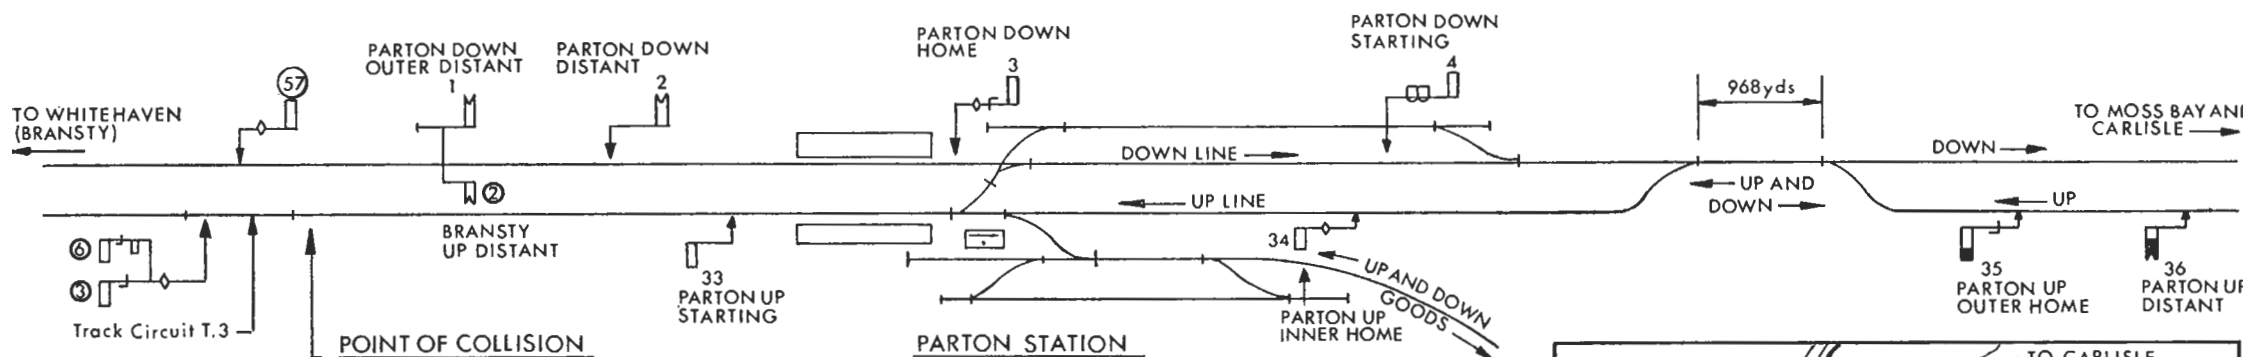
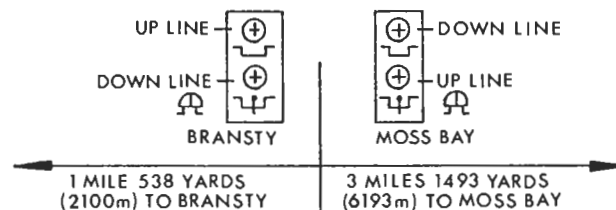
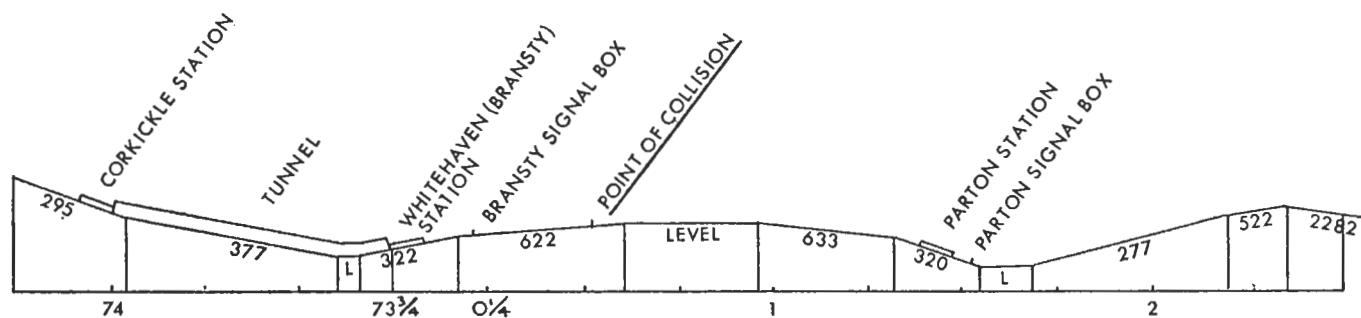
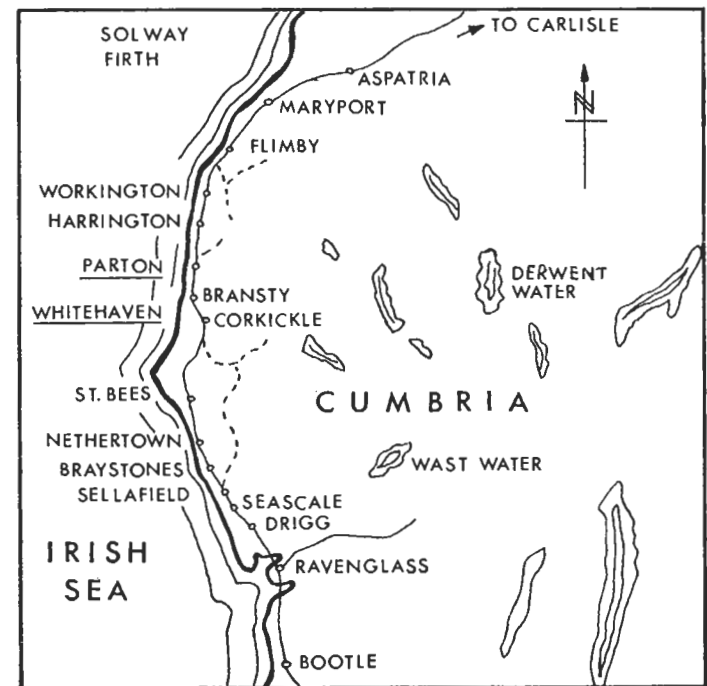
DIAGRAMS SHOWING LOCATION, SIGNALLING, AND GRADIENTS - NOT TO SCALE

4. A diagram showing the important features of the line, including the signalling, is at the front of the report.
