DEPARTMENT OF TRANSPORT

### **RAILWAY ACCIDENT**

## Report on the Collision that occurred on 31st May 1985 at Battersea Park Station

IN THE SOUTHERN REGION OF BRITISH RAILWAYS

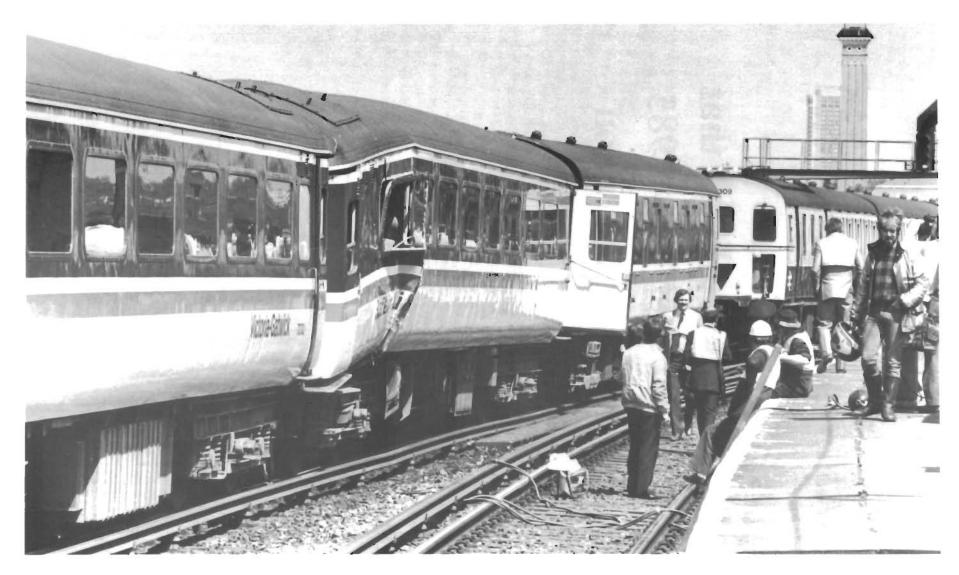
#### The scene after the accident, looking towards Victoria

The front of the Gatwick Express is in the foreground and the rear of the DEMU in the background. Signal VC552 is just visible at the extreme right.

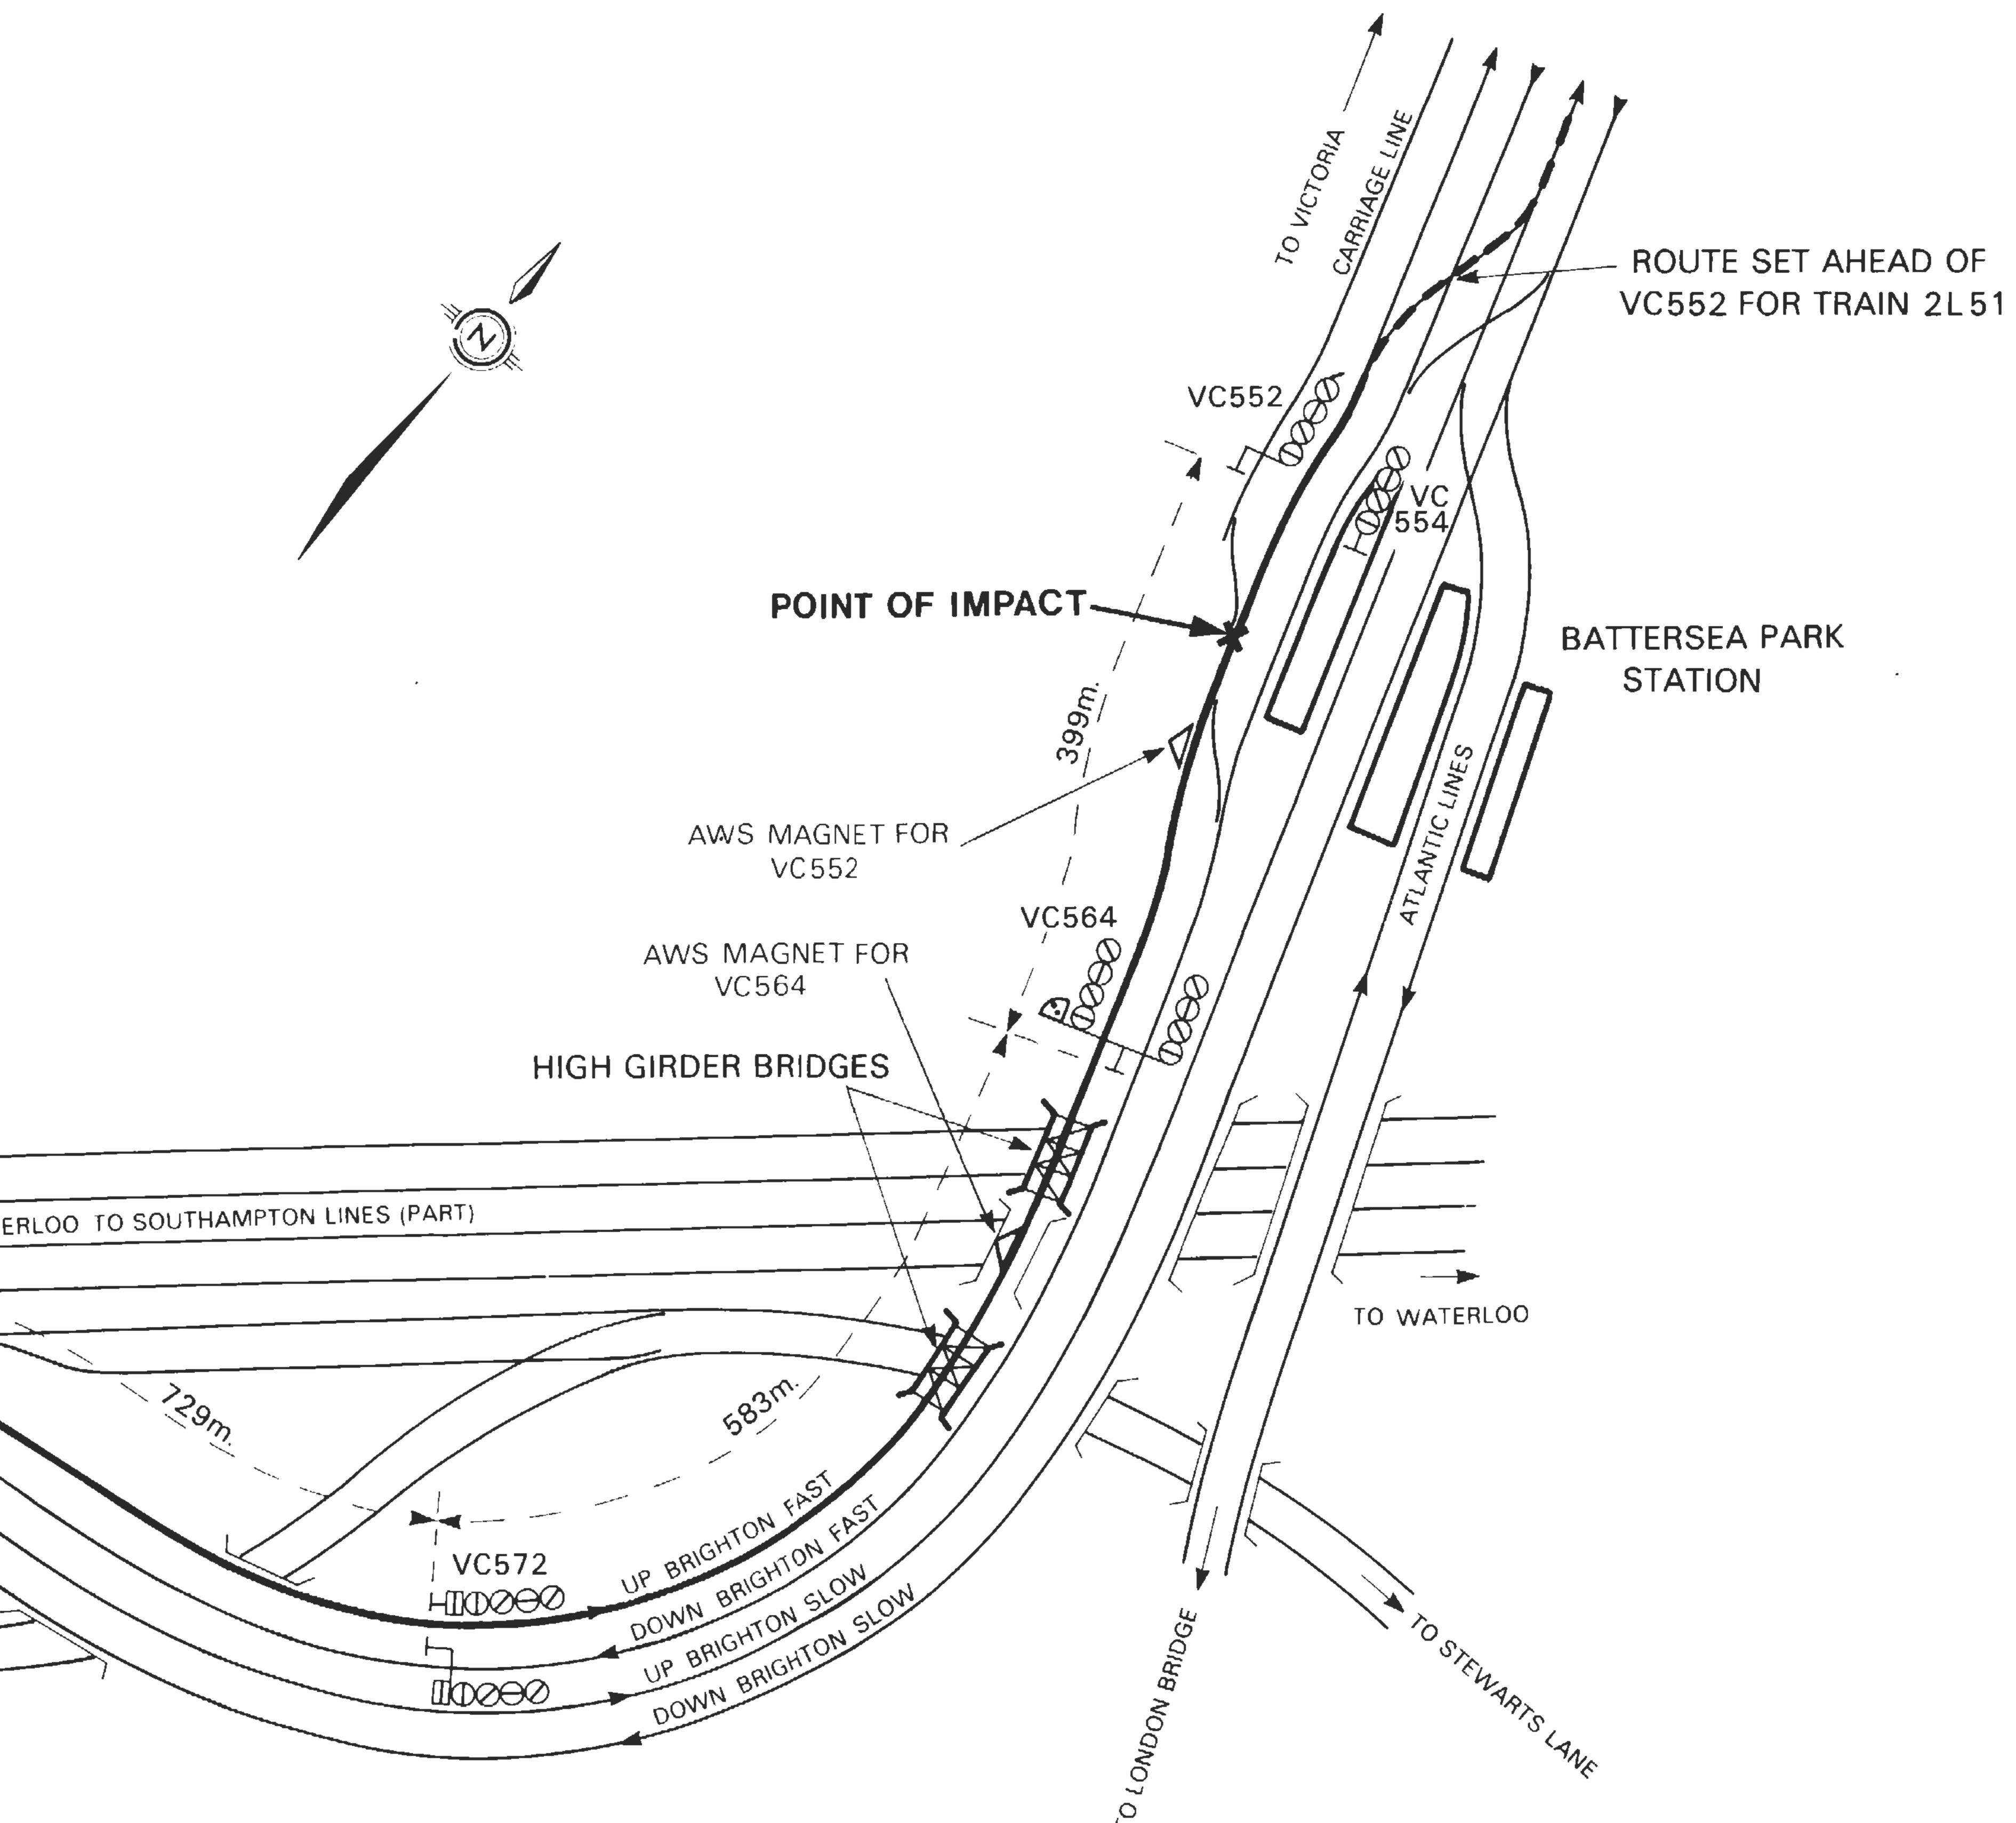
The Permanent Under-Secretary of State Department of Transport Simplified Sketch of Track Layout and Signals from Clapham Junction to Battersea Park Station

2. The signalling is controlled from Victoria Signalling Centre (which is actually located at Clapham Junction) using the Track-Circuit Block system. All running line signals are of the four-aspect colour-light type and are equipped with British Railways Automatic Warning System (AWS). AWS is an aid to drivers which, by means of magnets in the track on the approach side of a signal, causes a horn to sound in the cab if the signal is displaying a Caution or Stop aspect and applies the brakes after 2-3 seconds. The driver can stop the horn and prevent the brake application by pressing a cancelling button, which causes an otherwise all-black indicator in the cab to show a black-and-yellow 'sunflower' pattern. On approaching a clear signal a bell sounds briefly and no action is required of the driver. Below is a list of the most important signals with topographical notes on the journey on the Up Fast line from Clapham Junction which, at 2½ miles from Victoria Station, is the station before Battersea Park en route to the London terminus. The signals described are shown on a diagram of the route at the back of this report.

- VC594 Stands at driver's eye level on a single post at the London end of the Up Fast line platform at Clapham Junction station. The line ahead curves slightly to the right, but distantly visible is -
- VC584 which together with a corresponding Up Slow line signal is on a long cantilever bracket from the right-hand cess. This signal, situated over straight track, has a left-hand lunar-light junction indicator for Pouparts Junction, at which point the main lines commence a long reverse curve, right-handed initially and then left-handed. The line rises at 1 in 120 from Pouparts Junction in

order to gain height to fly over the lines to Waterloo Station, which the Brighton to Victoria lines parallel between Clapham Junction and Pouparts Junction. First visible from the right-hand curve, but actually situated on the left-hand curve, is -

- VC572 which is mounted on a single post to the left, with a right-hand-bracketed Up Slow line signal beside it. Still curving left and rising, the high bowcd girders of two parts of the flyover come into sight, and soon after passing VC572 there becomes visible beyond the flyover a Tee-shaped bracket bearing at its left-hand end -

- VC564 At the right-hand end of the same structure is an Up Slow line signal, which is visible moments before VC564, but only for such a short time at long range as to be insignificant. Because of the line curvature, the structures of the two bowed-girder bridges each briefly interrupt the view of VC564, before the line straightens over the second bridge, when the signal is clearly and continuously visible above the track to which it applies. At the permitted line speed of 45 mile/h, signal VC564 first comes into view at about 22 seconds running time away, and its sighting is twice interrupted for 1 to 1.5 seconds, before it comes into full view above the track for about 11 seconds before passing under it. The AWS inductor for VC564 is located in the interval between the two bowed bridge girders, but the signal is in full view before the AWS bell or horn sounds in the driving cab. The bridges are at the summit of the rising gradient; from them the lines fall at 1 in 120 to Battersea Park Station. After passing VC564 the line curves left again, and a building on the left initially obscures the view forward to the next signal.

- VC552 comes into view about 5 seconds after passing VC564; because of the curvature and obstructions on the left, the signal head becomes visible first, and the track leading up to it shortly afterwards. This signal is mounted above the track on a bracket from the left, and the corresponding Slow line signal VC554 is on a post at the end of Battersea Park Up Slow line platform. VC552, in addition to the main aspects, has a lunar light junction indicator to the right, which, when illuminated, indicates a route via the crossover ahead onto the Up Slow line. After VC552 comes into view the left hand curve eases and then reverses to become a very slight right hand curve past Battersea Park Station but the curvature is so slight as to provide a virtually straight line view along the track approaching VC552.
