DEPARTMENT OF TRANSPORT

RAILWAY ACCIDENT

Report of the Inquiry into the Collision at Bellgrove Junction on 6 March 1989

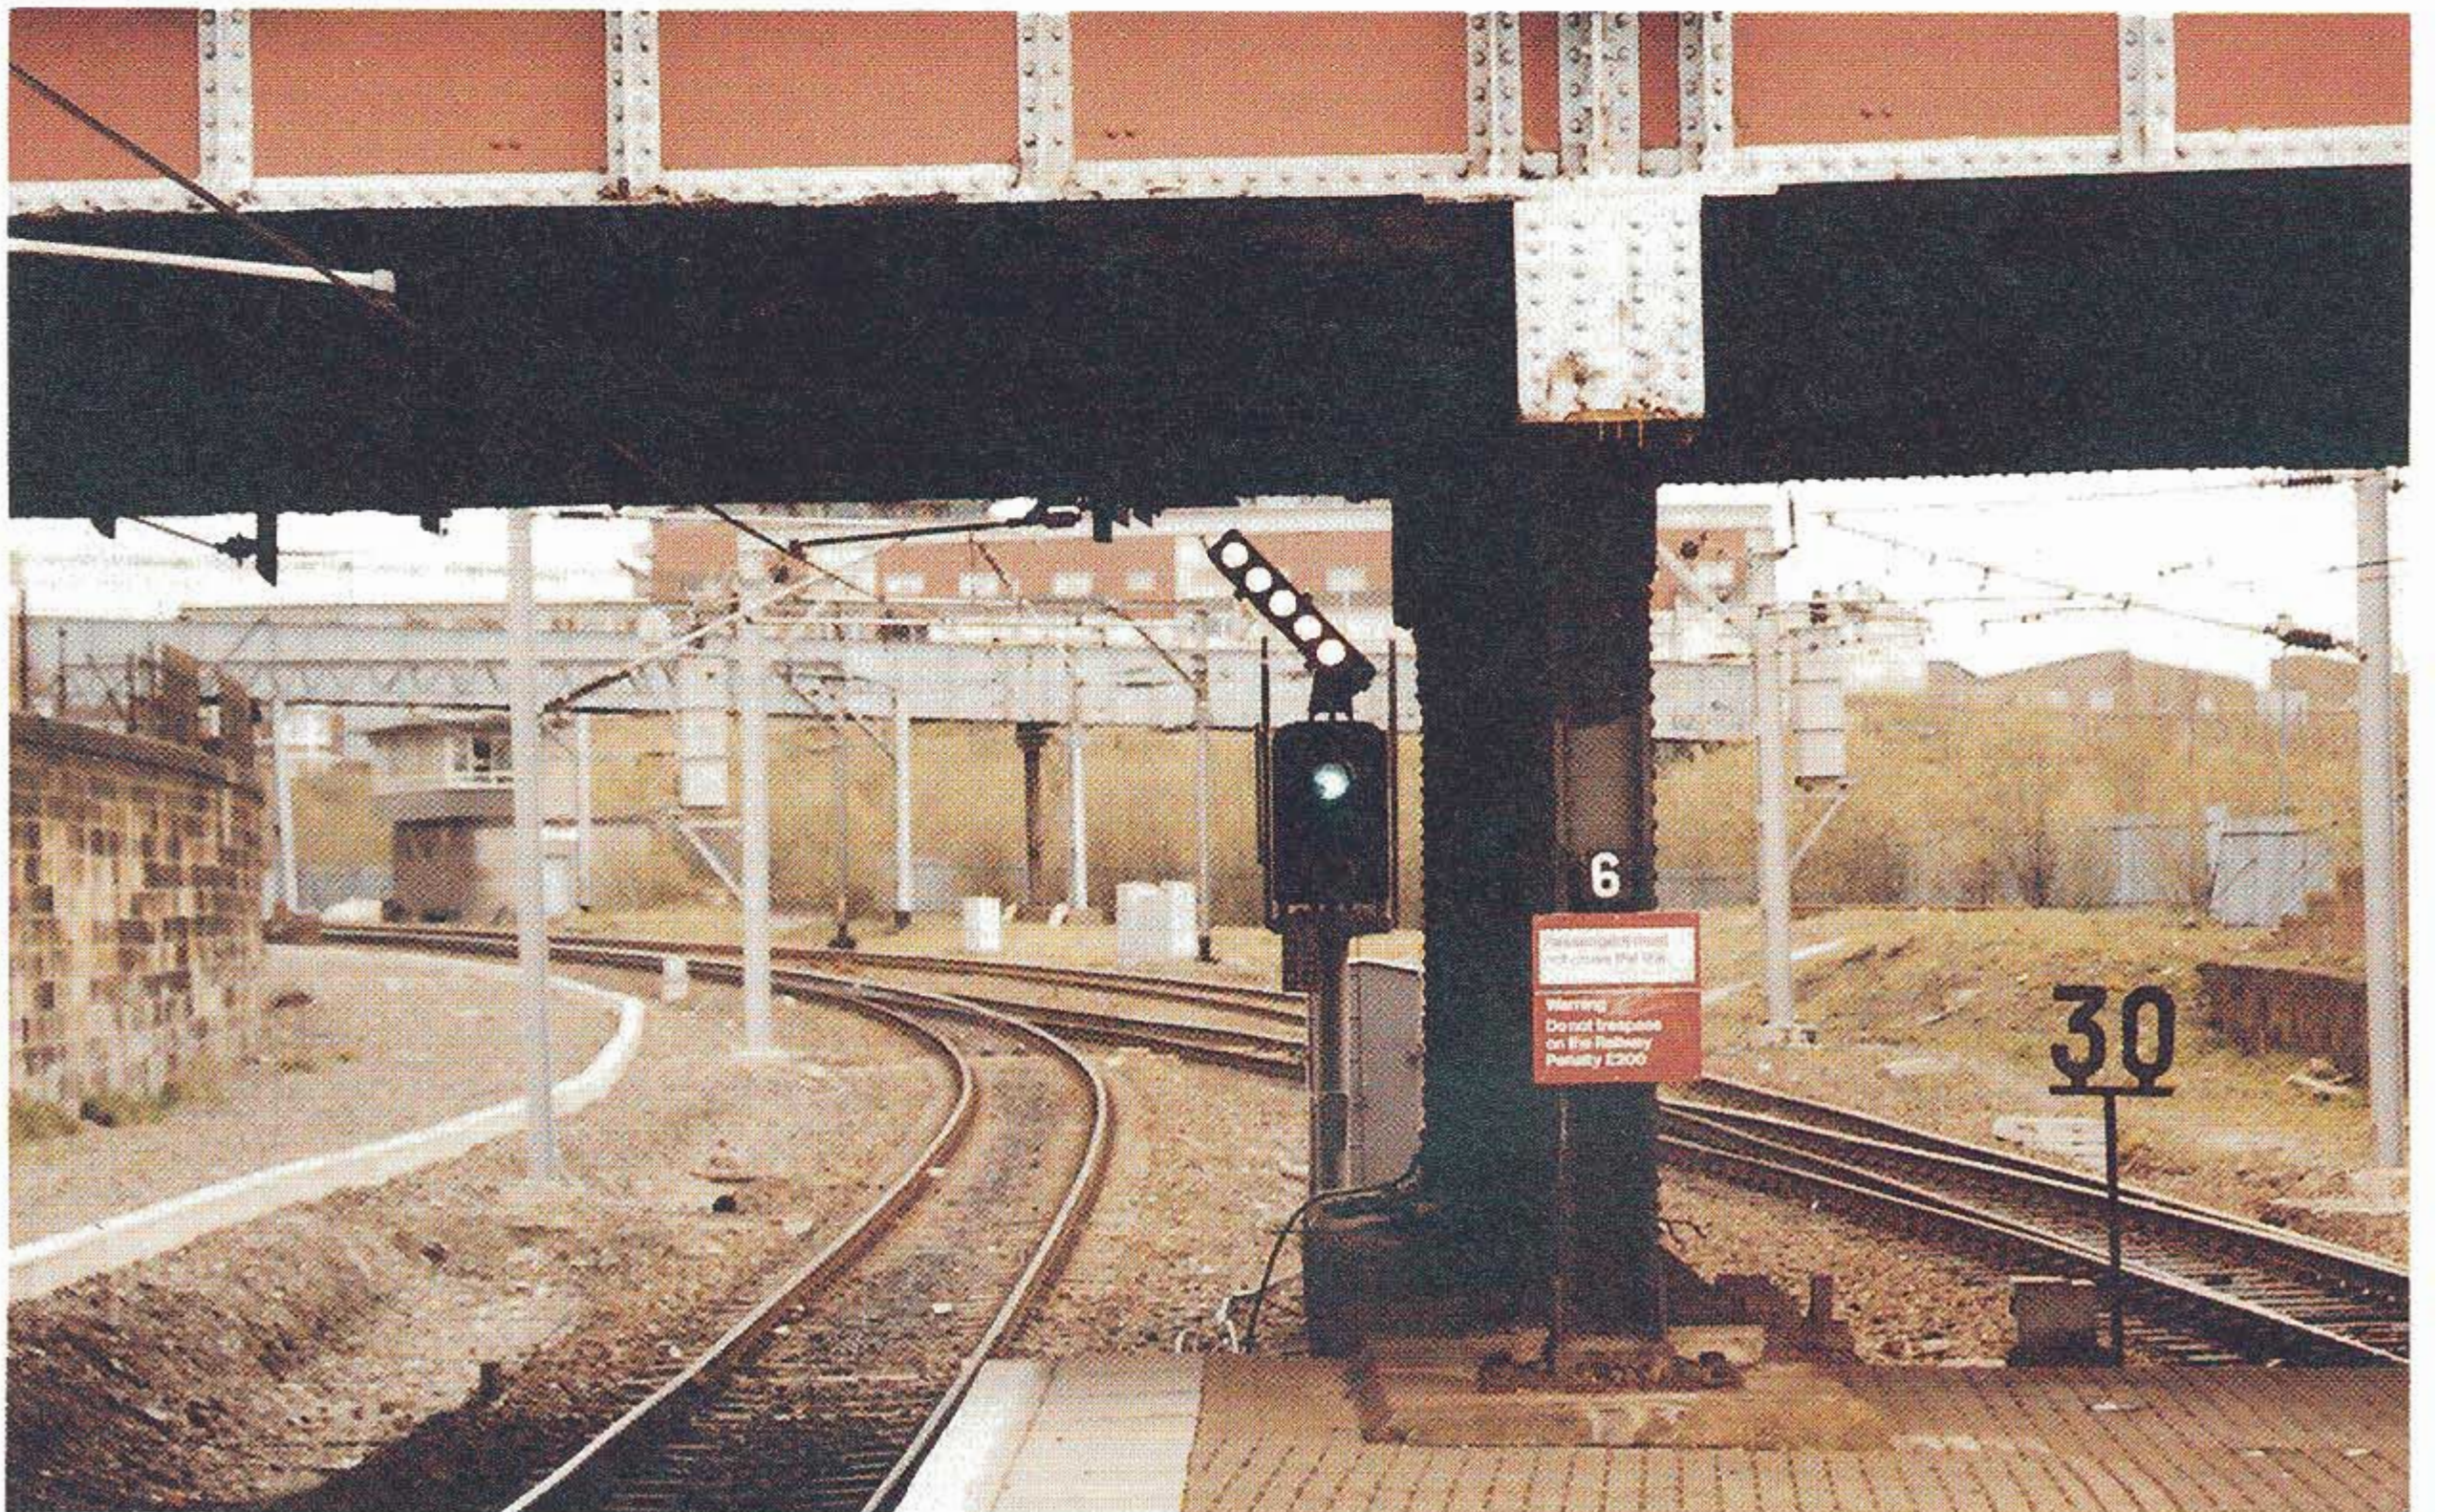
20. *BL86* is the platform starting signal at Bellgrove Station: a 3-aspect signal with a route indicator consisting of a diagonal row of 5 white lights mounted above the main signal. (Photographs B and C illustrate this signal – it will be noted that it is situated on the righthand side of the track instead of in the customary lefthand side position.)

left. Photograph B shows that the signal is very conspicuous, and there was no evidence at our Inquiry to suggest that Driver McCafferty had any difficulty in observing it. Nevertheless we consider that the possibility of confusion should be reduced to a minimum by locating all lineside signals on the lefthand side unless the local conditions render this impracticable.

We recommend that BL86 Signal should be moved to the lefthand side of the Up line, the normal position for a lineside signal. Consideration should also be given to providing a repeater signal or "off" indicator on the platform where it can easily be seen by a guard from his position on the train.

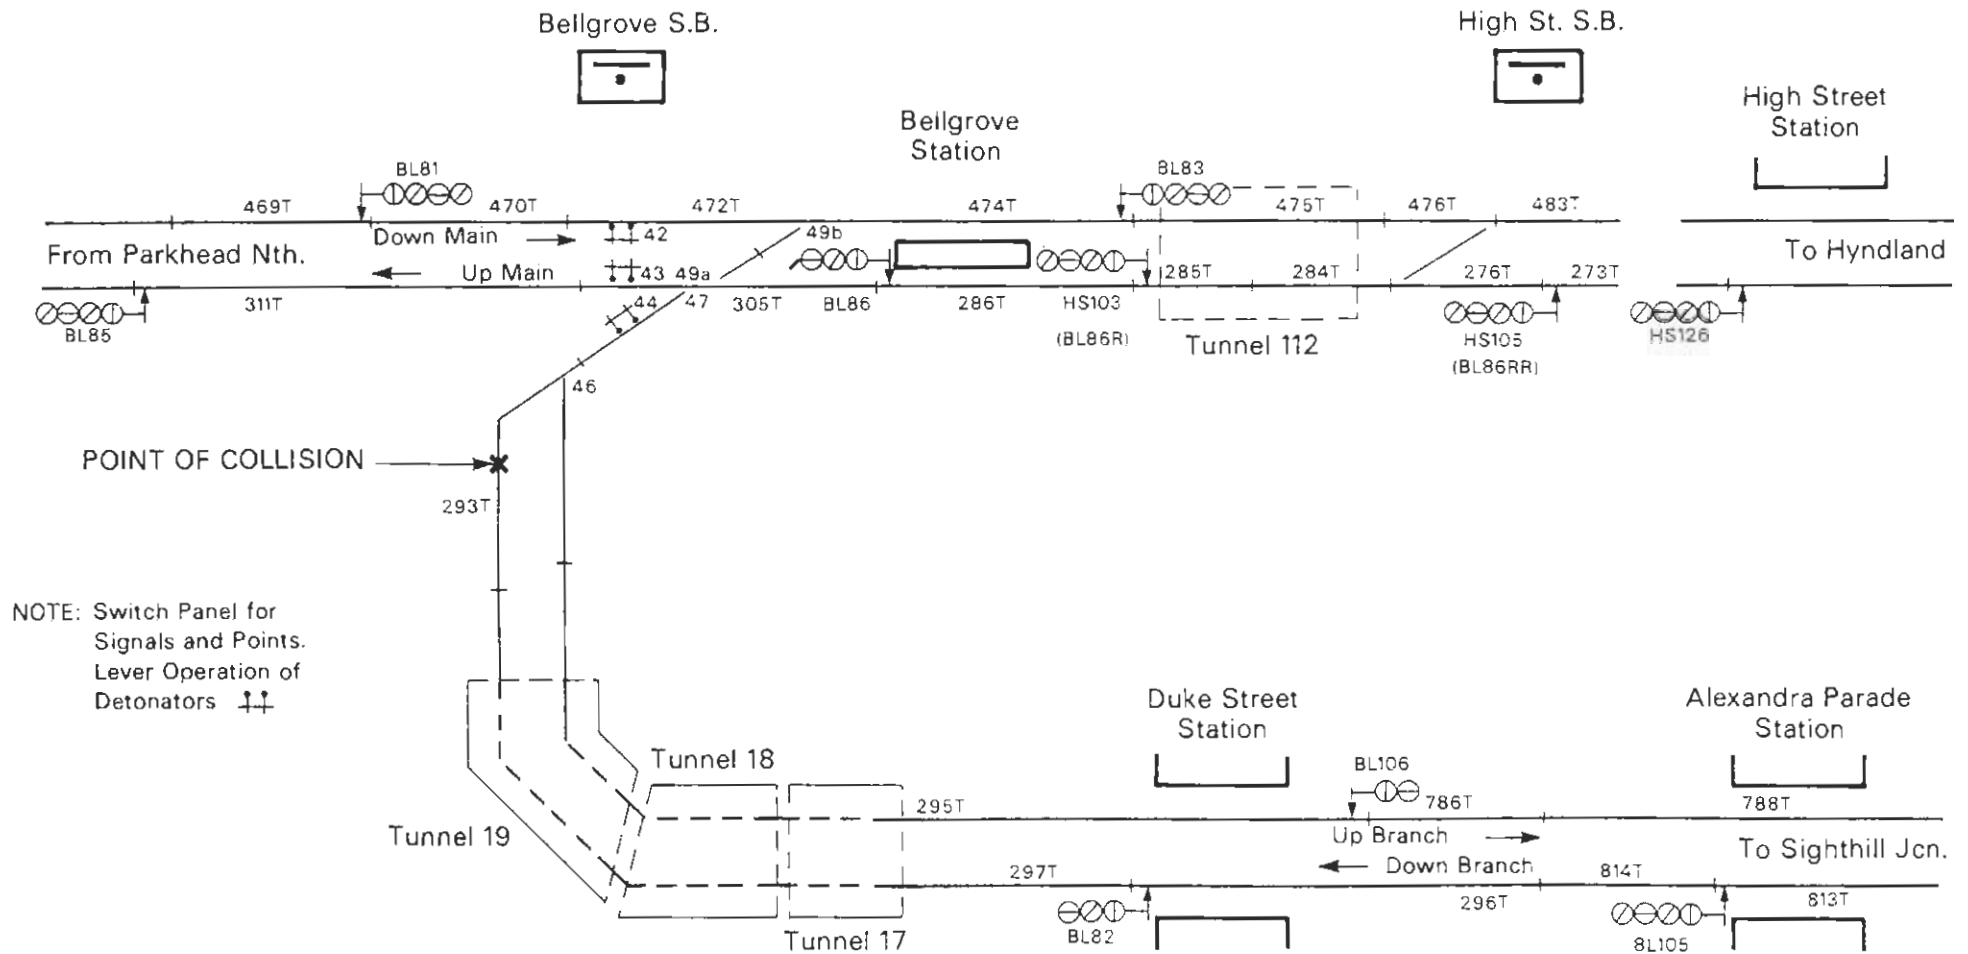
DIAGRAM 1

18. *Mr Mackie and Mr Nelson* jointly explained the operation of individual signals in the vicinity of the accident: their locations, and the points and track circuits (TC) referred to by number in this report, are illustrated in the accident plan at Diagram 1.

BELLGROVE ACCIDENT PLAN

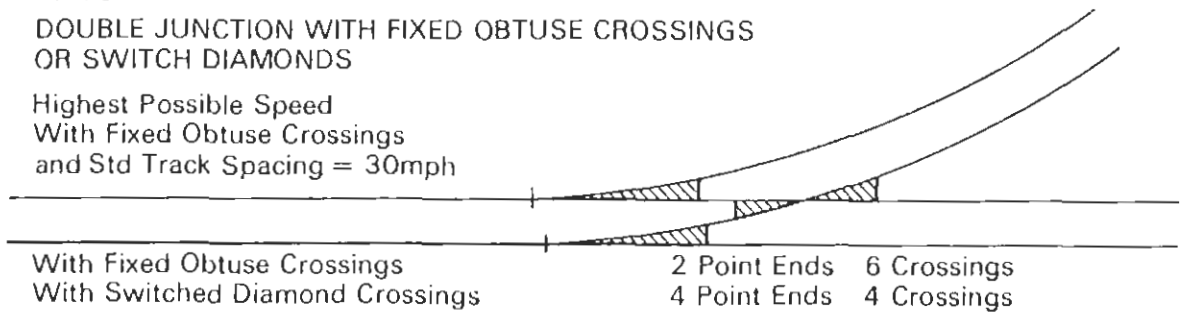
"TYPE 1"

DOUBLE JUNCTION WITH FIXED OBTUSE CROSSINGS
OR SWITCH DIAMONDS

Highest Possible Speed
With Fixed Obtuse Crossings
and Std Track Spacing = 30mph

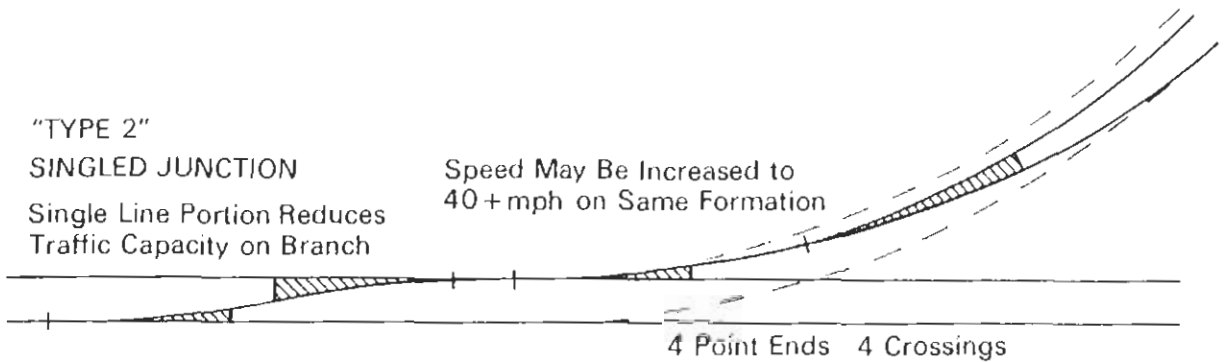
"TYPE 2"

SINGLED JUNCTION

Single Line Portion Reduces
Traffic Capacity on Branch

Speed May Be Increased to
40+ mph on Same Formation

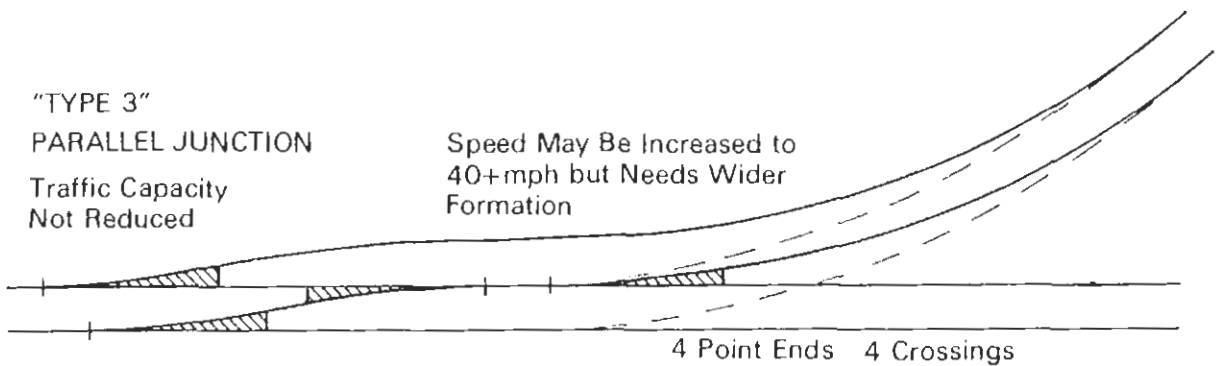
"TYPE 3"

PARALLEL JUNCTION

Traffic Capacity
Not Reduced

Speed May Be Increased to
40+ mph but Needs Wider
Formation

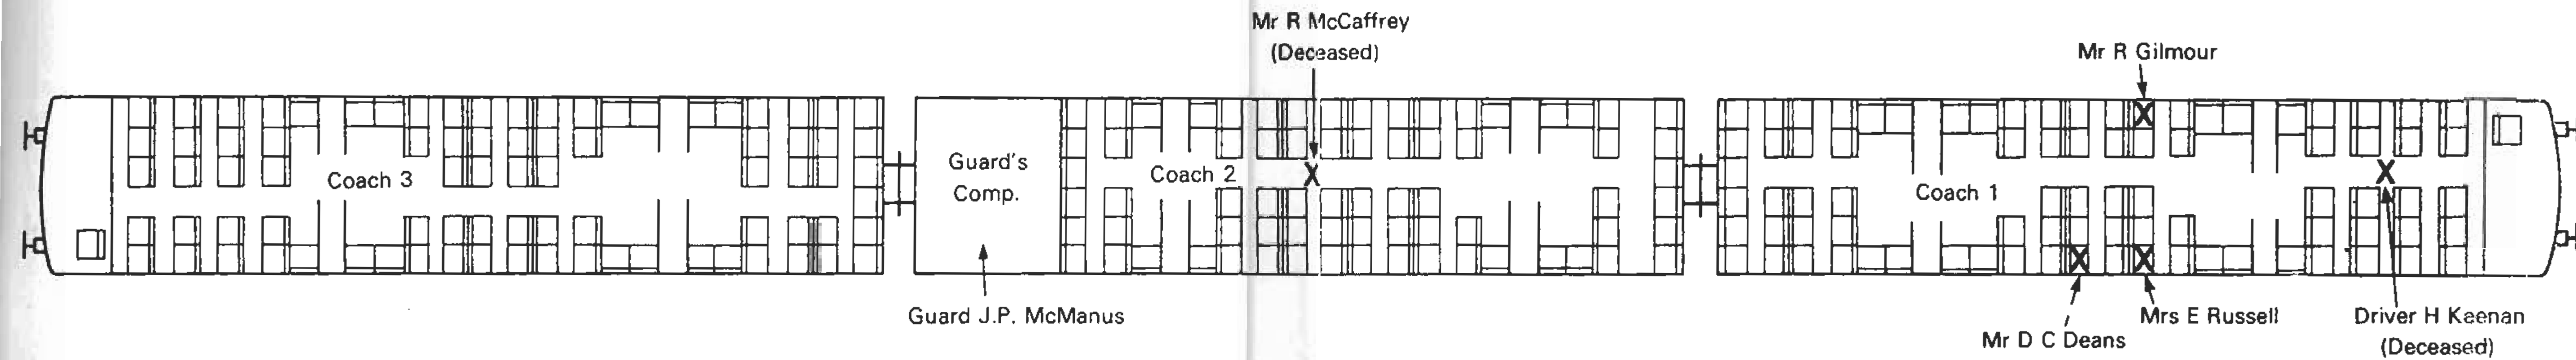
2A01 SPRINGBURN TO MILNGAVIE (DOWN)

9. Each train was made up in a similar way, consisting of a Driving Trailer in the lead, followed by a Motor Open Brake carriage, with a Driving Trailer in the rear. When the two trains collided the leading vehicle of the Up train overrode the headstock and underframe of the Down train's leading vehicle, crushing the driving cab and compressing it back into the front passenger saloon. Photograph A illustrates the scene, with the Up train in the foreground. The leading vehicle in each train was severely damaged in the collision and had to be "written off". The two Motor Open Brake carriages sustained damage to their body frame and door assemblies. The two rear vehicles were undamaged.
