DEPARTMENT OF TRANSPORT

RAILWAY ACCIDENT

Report on the Collision that occurred on 11th November 1976 at Melton Lane near Ferriby

IN THE
EASTERN REGION
BRITISH RAILWAYS

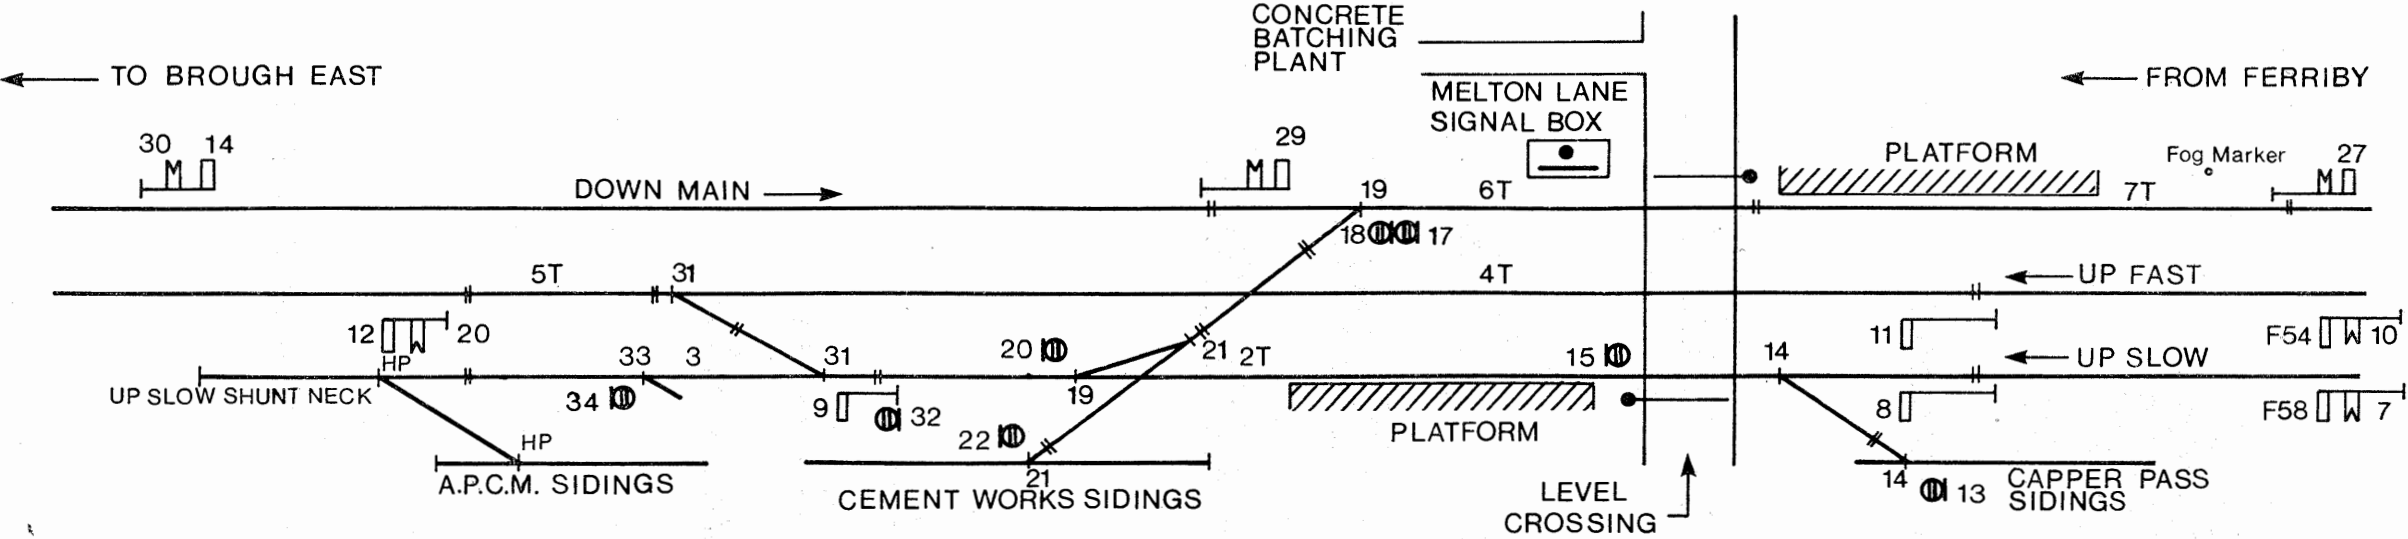
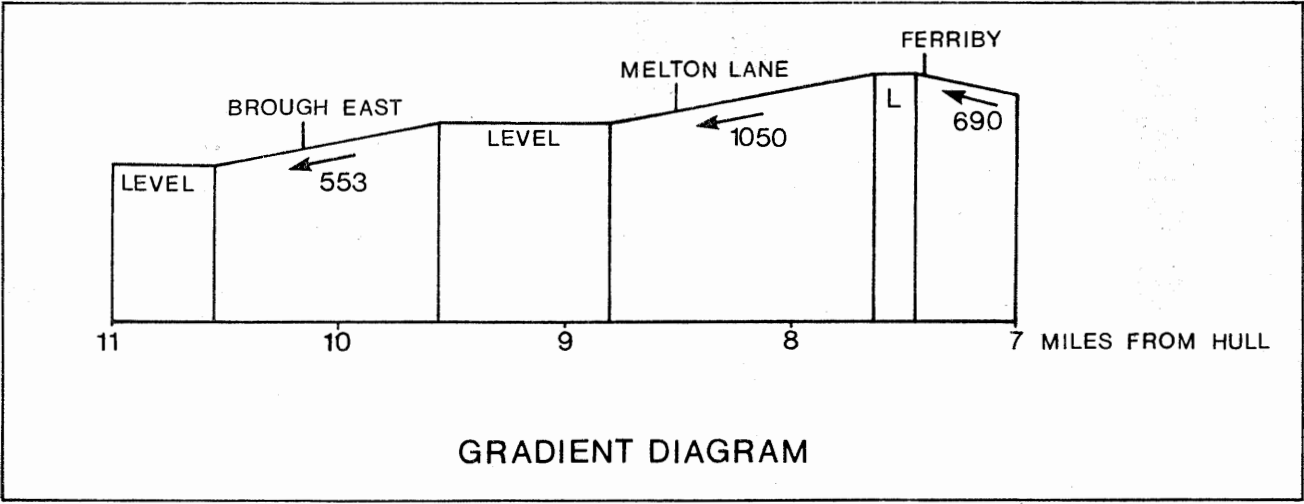
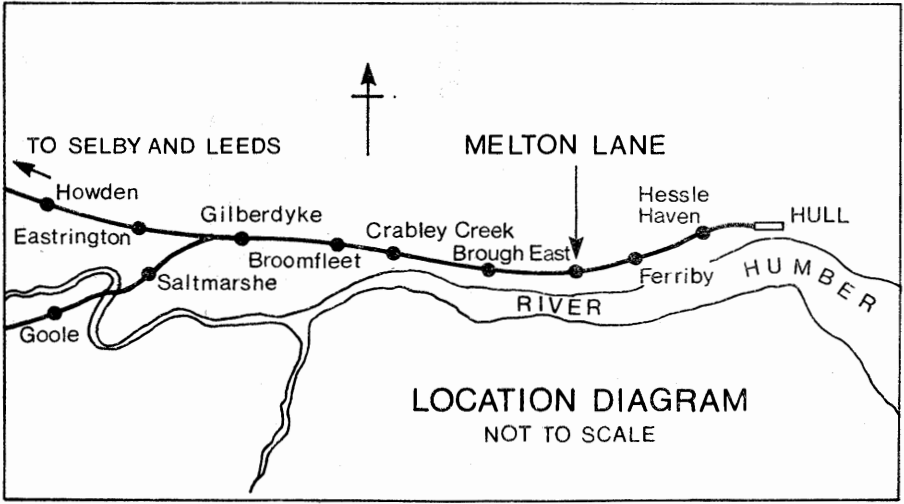
PLAN SHOWING POINTS AND SIGNALS - NOT TO SCALE

3. Melton Lane Signal Box is a 31 lever mechanical-frame box. The Absolute Block Regulations apply on all lines, signalling of trains being by upper quadrant semaphore signals situated on the left of the line to which they apply. The box has an illuminated diagram showing occupation of track circuits. Details of the track circuits, together with other features of the layout and signalling, are shown on the Diagram at the front of the report: it will be noted that, at the time of the accident, there was no track circuit in rear of Signal No. 8, the Up Slow Home signal.

48. At Melton Lane the grounds for uncertainty would not have existed had there been a track circuit in rear of Signal No. 8. At the time of the accident, of the seven mechanical signal boxes between Hull and Goole those at Ferriby, Broomfleet, Gilberdyke, and Saltmarshe were provided with berth track circuits in

rear of all their Home signals; none of the Home signals was so equipped at Melton Lane or Crabley Creek; and at Brough East the Down Main Home signal had a berth track circuit but the Up Main Home signal had not. This somewhat illogical situation resulted from piecemeal improvement to the signalling that had taken place over many years and it typifies the situation that can arise when mechanical signalling has to be retained on an important line and where investment restraint precludes its comprehensive upgrading. I understand that the Railways Board plan to install modern colour-light signalling on the Hull to Selby line but that this is unlikely to be done within the next eight to ten years. This being the case I recommend that berth track circuits be provided at the Home Signals at Melton Lane, Brough East, and Crabley Creek where none are at present provided.
