RAILWAY ACCIDENT

Report on the Collision that occurred on 24th March 1987 at Frome

IN THE
WESTERN REGION
OF BRITISH RAILWAYS

COLLISION AT FROME ON 24th MARCH 1987

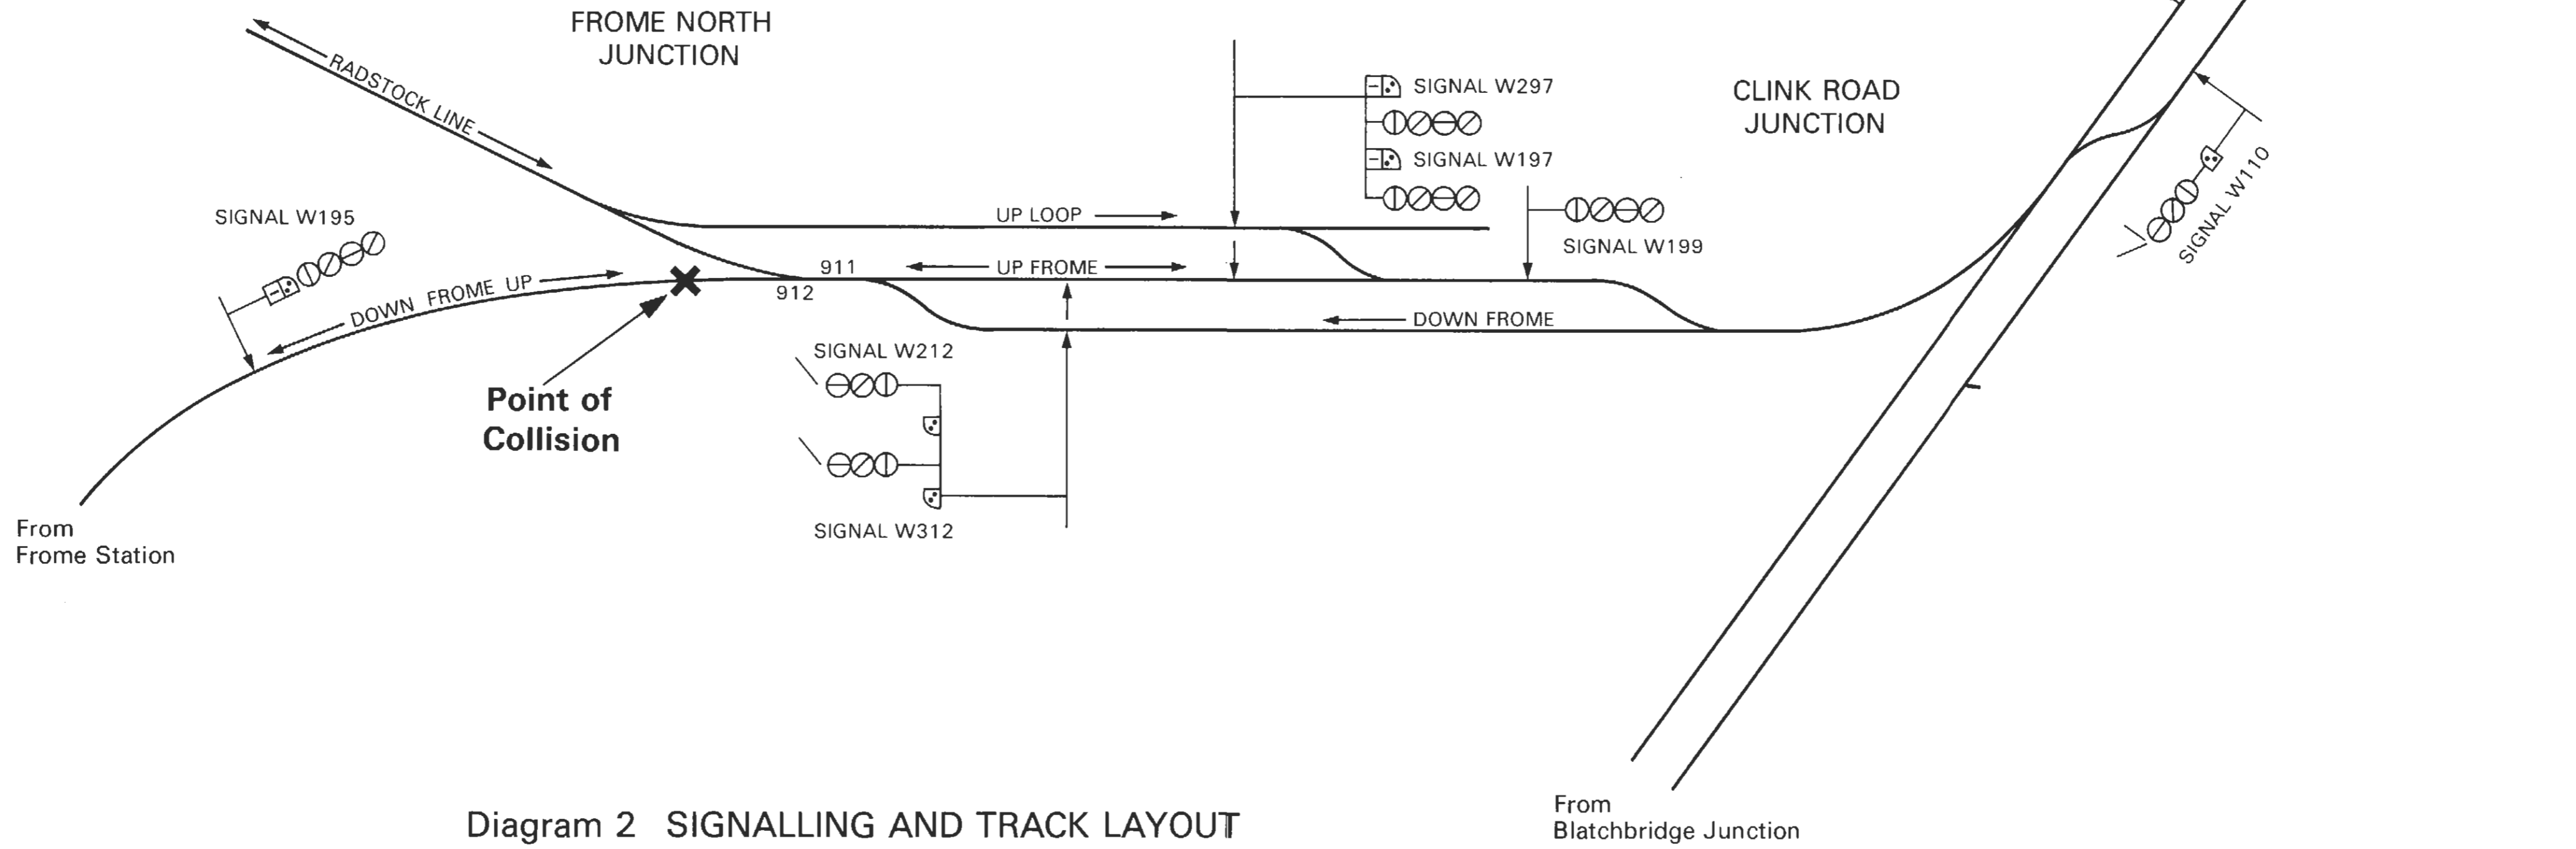
2. The Frome area is controlled from Westbury Signal Box and is operated in accordance with the Track Circuit Block Regulations. The signalling was commissioned on the 8 October 1984 and the signals, which are equipped with the Automatic Warning System (A.W.S.), are multiple-aspect colour lights. The interlocking is achieved by electrical relays and there is a remote relay room at Frome. The track and signalling layout is shown on Diagram 2.

3. On the Down Westbury line on the approach to Clink Road Junction is Signal W110. With the route set to either the Down Frome line or the Up Frome line the signal is 'Approach Controlled' and when the signal clears it displays the appropriate junction indicator. Signal W312 on the Down Frome line signals trains onto either the Down and Up Frome line or the Radstock Branch. For a move onto the Down and Up Frome line a main aspect is displayed. For a move onto the Radstock Branch a main aspect with the junction indicator is displayed and is 'Approach Released'. There is a subsidiary route to the Radstock Branch with the red main aspect maintained and a position light and junction indicator displayed. A more restrictive 'Approach Release' applies to this subsidiary route.
