DEPARTMENT OF TRANSPORT

RAILWAY ACCIDENT

Report on the Derailment
that occurred on
11th September 1978
at Greenhill Lower Junction

IN THE
SCOTTISH REGION
BRITISH RAILWAYS

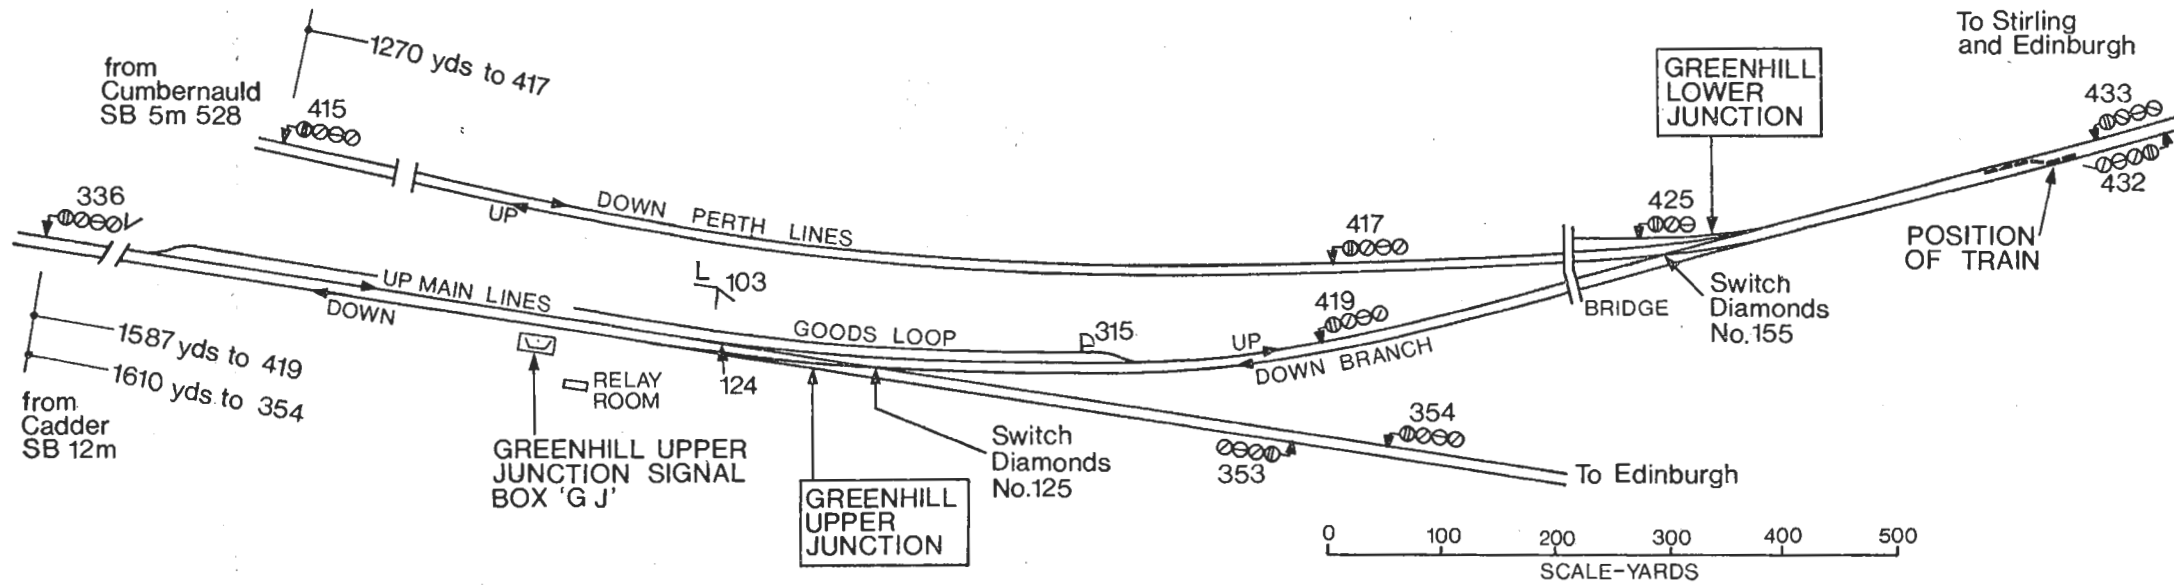
GREENHILL JUNCTIONS Fig 1.

1. Greenhill Upper Junction lies some 18 miles from Glasgow and 28 miles from Edinburgh on the Main Lines. The Perth lines via Cumbernauld to the south, pass under the Main lines west of the Junction and then run almost parallel to them, before turning away to the north via Larbert. At Greenhill, branch lines some 1000 yards in length, connect the Main lines at Greenhill Upper Junction to the Perth lines at Greenhill Lower Junction, as shown in figure 1 at the front of this report. A connection from the Perth lines via Falkirk Grahamston rejoins the Main lines by Polmont, and a proportion of Glasgow to Edinburgh trains take this route; the train involved in this accident was the first train in the day to do so.

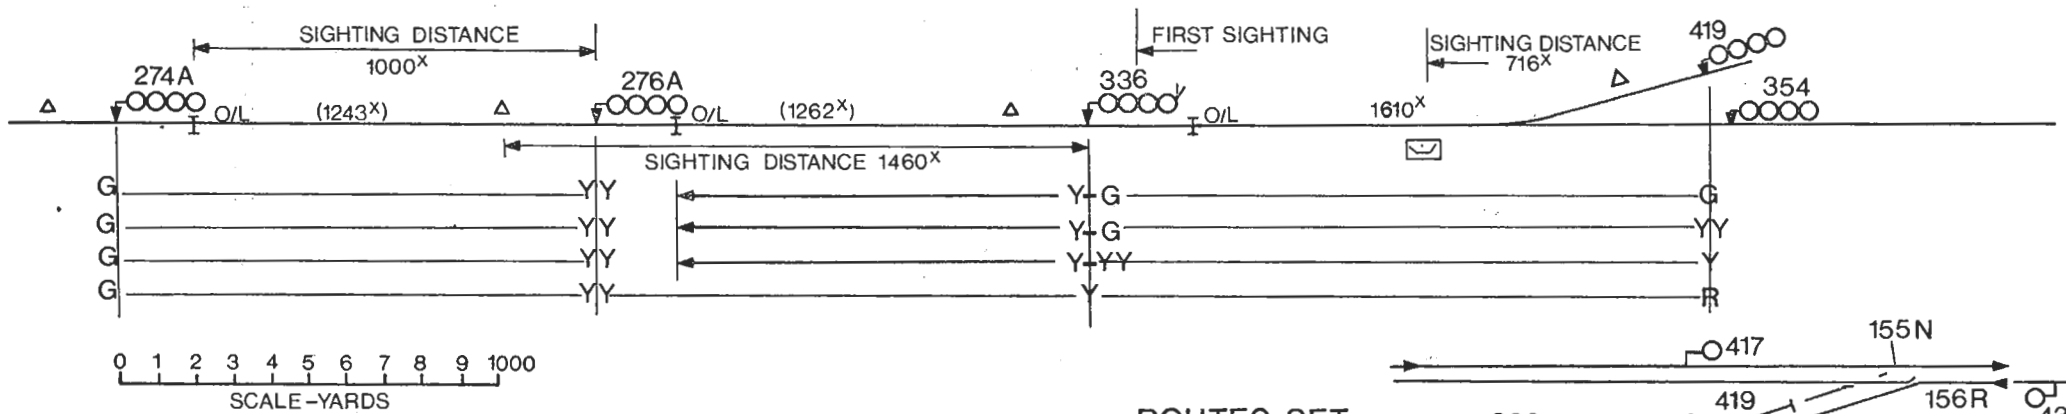
APPROACH SIGNALLING Fig 2.

5. The signalling approaching Greenhill Upper Junction in the Up direction is illustrated in figure 2 which shows signal spacings and the aspects displayed when a route is set onto the Branch line. In accordance with the standard British Railways practice for a high-speed junction, the junction signal GJ336 is held at a single yellow aspect with a 'position 1' route indication for the branch until, if GJ419 on the Up Branch line is *NOT* at Danger, GJ336 is released to a YY or G aspect when a train occupies track circuit 322T at a point 1062 yards before the signal. At this point, the signal has already been in view for a distance of some 400 yards.

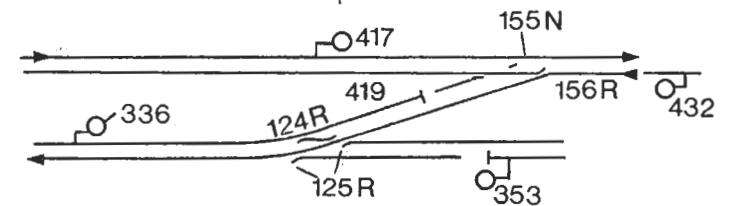
ROUTES SET Fig 3.

13. On hearing that 1S15 was passing Gartsherrie he had decided to pass that train first because it was a higher class of train and was already running about half an hour late. He therefore set the route for it along the Down Perth line and he set the route for 2G20 up to Signal GJ419 on the Up Branch line so that the Main line would be clear for traffic to pass behind it. He noted that Signal GJ419 was indicated on the signal box diagram as being at Danger. He had not set any route beyond the junction on the Main line and Signal GJ354 remained at Danger also. There were no flashing lights on the panel and he therefore assumed that points No. 155 at Greenhill Lower Junction were correctly set Normal for the Perth lines.

28. The fact that Driver Bowie's train was driven through switch diamonds No. 155 Reversed proves that he must have driven it past Signal GJ419 at Danger, and that it must have been at Danger for at least two minutes. At 70 mile/h the signal must have been at Danger when the train passed Signal GJ274. When I pointed this out to him Driver Bowie accepted that this must have been so.
