DEPARTMENT OF TRANSPORT

RAILWAY ACCIDENT

Report on the Collision that occurred on 5th April 1981 at Kirby Cross

IN THE
EASTERN REGION
BRITISH RAILWAYS

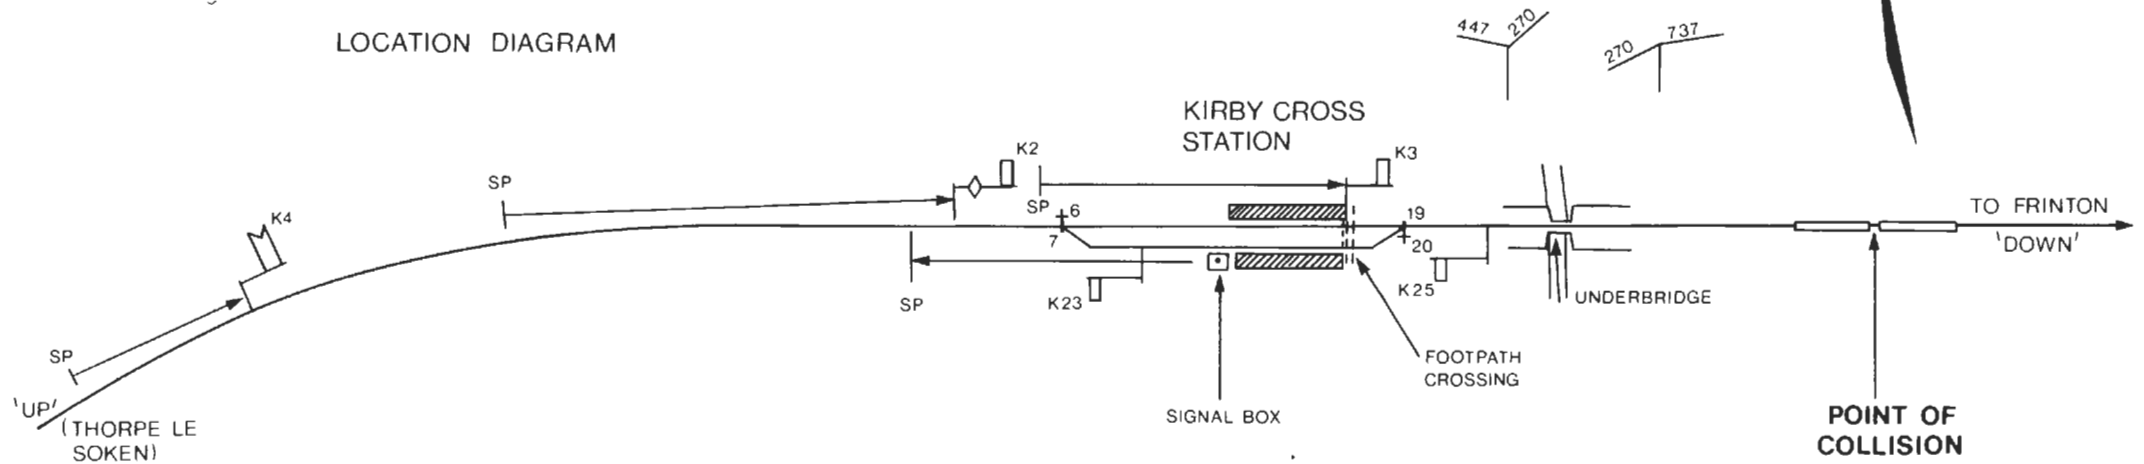
LOCATION DIAGRAM

<i>Worked by lever</i>		<i>First seen from</i>	
Down Distant Signal	K4	212 m	— 767 m to
Down Home Signal	K2	490 m	— 128 m to
Loop Up trailing points	K7		— 184 m to
Platforms and signal box			— 108 m to
Down Section Signal	K3	346 m	— 73 m to
Loop Up facing points	K19		— 165 m to
A rail-over-road bridge			— 346 m to
Point of contact
