RAILWAY ACCIDENT

Report on the Collision that
occurred on 19th July 1976
between Merkland Street and
Govan Cross

ON THE
UNDERGROUND RAILWAY
OF THE
GREATER GLASGOW PASSENGER
TRANSPORT EXECUTIVE

COLLISION BETWEEN
MERKLAND STREET
AND
GOVAN CROSS
ON
19th JULY 1976

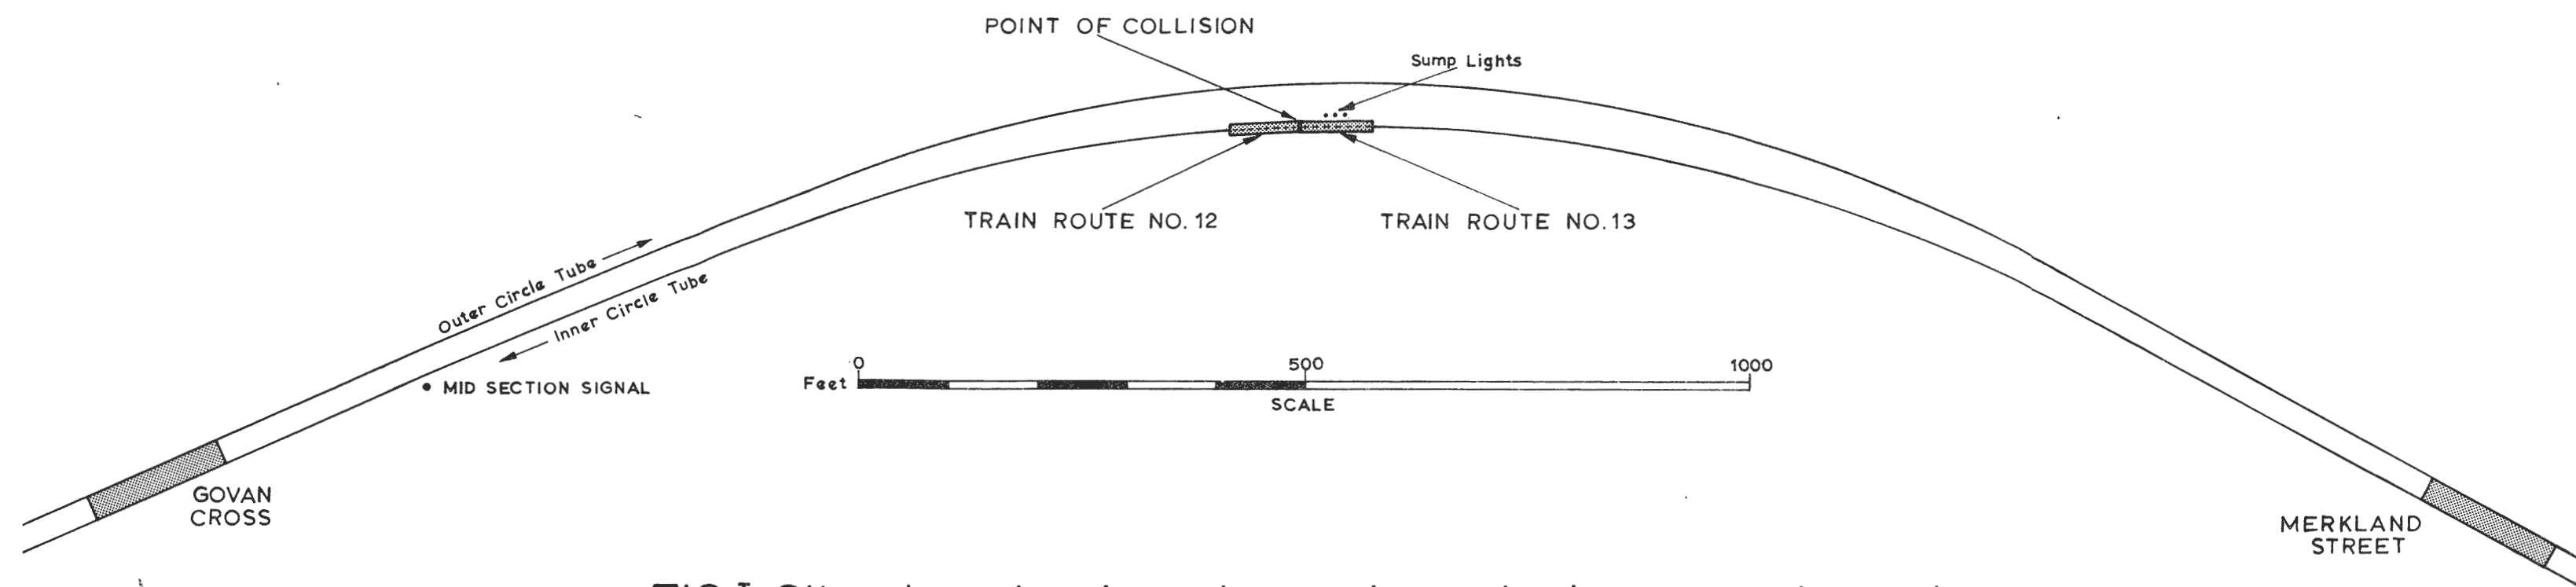
FIG.I Site plan showing place where trains came to rest.

3. A plan showing the location of the tunnels under the Clyde, the place where the two trains came to rest, and the estimated positions of the trains when the crew of Train Route No. 13 first sighted the rear lamp of Train Route No. 12 are shown at Figure No. I at the end of this Report, while a vertical elevation of the tunnel, showing the gradients in the area of the collision and both approaches to it, together with positions of the trains and their sighting positions, is given at Figure No. II. A further plan showing the Merkland Street-Govan Cross section together with the location of the collision is given at Figure No. III.
