# **RAILWAY ACCIDENT**

**Report on the Collision that  
occurred on 16th April 1979  
near Paisley (Gilmour Street)**

**IN THE  
SCOTTISH REGION  
BRITISH RAILWAYS**

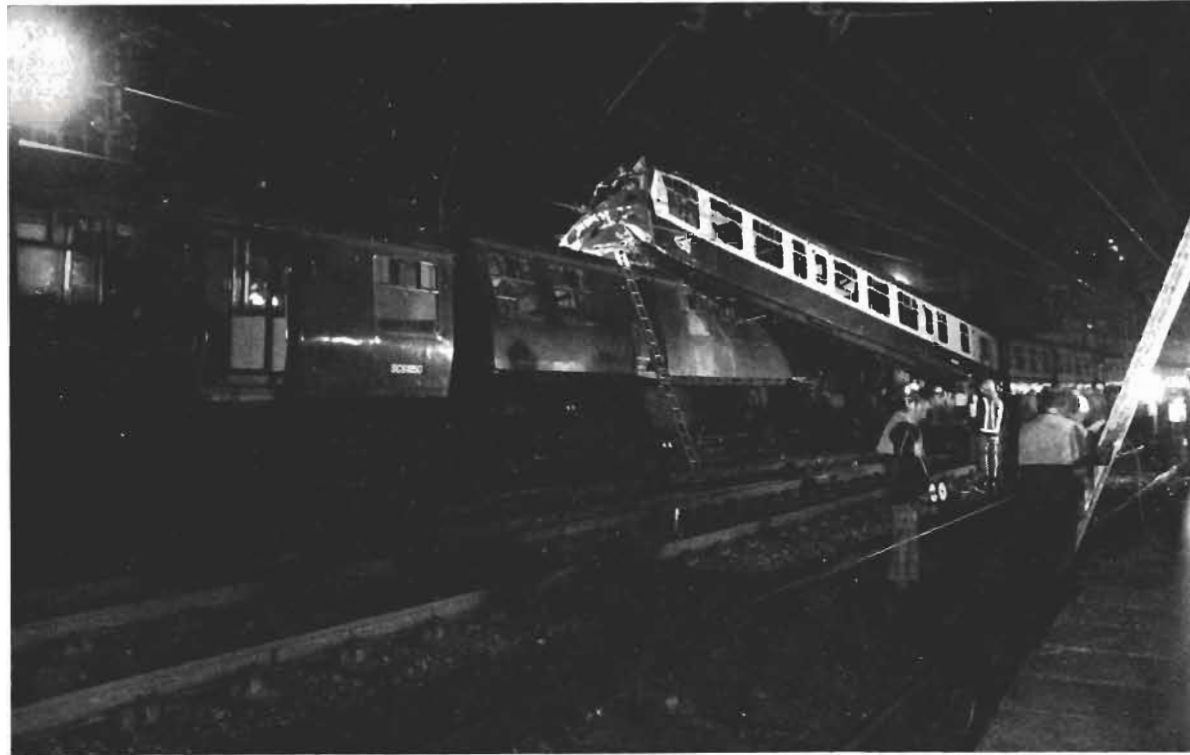
The leading vehicles of both trains were extensively damaged, the leading part of the first vehicle of the EMU being driven into the leading vehicle of the DMU, which rode up over the EMU, although the rear end of the vehicle remained on the rails. The leading bogie of the EMU became dislodged and the right hand wheels were raised above the rail, but otherwise there was no derailment of any of the EMU vehicles. The leading bogie of the DMU became detached from its vehicle and was derailed all wheels.

*Photograph No. 1. General view of site of collision showing leading coach of DMU on top of leading coach of EMU.*

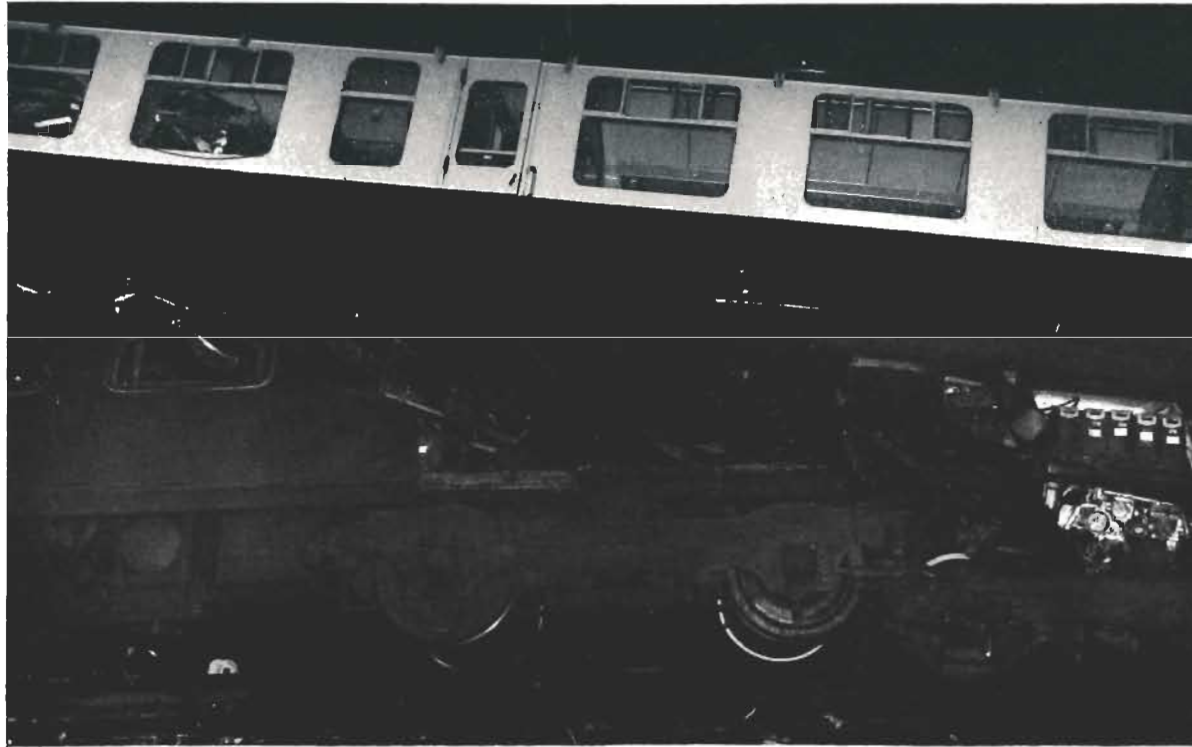
8. The leading vehicle of the EMU 1N35, BDT 75840, was extensively damaged, the leading cab and half of the passenger saloon being completely destroyed. The leading buffer beam was extensively damaged and the underframe behind it badly distorted; the buffing and drawgear was severely damaged. The leading bogie was also severely damaged with the side frames and transoms badly bent. The damage to the remaining vehicles of 1N35 was not so severe, being mainly confined to the bogies, the frames and transoms of which were bent. In addition, minor damage occurred to the door operating equipment and several seats were dislodged from their mountings.

*Photograph No. 2.* Close-up showing the extensive damage caused to the front part of the leading coach of the EMU, the driver's cab and leading section of the passenger accommodation having been totally demolished by the DMU.
