# **RAILWAY ACCIDENT**

## **Report on the Collision that occurred on 26th September 1985 near Paisley**

IN THE  
SCOTTISH REGION  
OF BRITISH RAILWAYS

COLLISION BETWEEN 2A14, 1230 GIRVAN TO GLASGOW  
& 7D13, 1421 HUNTERSTON TO RAVENSCRAIG  
THURSDAY 26TH. SEPTEMBER 1985

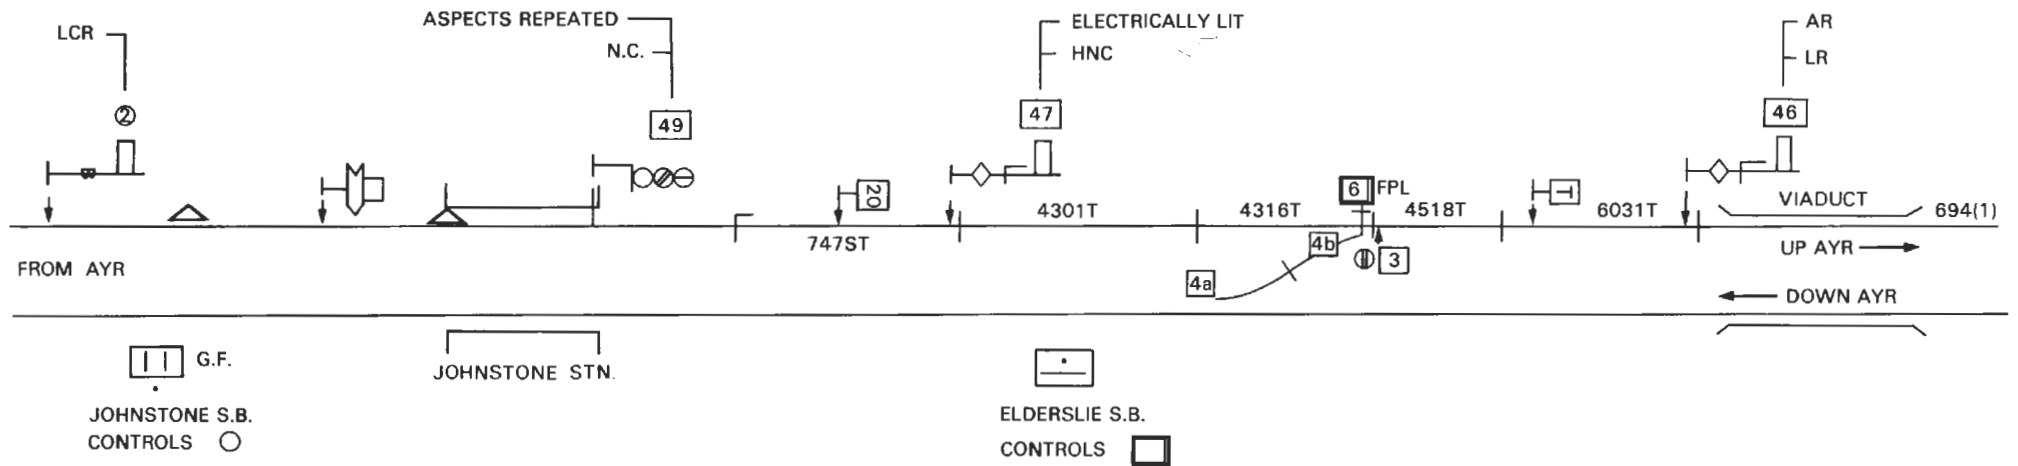
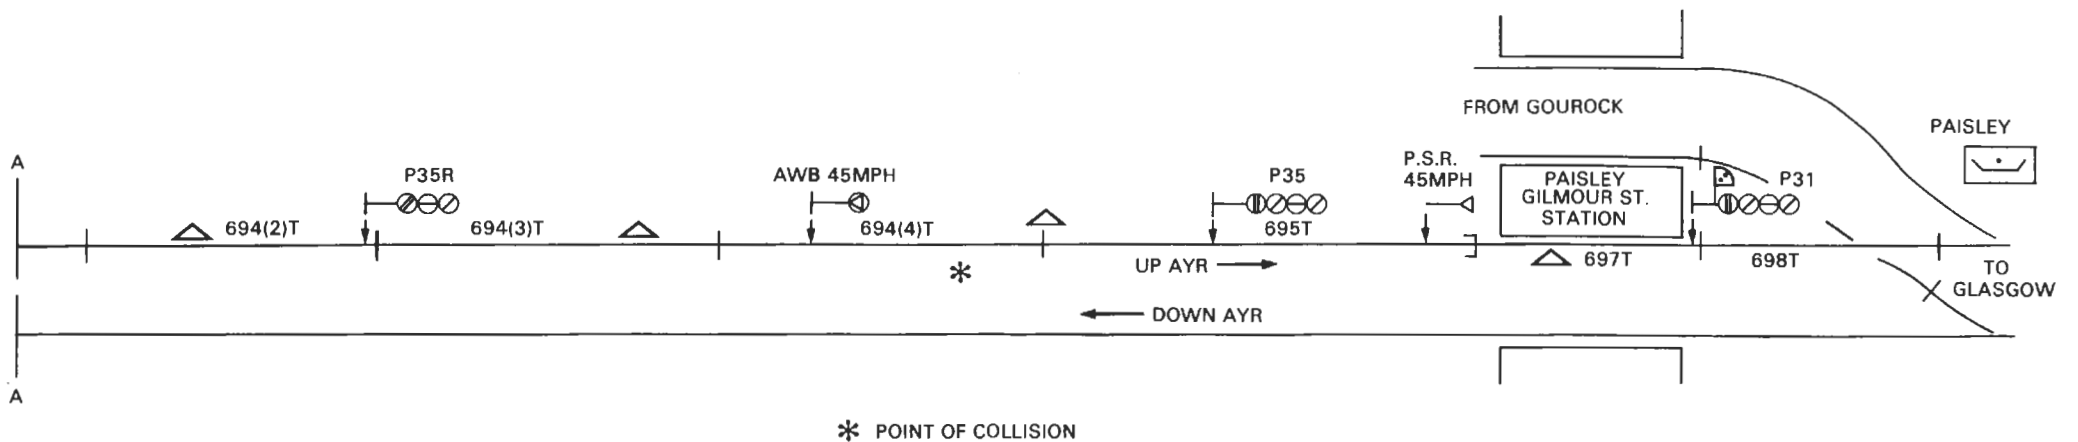
13. Track Circuits 694(1), (2), (3), (4), and 695T had to be clear, ie to the overlap of Signal P35, and Signals P35 and P35R alight before lever No. 46 could be reversed. AWS magnets were provided at the Warning Board for the 20 mile/h. TSR and the Advanced Warning Indicator for the 45 mile/h Permanent Speed Restriction at Paisley. A diagram of the signalling is at the front of the report.
