RAILWAY ACCIDENT

Report on the Collision that occurred on 11th December 1981 near Seer Green

IN THE
LONDON MIDLAND REGION
OF BRITISH RAILWAYS

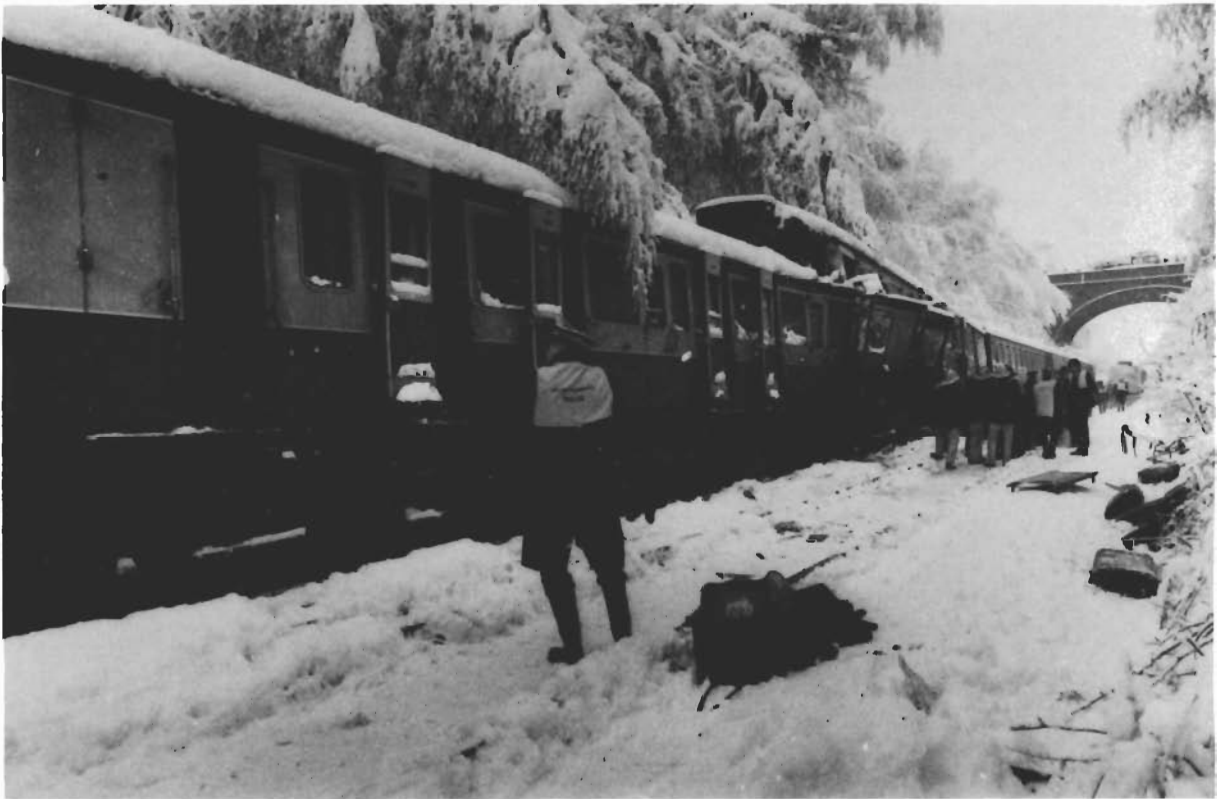
View looking towards Seer Green showing the two
trains and the overhanging branches
