RAILWAY ACCIDENT

**Report on the Collision that
occurred on 3rd February 1984
at Wigan North Western Station**

**IN THE
LONDON MIDLAND REGION
OF BRITISH RAILWAYS**

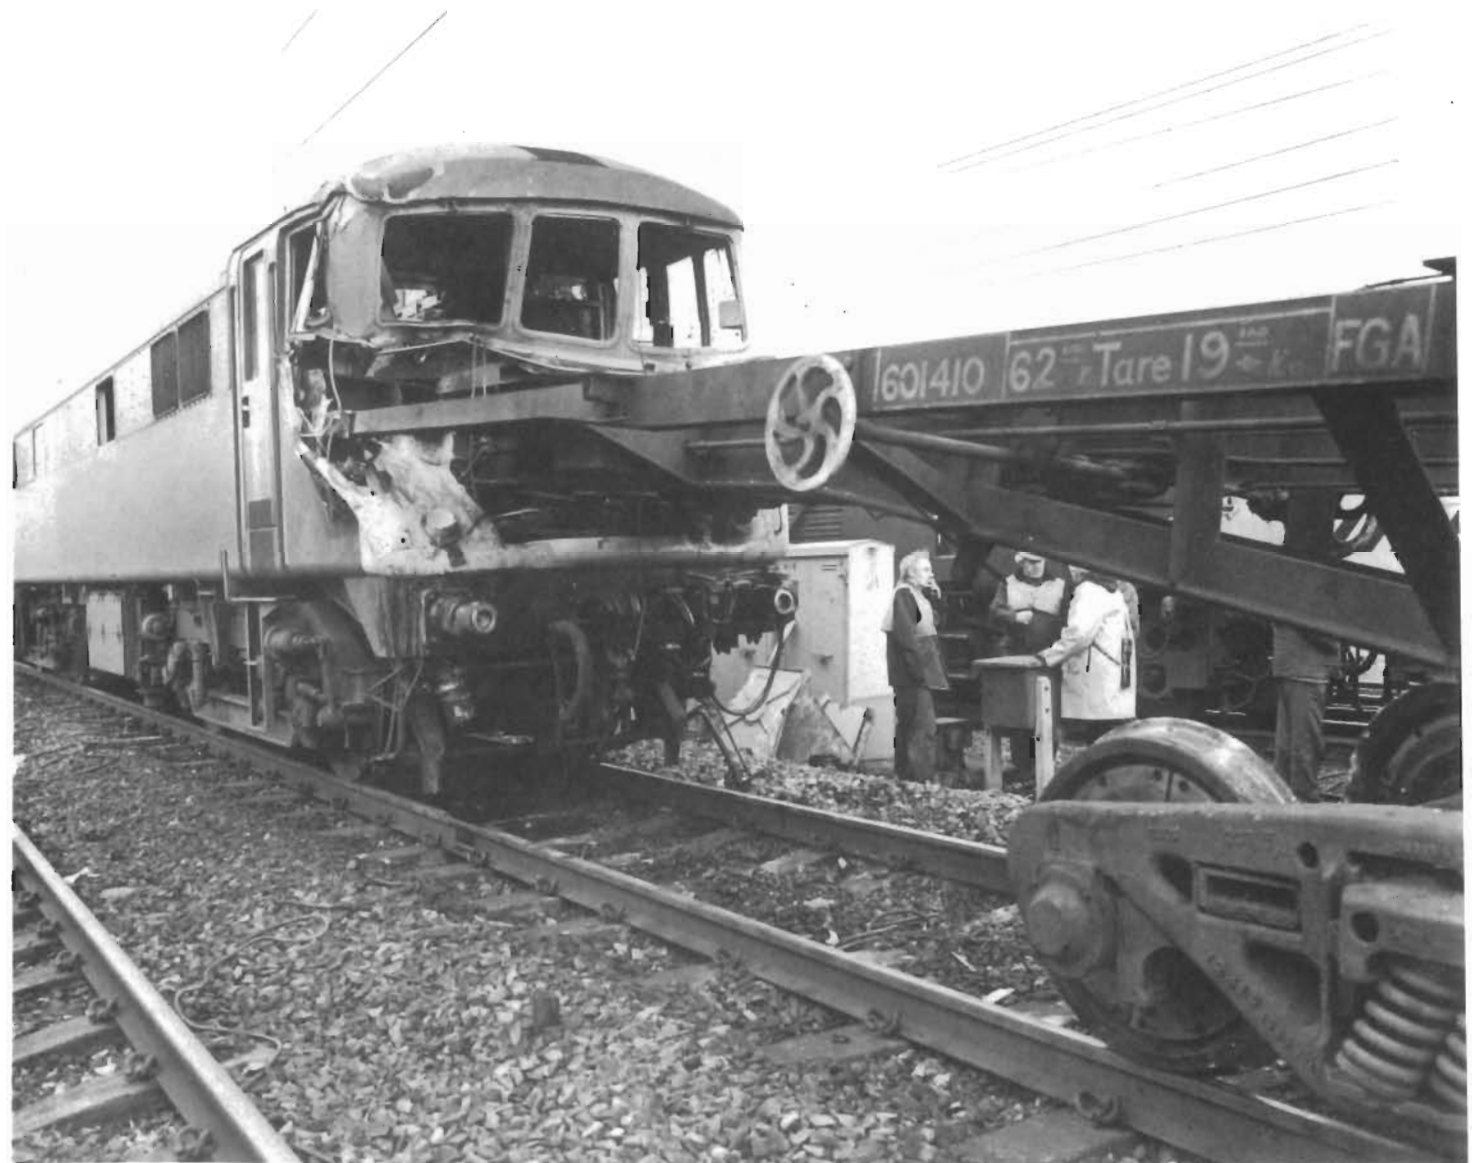
The Freightliner wagon embedded in the locomotive of the Speedlink Train.

2. A Freightliner train, 4M51, was standing at signal WN 44 on the Up Main line at Wigan when it was struck from behind by a Speedlink train, 6M79. The force of the collision pushed the Freightliner train forward 16.3m and lifted the end of the rear (unladen) Freightliner wagon from its bogie whereupon the wagon underframe rose over the buffers of the locomotive of the Speedlink train and destroyed its cab. Of the two occupants of the cab, Driver B. Leonard died instantly and Guard J. A. Young was trapped in the wreckage and was given medical aid whilst attempts were made to free him; he eventually died at 04.25 and his body was finally cut free and removed from the wreckage at 05.30.

- No. 1 end cab, the cab to equipment room bulkhead and all cab equipment destroyed.
- No. 1 end blower motor, brake/power switch compartment and main fuse/circuit breaker panel severely damaged.
- No. 2 end 'D' link of coupling snapped.

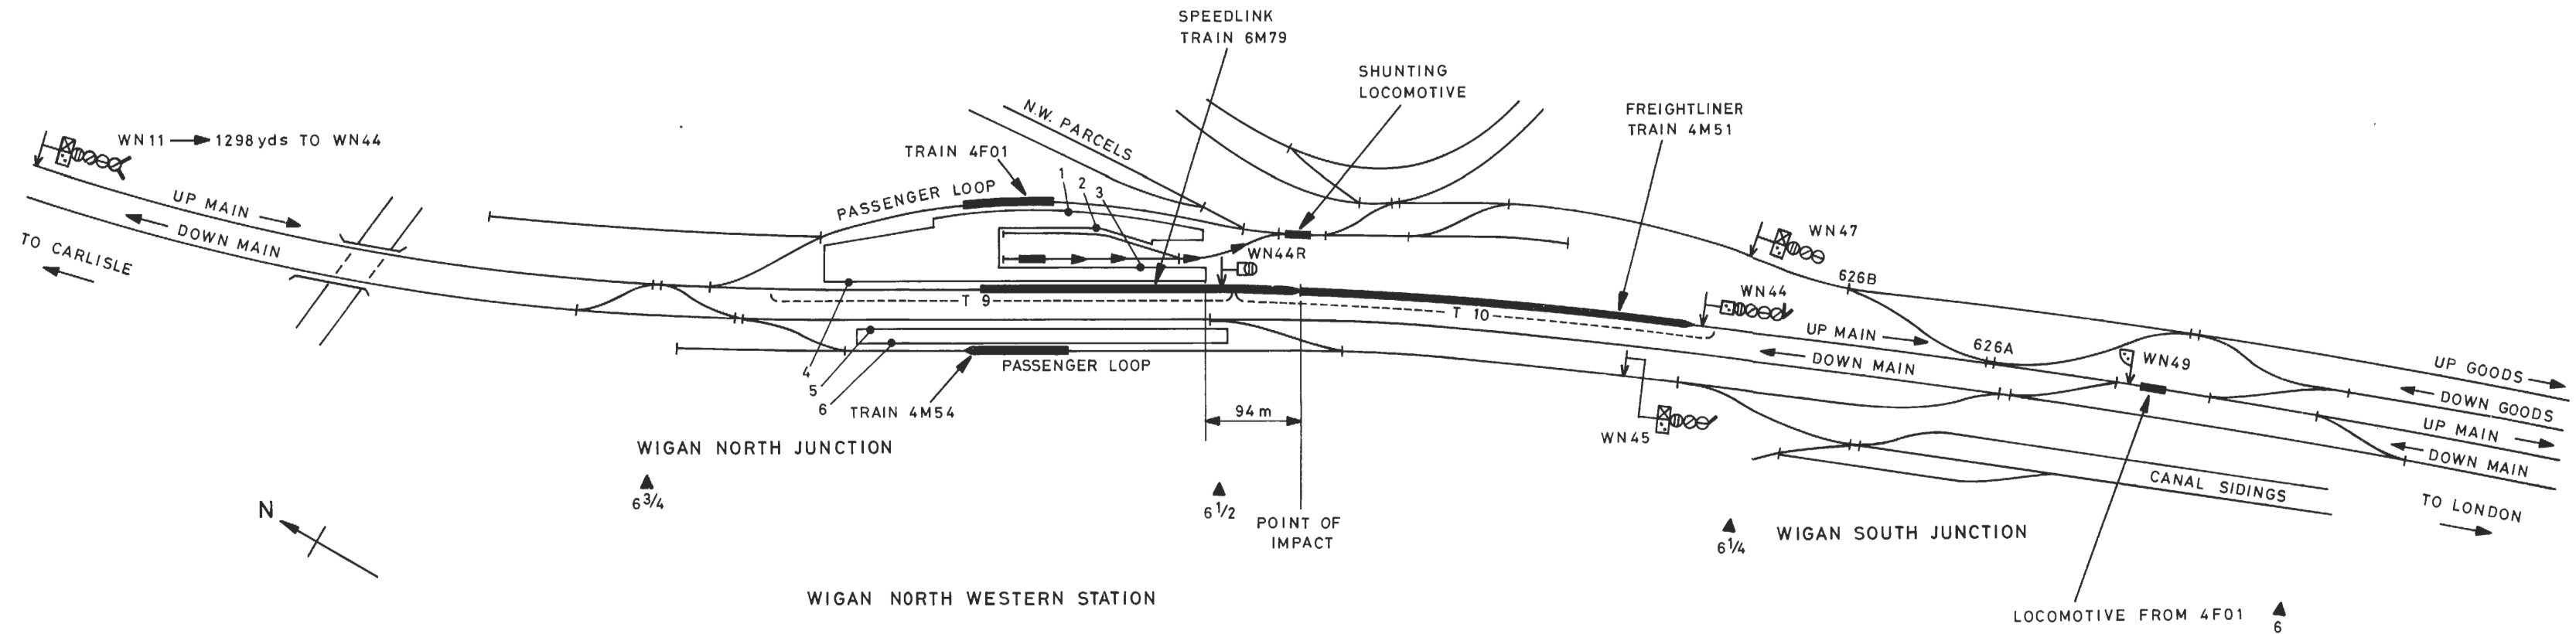
COLLISION AT WIGAN ON 3rd FEBRUARY 1984

9. Wigan is 208 miles from Glasgow on the West Coast Main line. The track layout in the vicinity of Wigan North Western Station, the relevant signals and the positions of trains are shown on the plan at the back of this report. The position of the collision, also marked, was on the Up Main line and 94m beyond the south or London end of the ramp of No. 4 platform.
