HM Railway Inspectorate

RAILWAY ACCIDENT AT COWDEN

A report of the Inquiry into the
collision between two passenger
trains which occurred at Cowden
on 15 October 1994

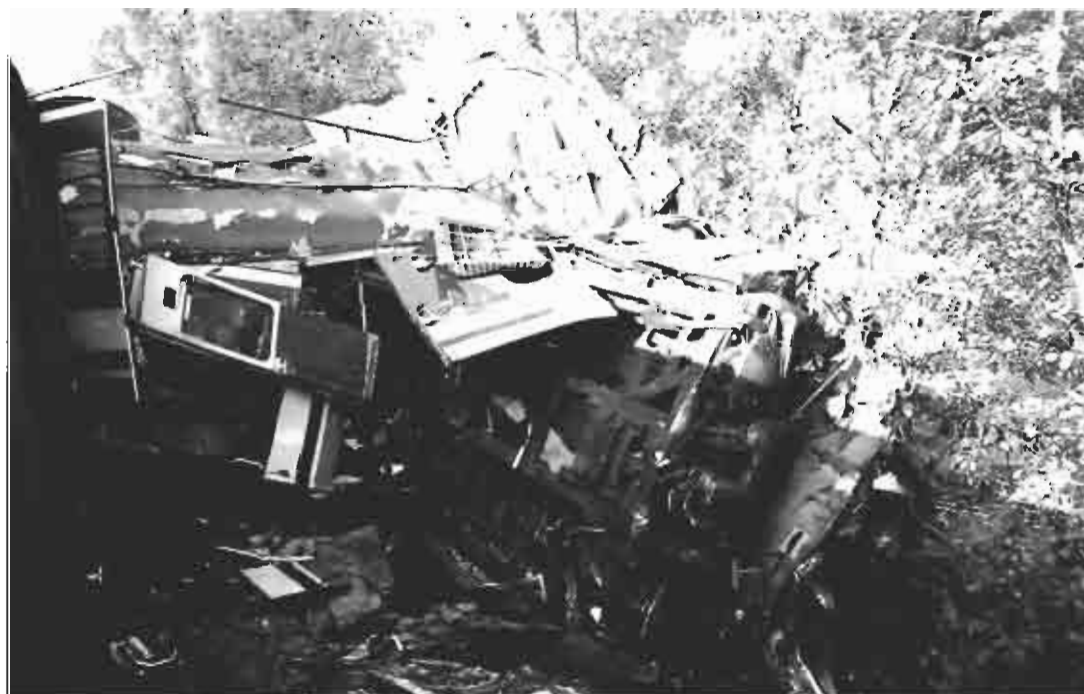
The overturned leading coach of the Down train with the wreckage of the leading coach of the Up train lying above it

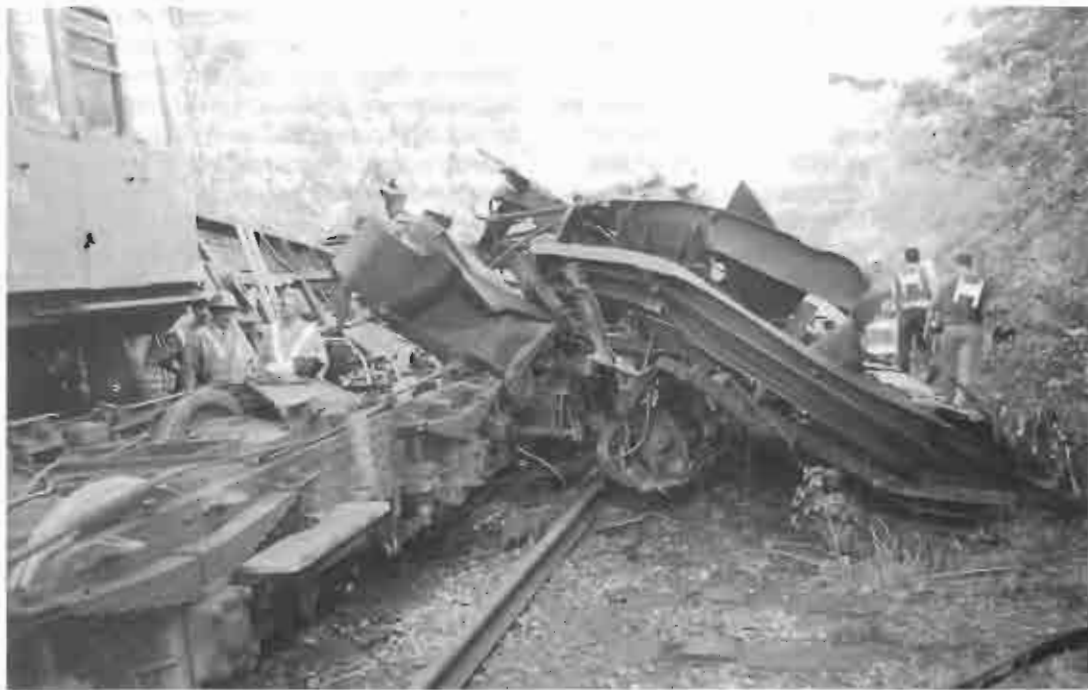
The twisted frame of the leading coach of the Up train

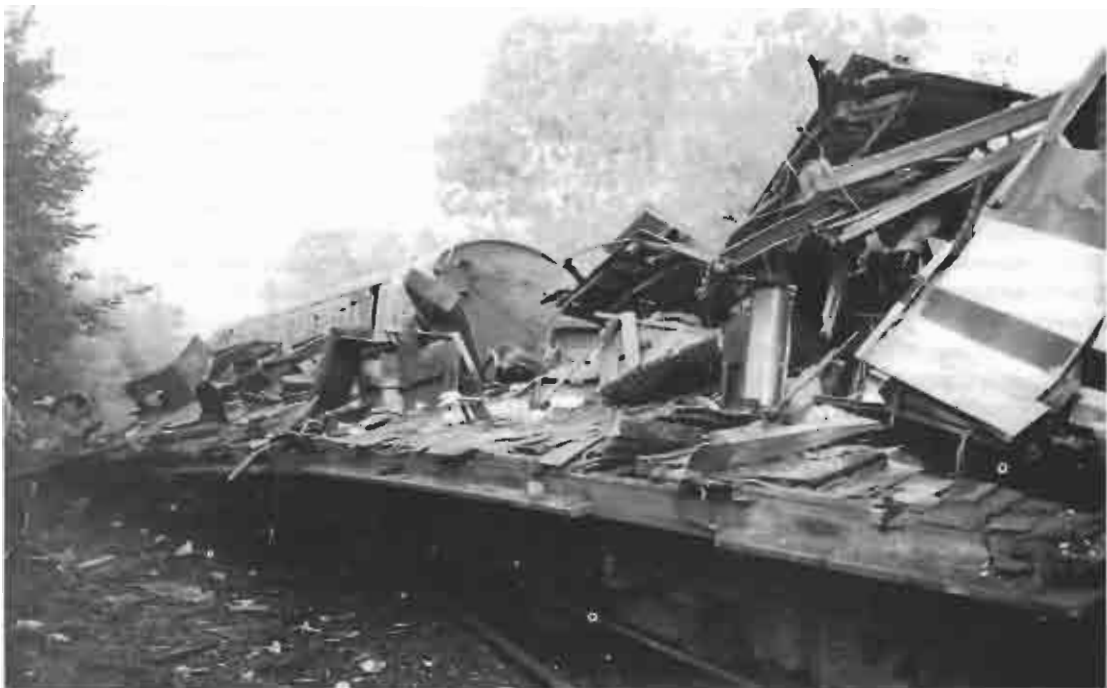
The frame of the leading coach of the Up train showing the destruction of the superstructure
