HM Railway Inspectorate

## **RAILWAY ACCIDENT AT HOLTON HEATH**

A report on a collision that occurred  
on 20 April 1989

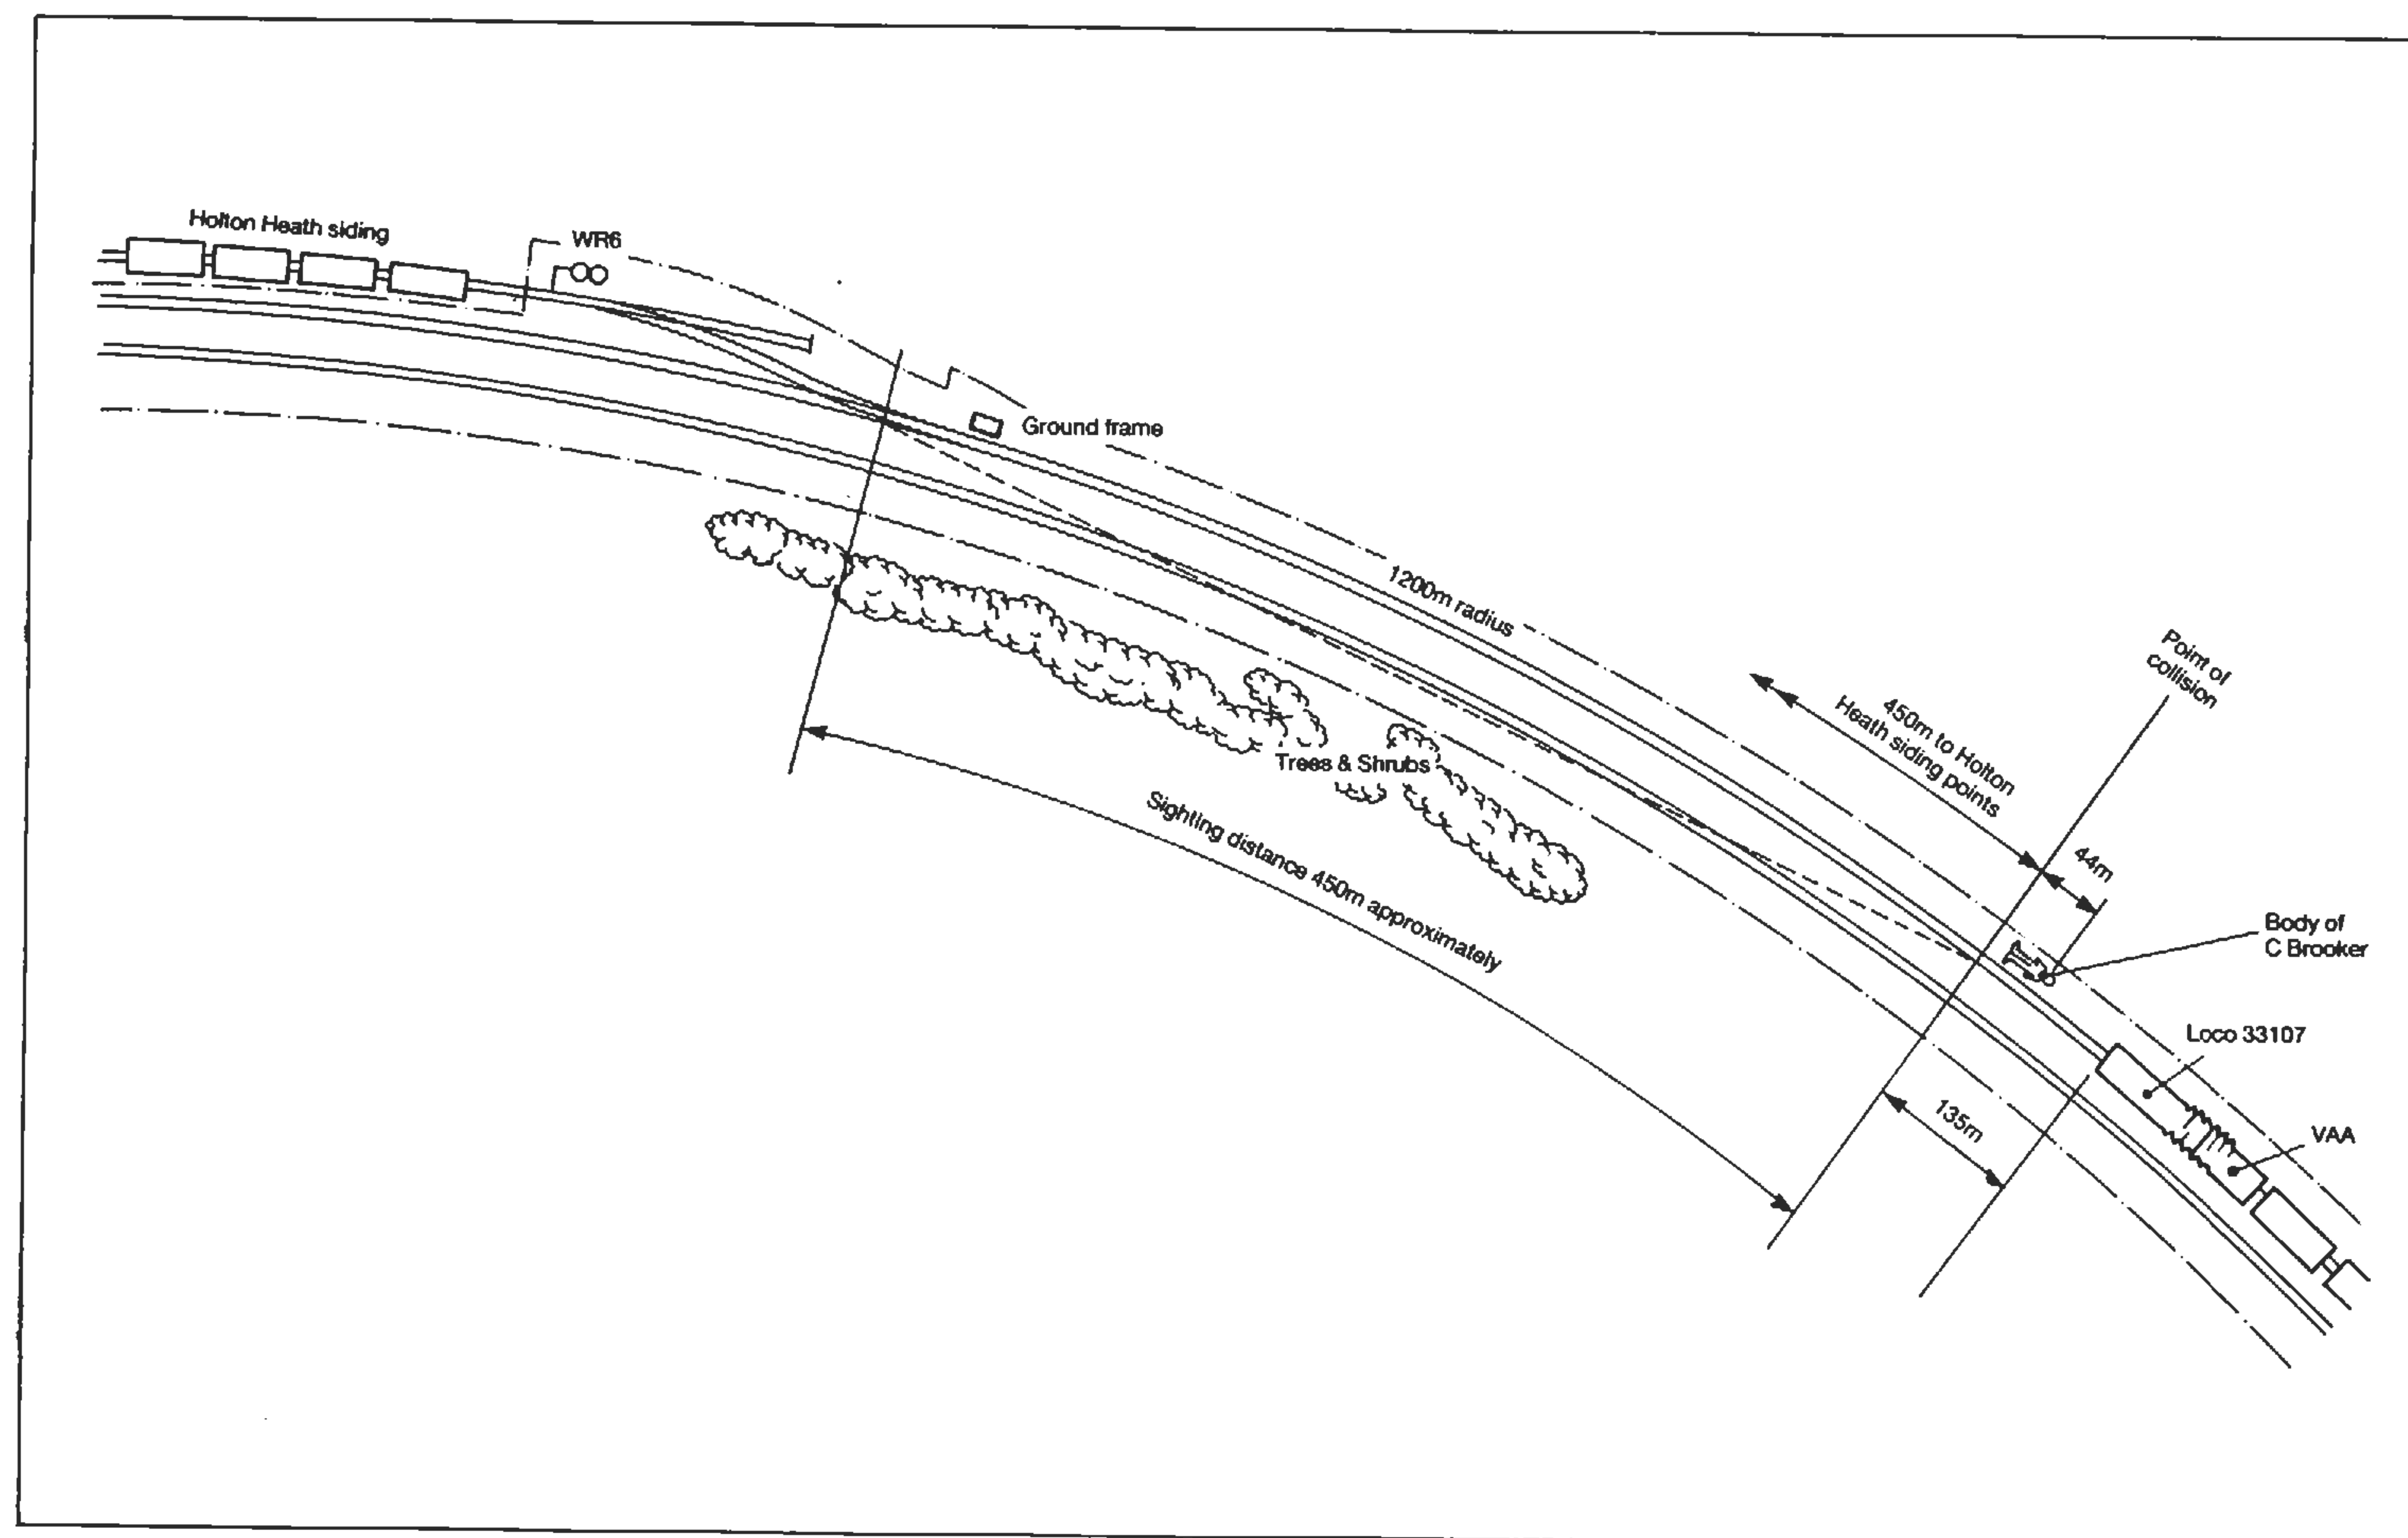
Figure 1 Location and general layout at site of accident

that he found evidence of the initial point of impact at the location identified as 118 miles 62 yards from London, which is about 450 m from the connection to the siding. A body, later identified as that of Driver Brooker, was found 44 m on the London side from the point of impact. He was in the cess, laying parallel and close to the running rail with his head towards London. The rear of the light locomotive had come to a stand 132 m from the initial point of impact.
