The Ladbroke Grove Rail Inquiry

Part 1 Report

The Rt Hon Lord Cullen PC

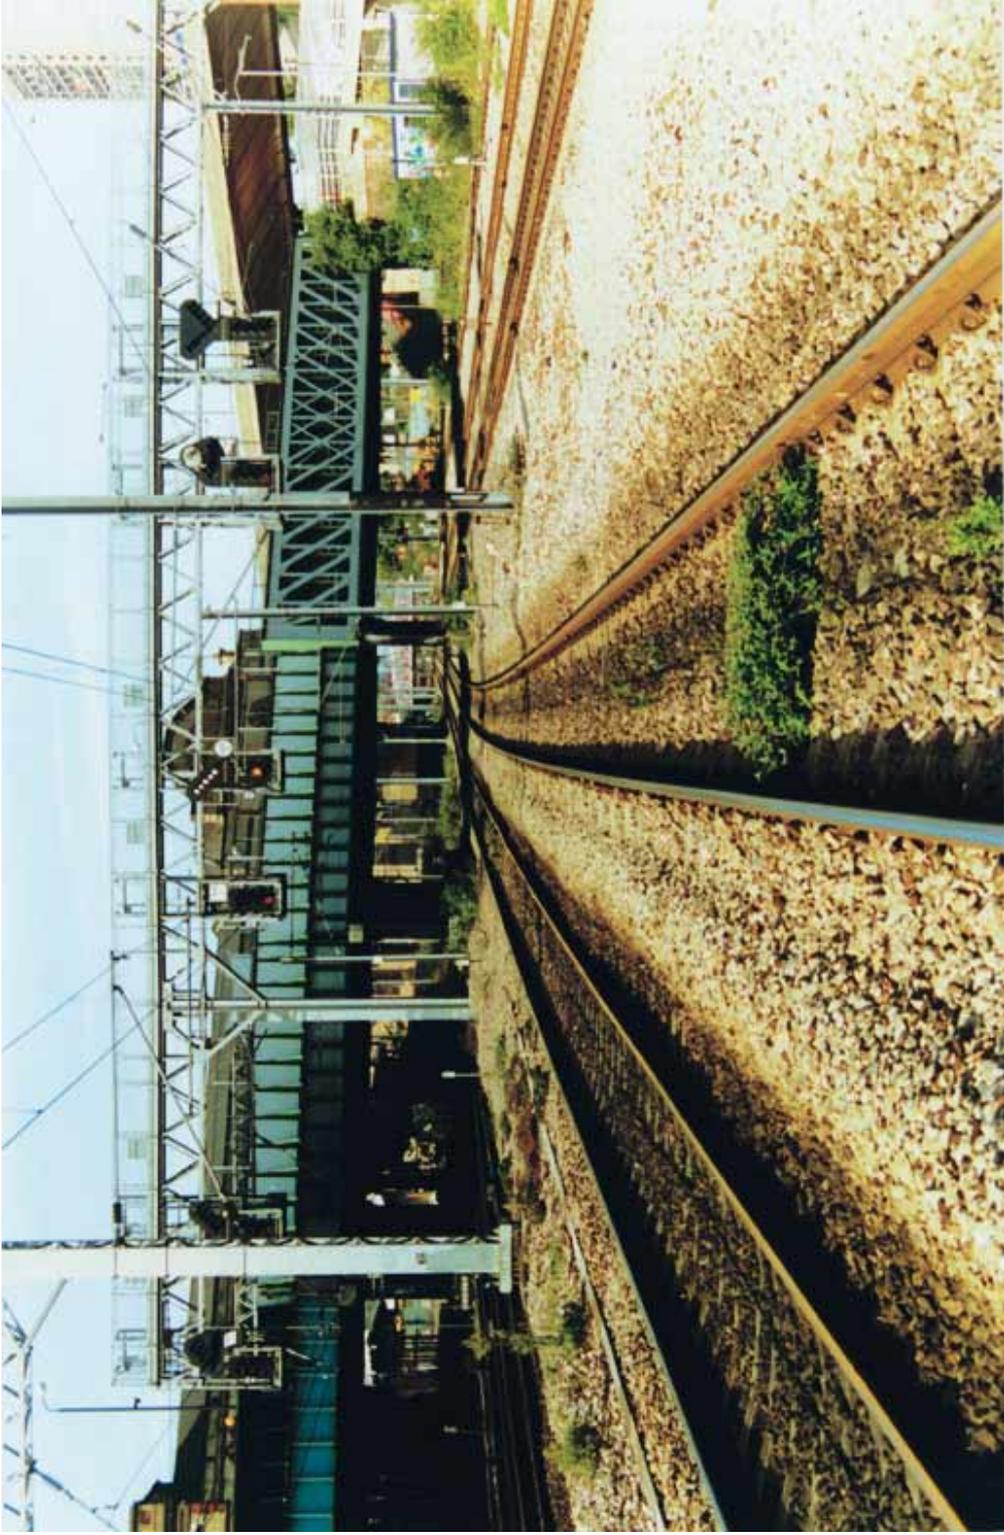
Plate 1: Gantry 6 showing, from left to right, signals SN81, SN83, SN85, SN87, SN89 and SN91. Taken from ground level on Line 4, to which SN87 applies.

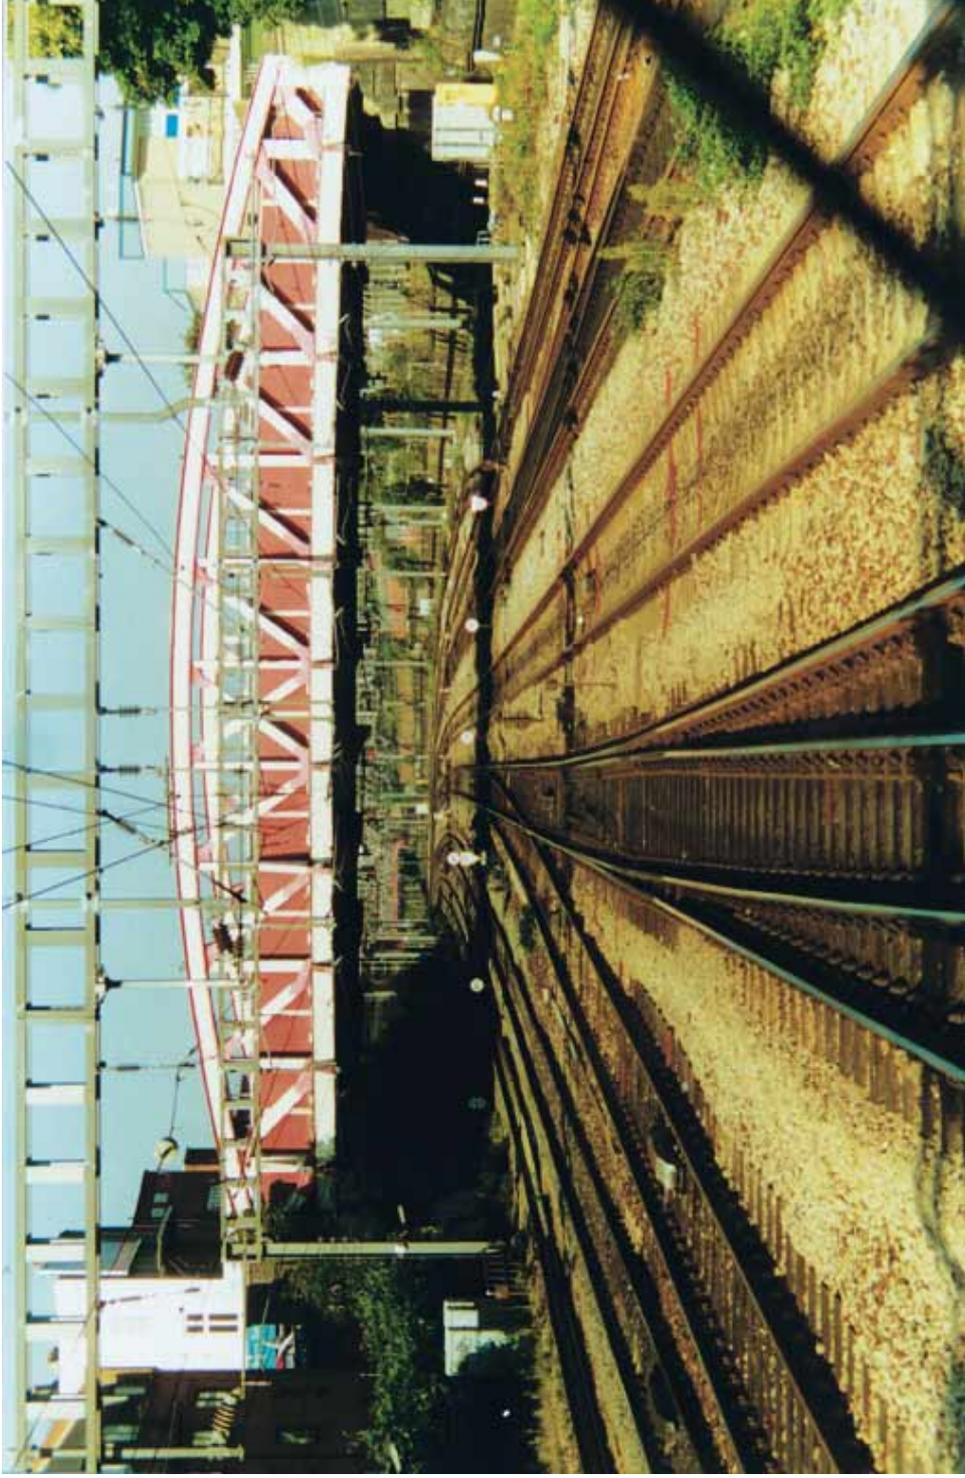
Plate 2: Gantry 8 at a distance of 218 metres. Taken from the driver's position in a Class 165 Turbo on the Line 4 to Line 3 crossover. Its signals, from left to right, are SN107, SN109, SN111, SN113 and SN115. SN105 is carried by a post at the trackside.

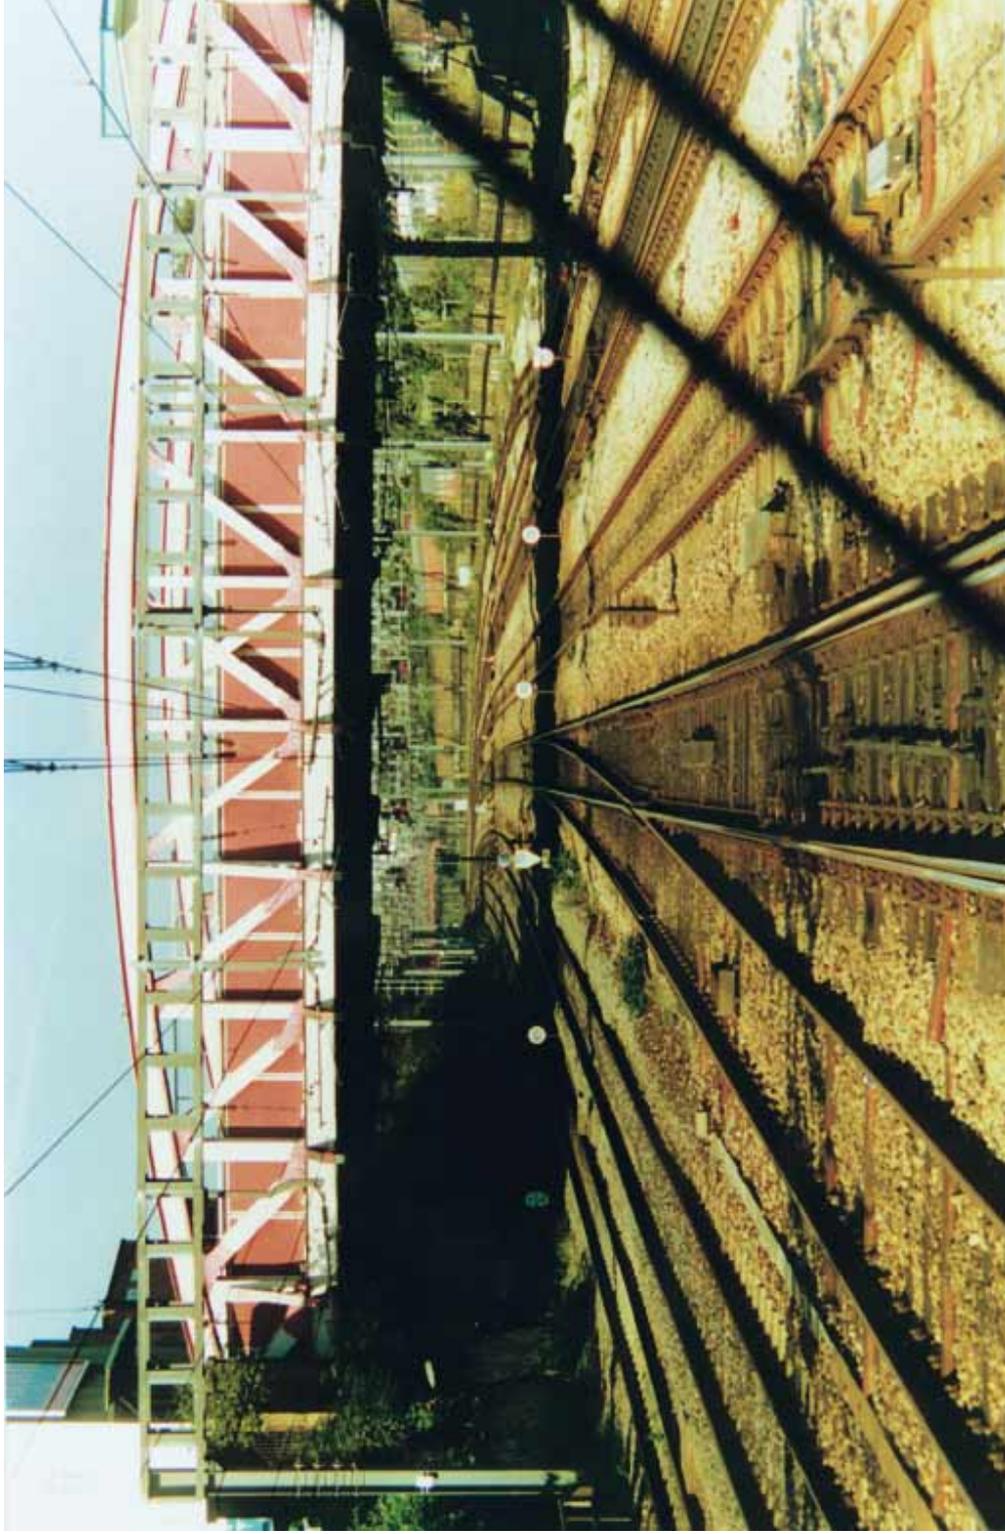
Plate 3: Gantry 8 at a distance of 188 metres. Taken from the driver's position in a Class 165 Turbo on the Line 4 to Line 3 crossover.

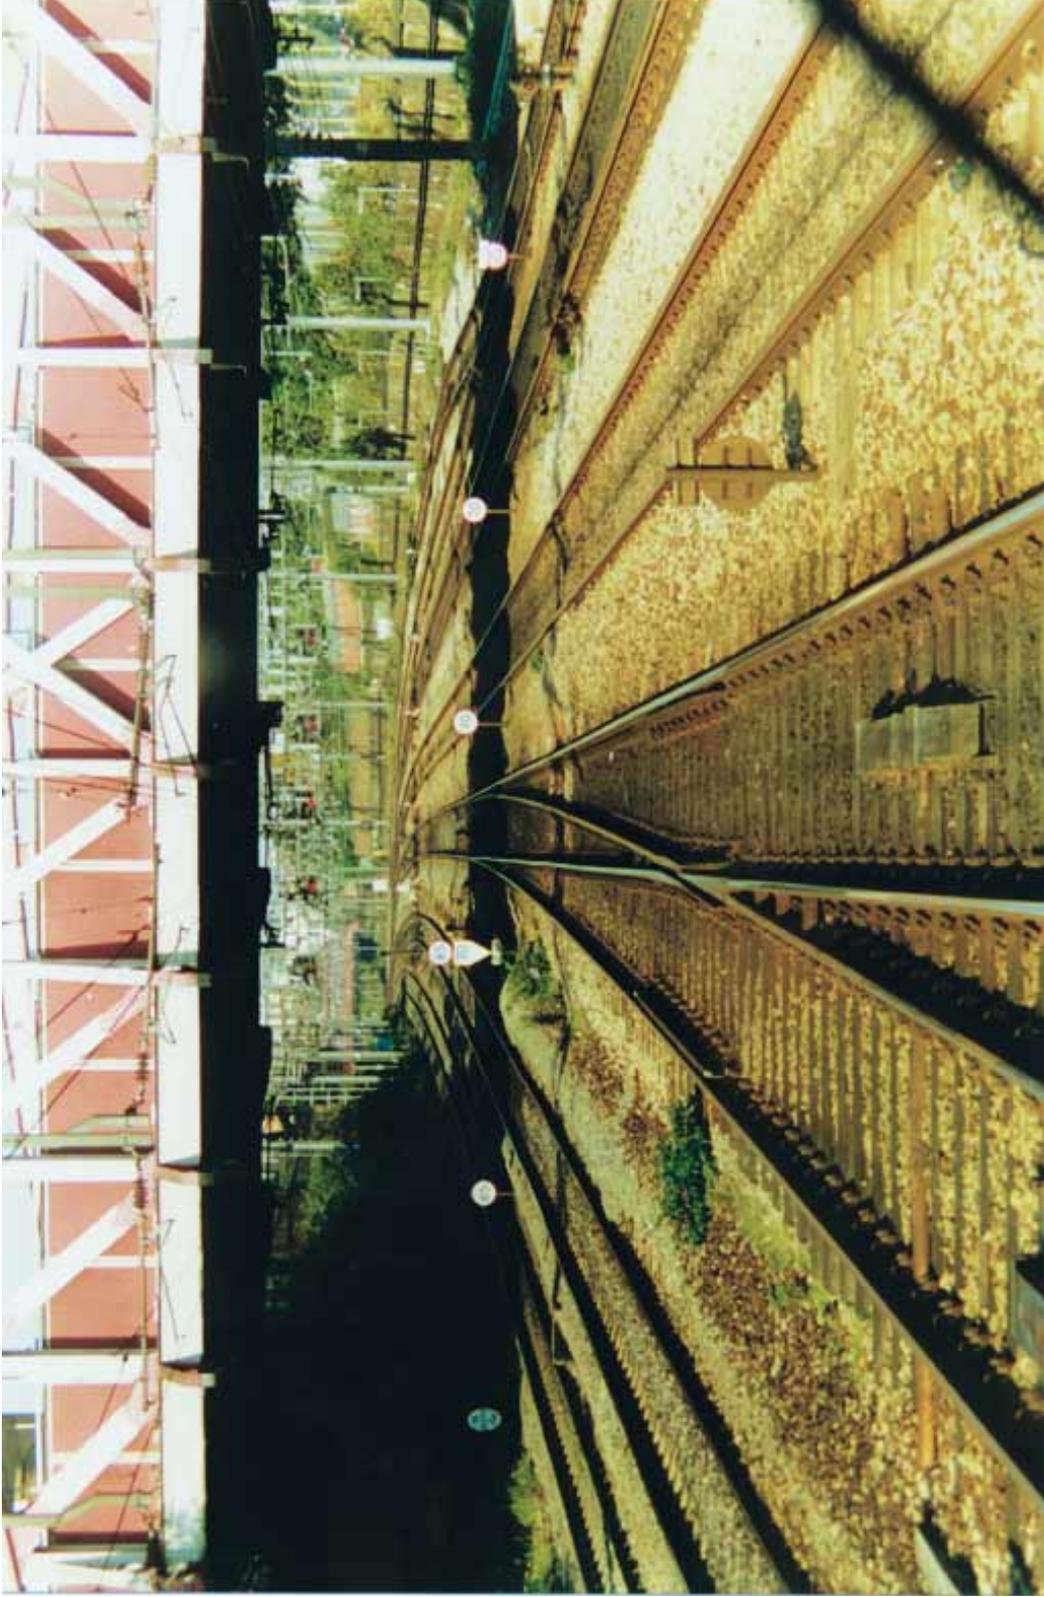
Plate 4: Gantry 8 at a distance of 168 metres. Taken from the driver's position in a Class 165 Turbo on Line 3.

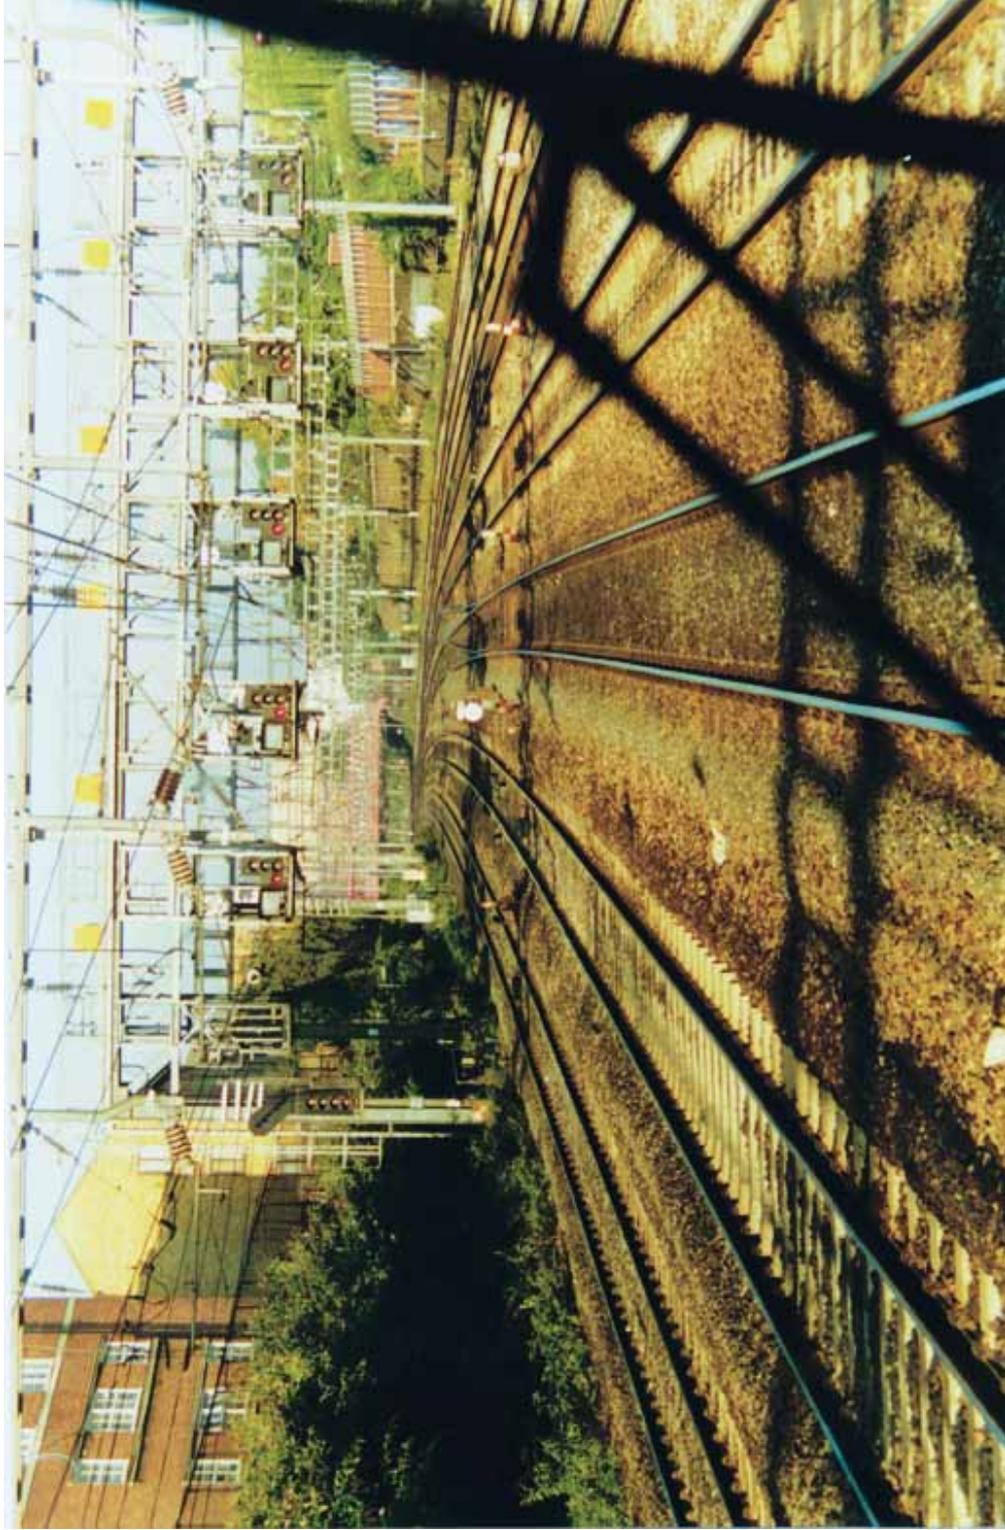
Plate 5: Gantry 8 at a distance of 60 metres. Taken from the driver's position in a Class 165 Turbo on Line 3, under conditions of bright sunlight, at 08:51 on 6 October 1999.

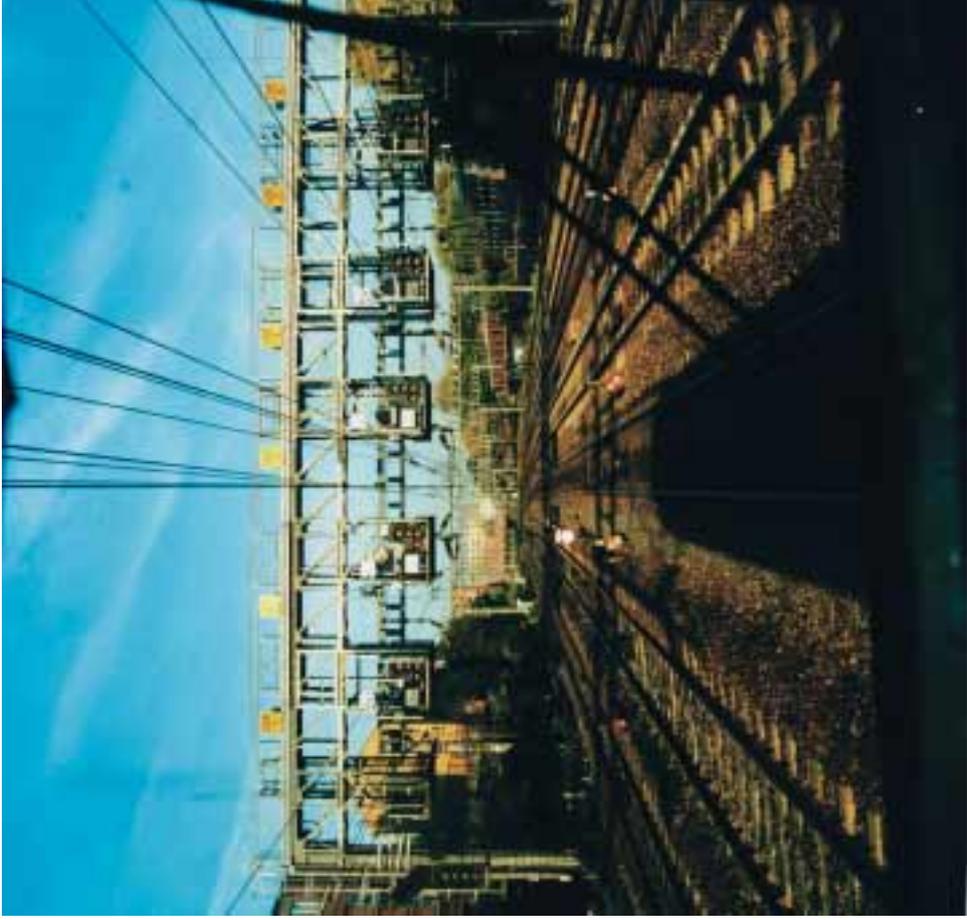
Plate 6: Gantry 8 at a distance of 17 metres. Taken from the driver's position in a Class 165 Turbo on Line 3, under conditions of bright sunlight, at about 08:14 on 6 October 1999.

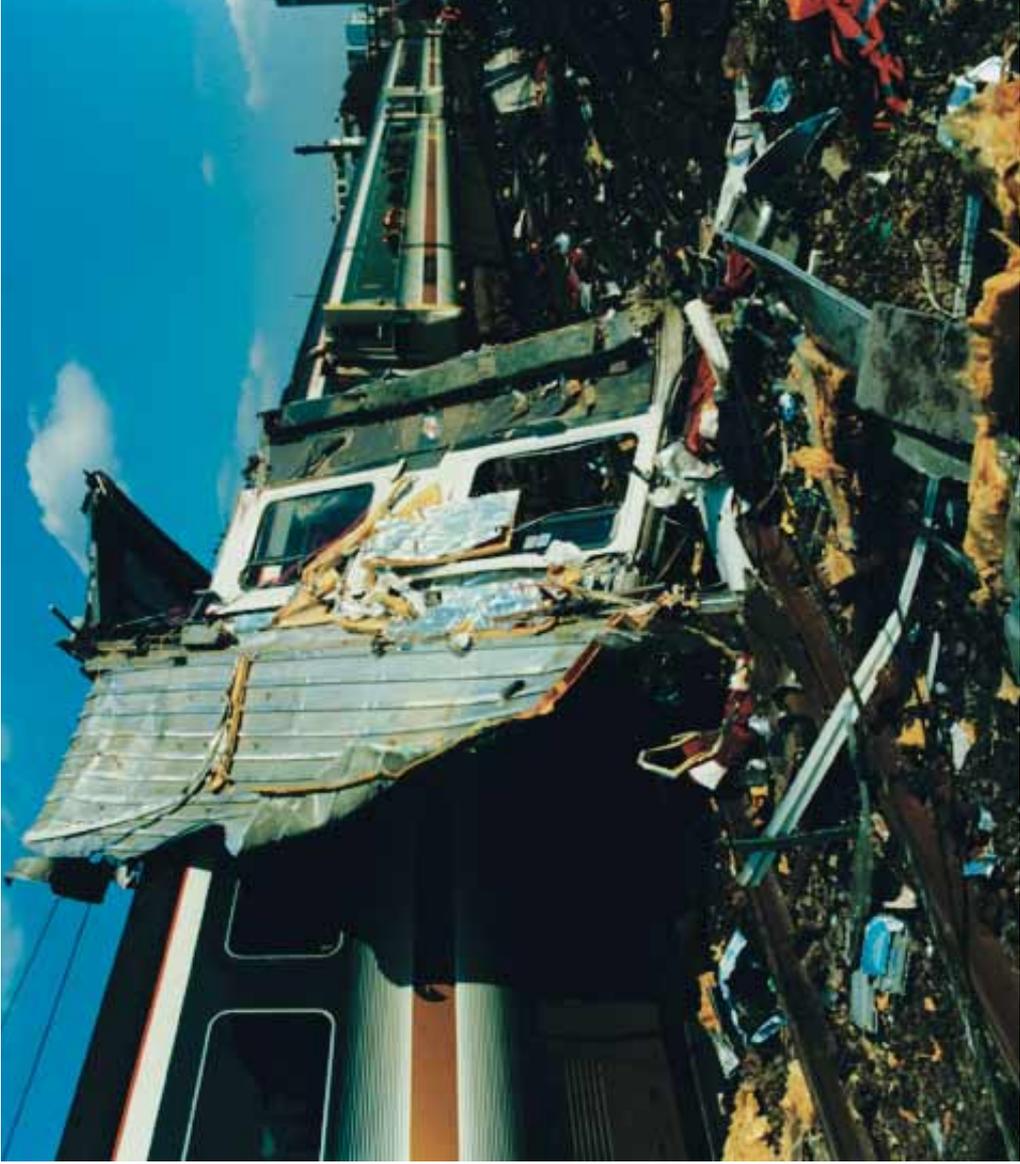
- 4.5 The trailing end of the front car of the Turbo struck the leading end of the middle car. The trailing end of the front car failed and was pushed inside the middle car. The gangway pillars of the middle car were likely to have been torn through the underframe of the front car before failing at floor level (*see Plate 8*). The leading end of the middle car failed along the right hand cantrail welds and the roof was pushed upwards. The left hand side failed along the welds to the solebar, and the floor was pushed down. The trailing underframe of the front car failed and fell into planks. The trailing bolster of the front car failed and its bogie detached. The leading end of coach H (the front coach) of the HST impacted on the trailing end of the power car. The trailing end of the power car was pushed inside the guard's compartment at the front of coach H, and coach H started to override the power car. Coach H lifted up as it overrode the power car. The underframe of coach H started to bend back on itself and the leading bogie fell away. The underframe of the power car was bent up and the superstructure pushed backwards into the vehicle. The superstructure of coach H was torn away from the solebar as the underframe bent back.

Plate 7: Part of the front car of the Thames Turbo against coach B of the HST: view from the west (south side of crash).

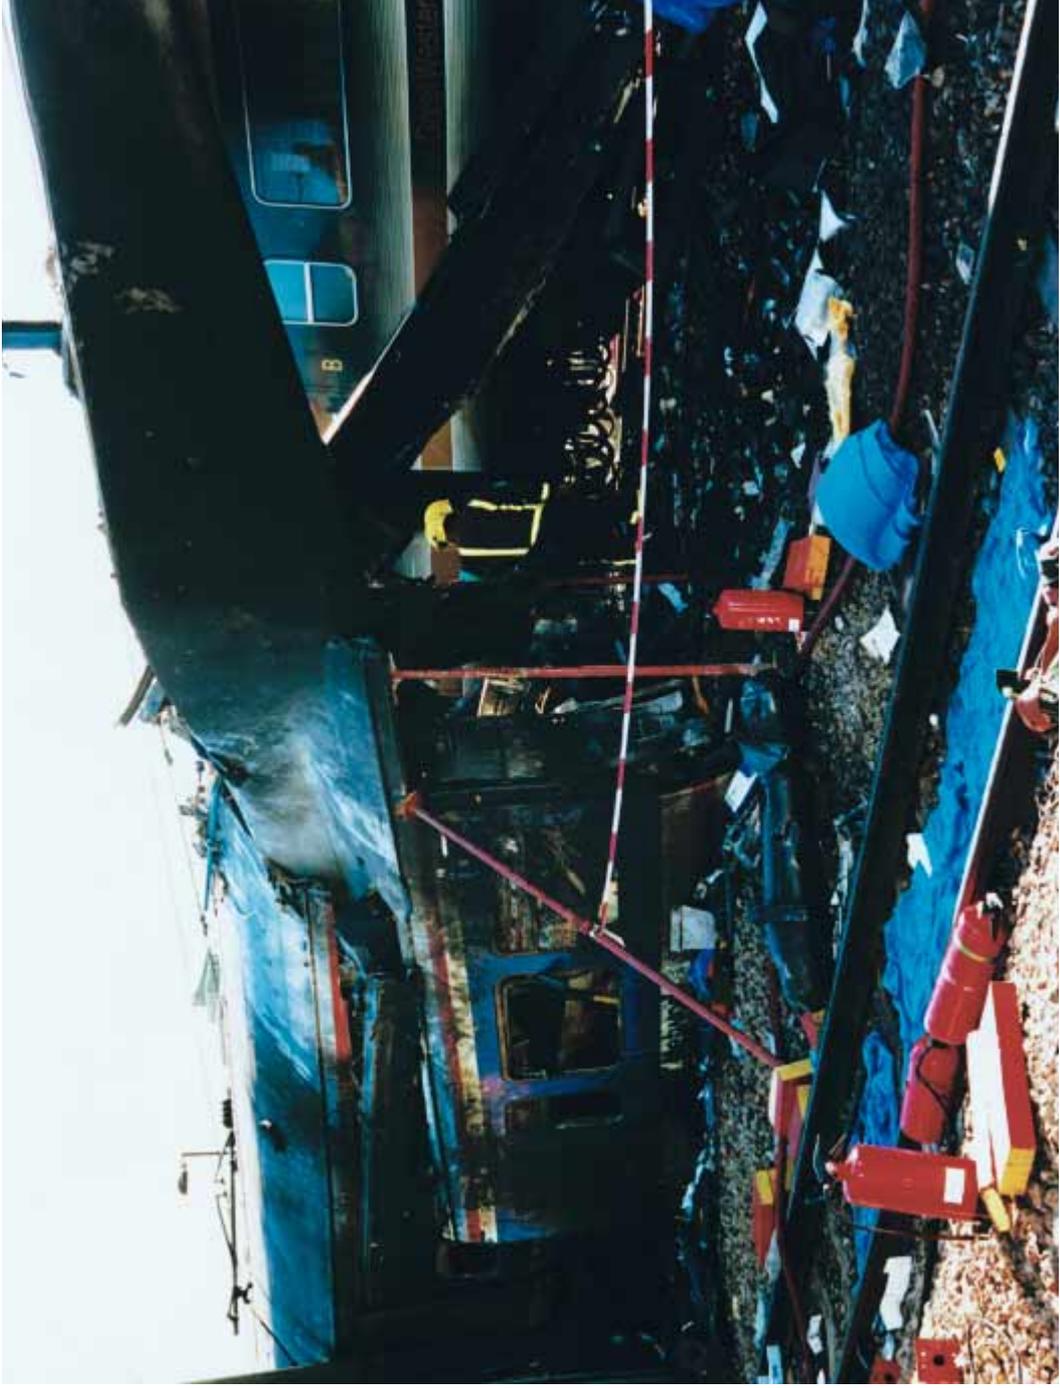
Plate 8: Front and middle cars of the Thames Turbo: view from the north.

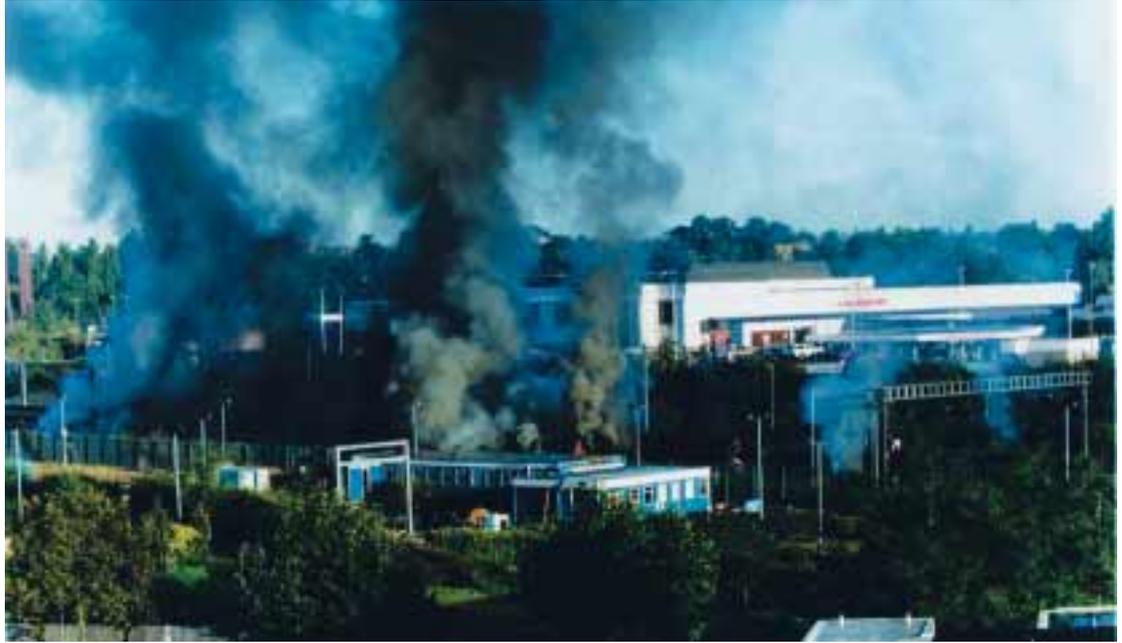
- 4.38 The fireball is likely to have been caused by the ignition of airborne fuel within the coach. The fireball originated at the rear end of the coach and propagated through it to, and a little beyond, the partition between the smoking and non-smoking sections. It is difficult to say whether the partition acted as a barrier. It is likely that the fireball did not proceed further due to the lack of airborne fuel which was within the limits required for flammability.

Plate 9: Early stage of the fire in coach H of the HST: view from the south.

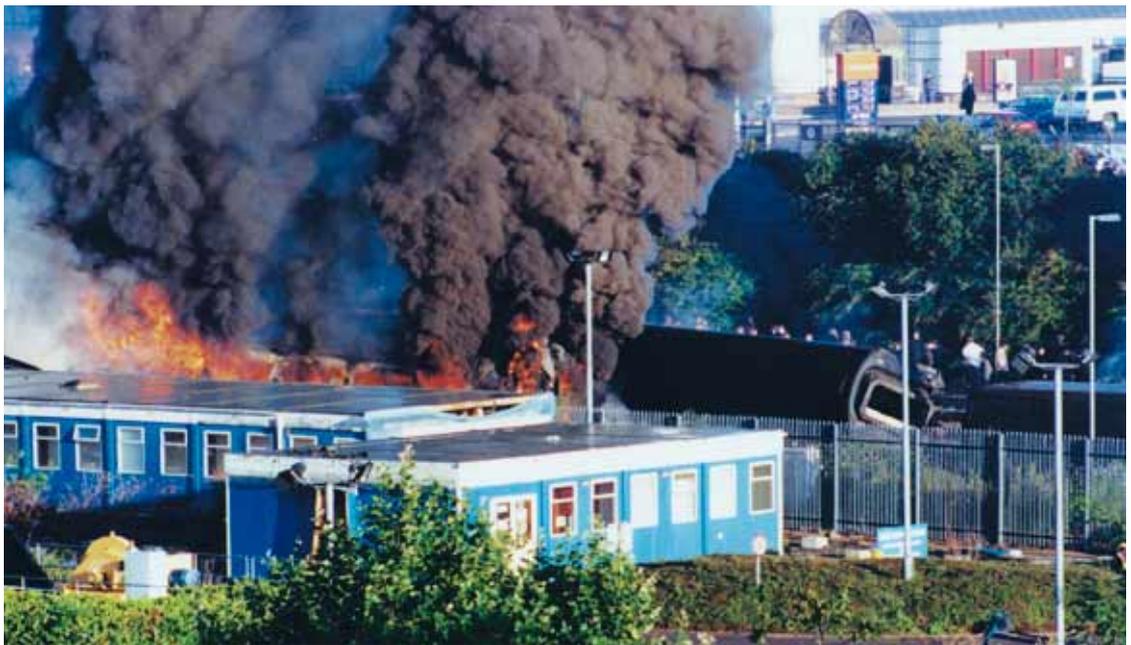
Plate 10: Later stage of the fire in coach H of the HST: view from the south.

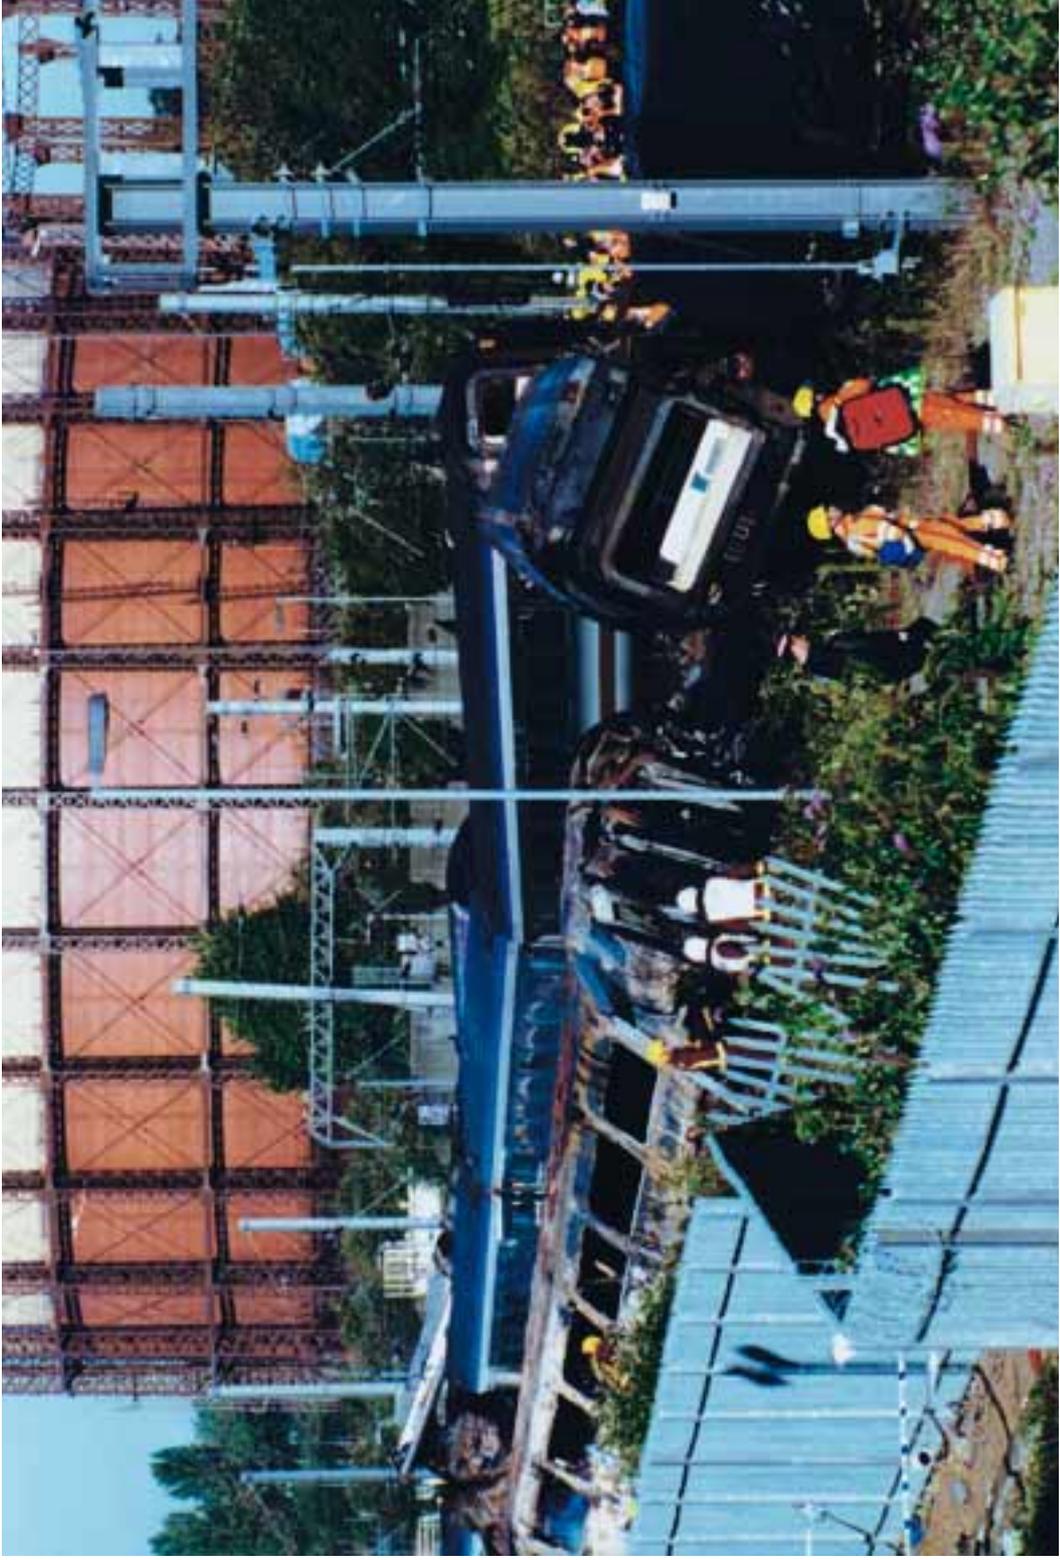
Plate 11: Crash site showing coaches F and H of the HST: view from the south-east.

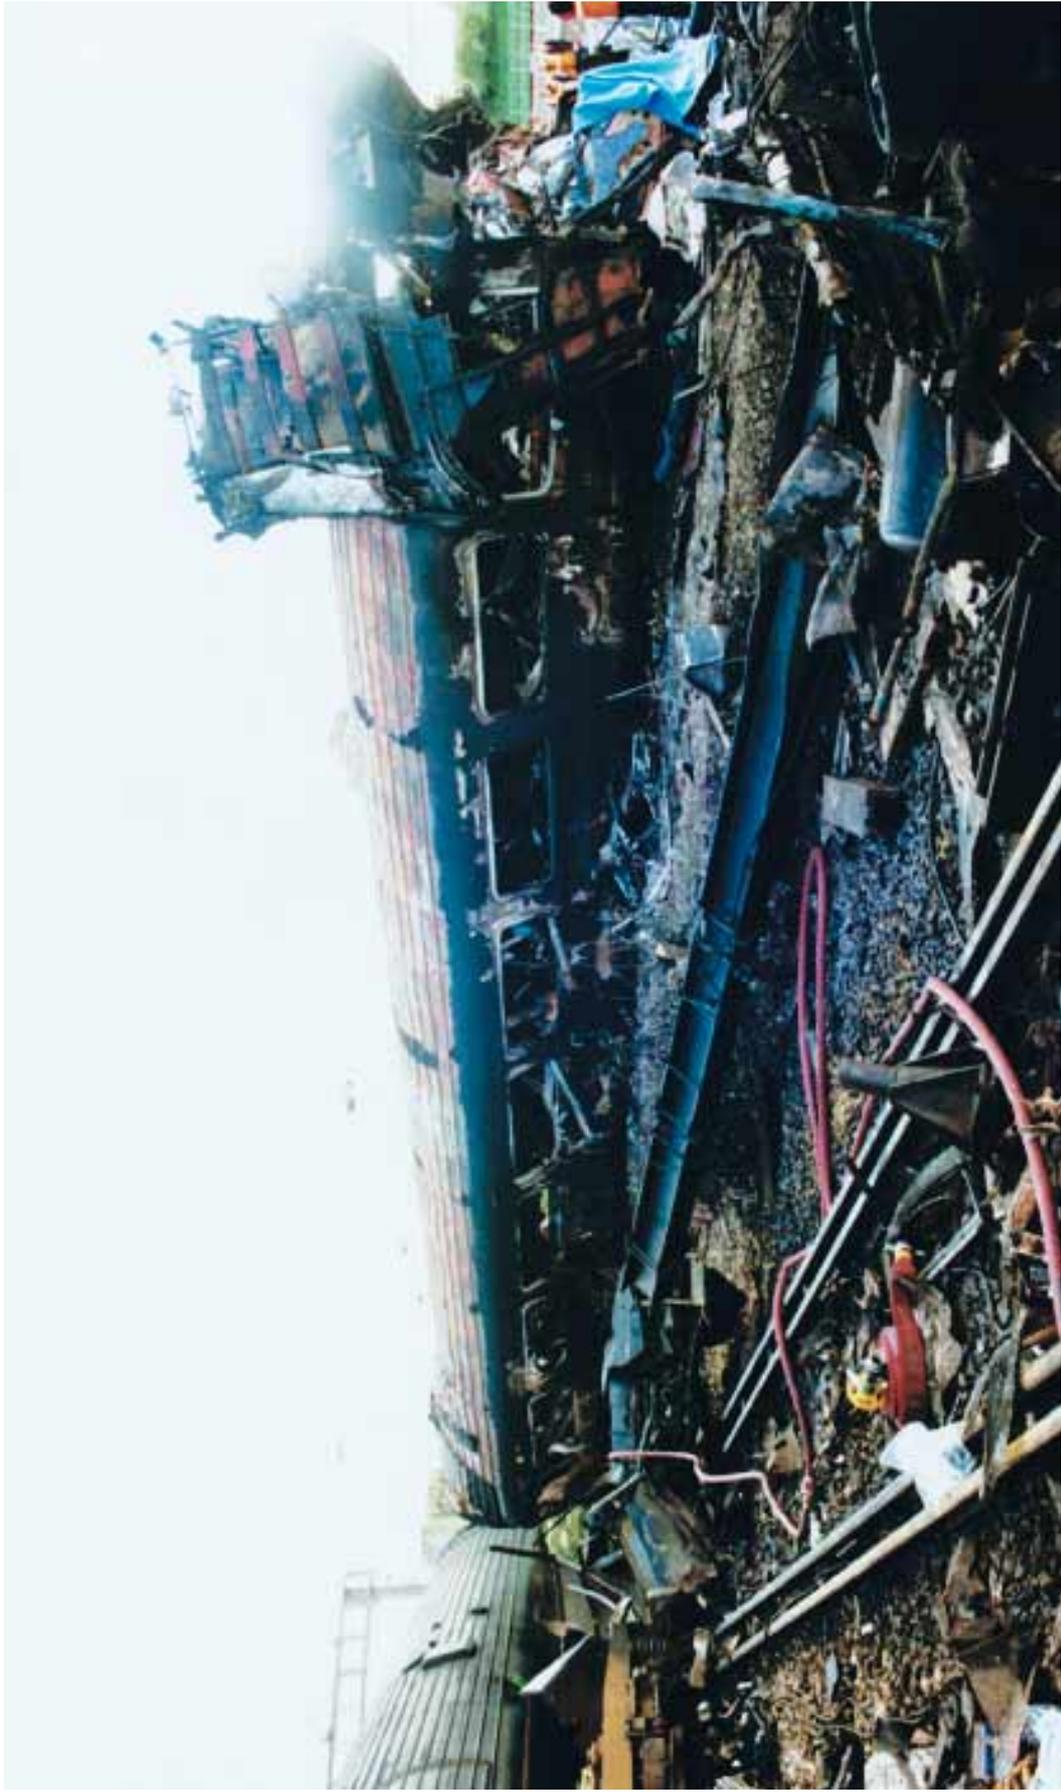
Plate 12: Coach H of the HST: view from the west.

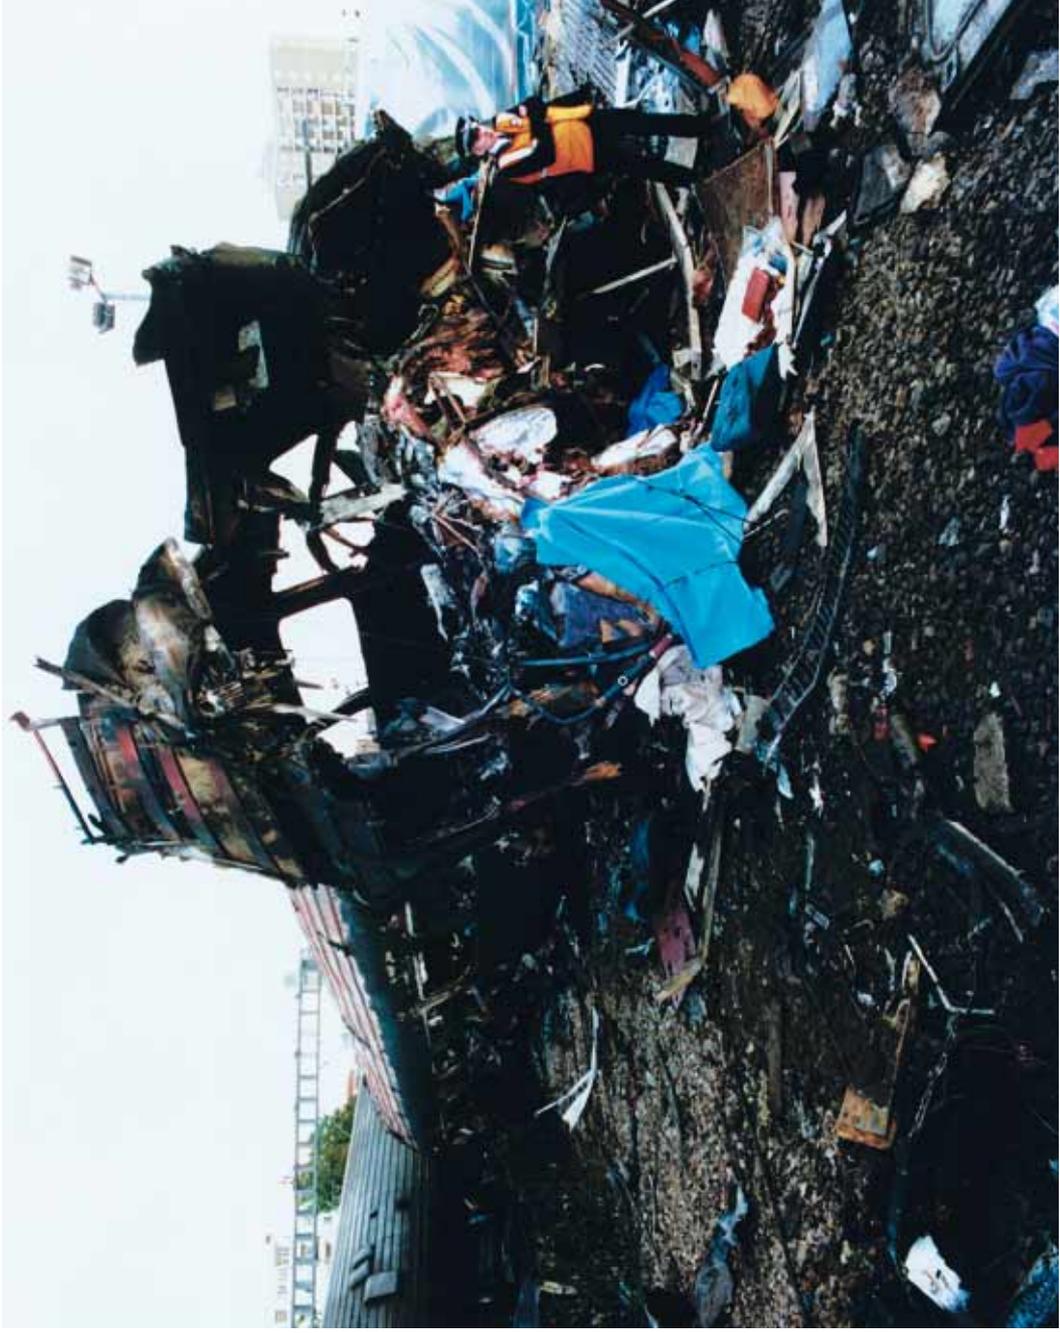
Plate 13: Coach H of the HST: view from the west.

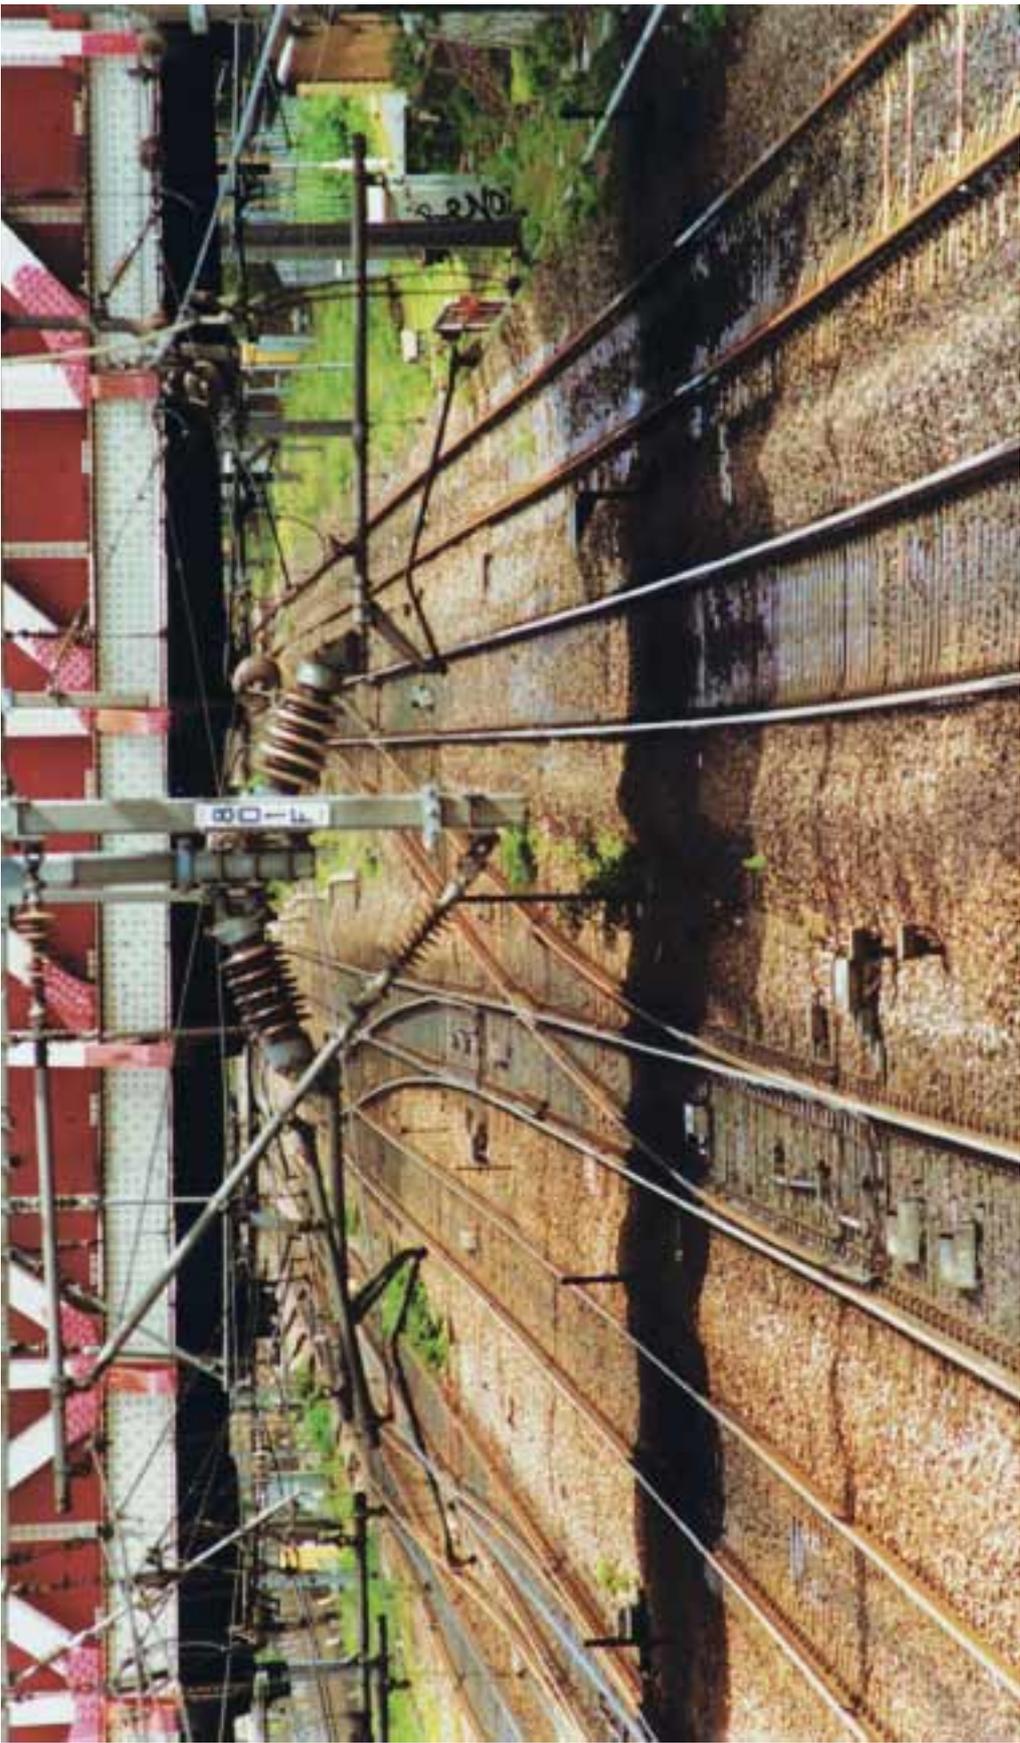
Plate 14: View towards Paddington. Taken from Gantry 8 with the camera placed directly above the red aspect of SN109. The lines are numbered 1 to 6 from right to left. SN109 applies to Line 3.

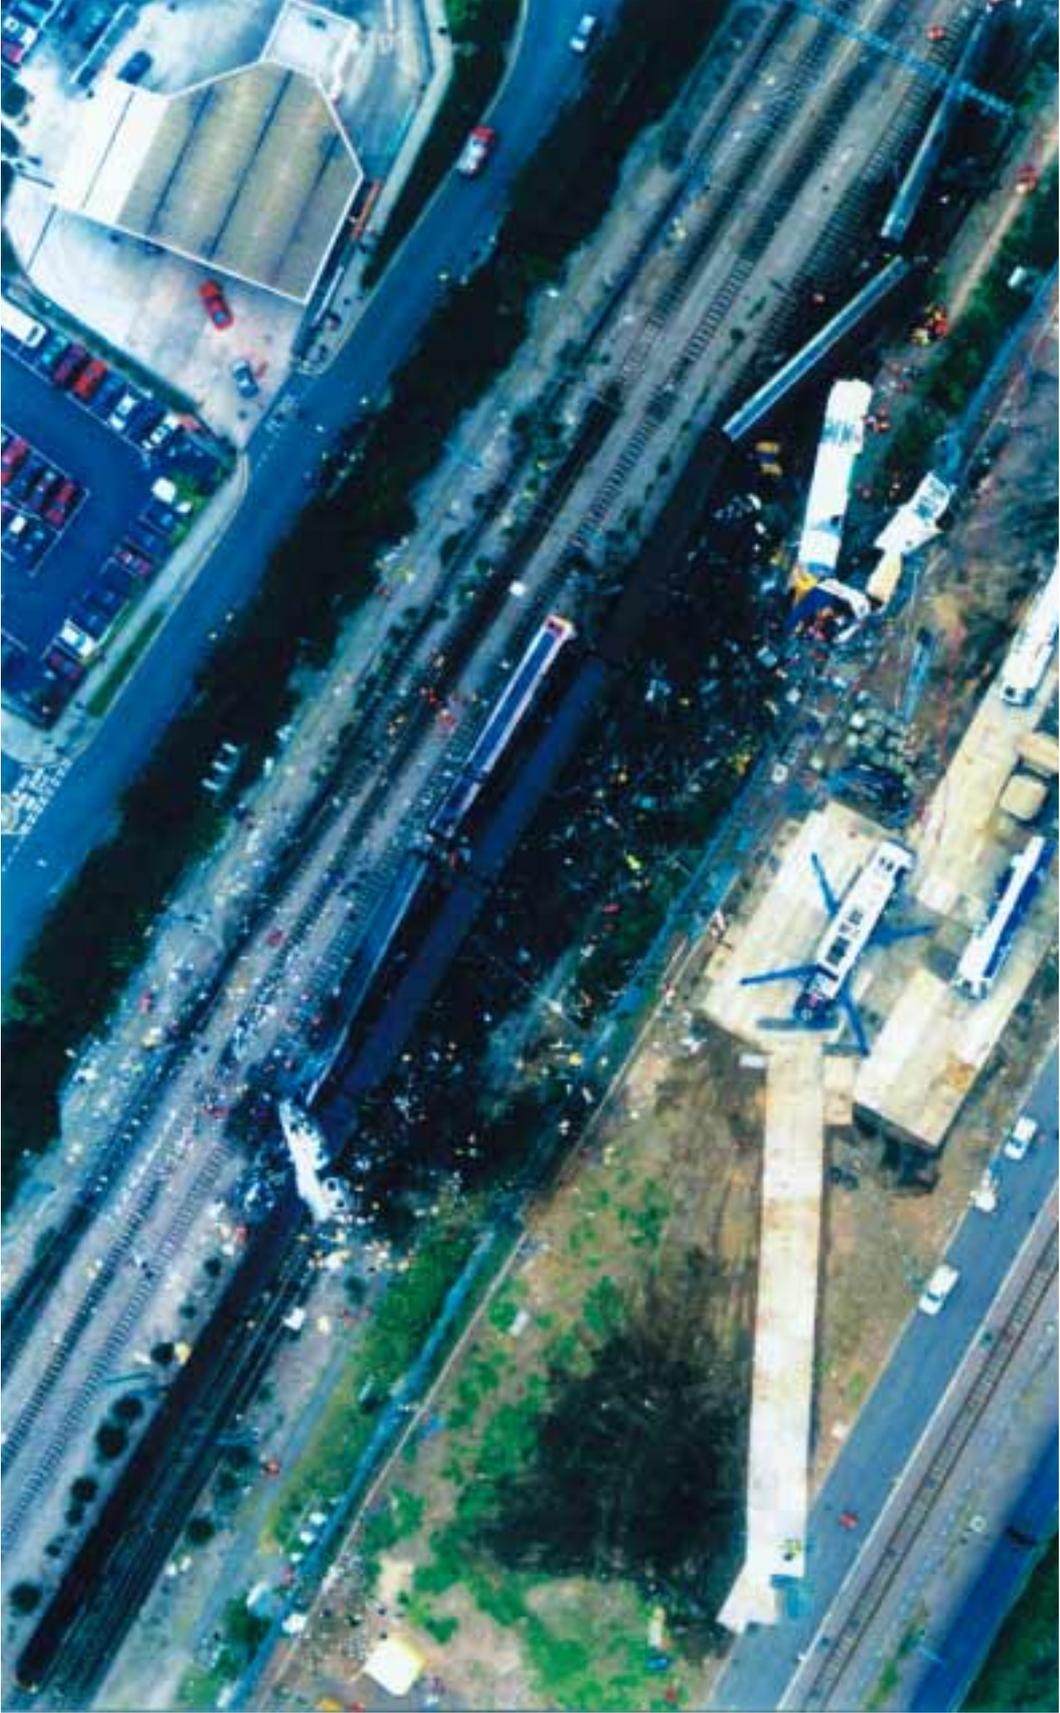
Plate 16: Aerial view of crash site taken on 7 October 1999.
